Hazardous, Toxic, and Radioactive Waste (HTRW) Phase I Appendix

Feasibility Study Horlick Dam Ecosystem Restoration Section 506 Project Racine, Wisconsin

Hydraulics and Environmental Engineering Section

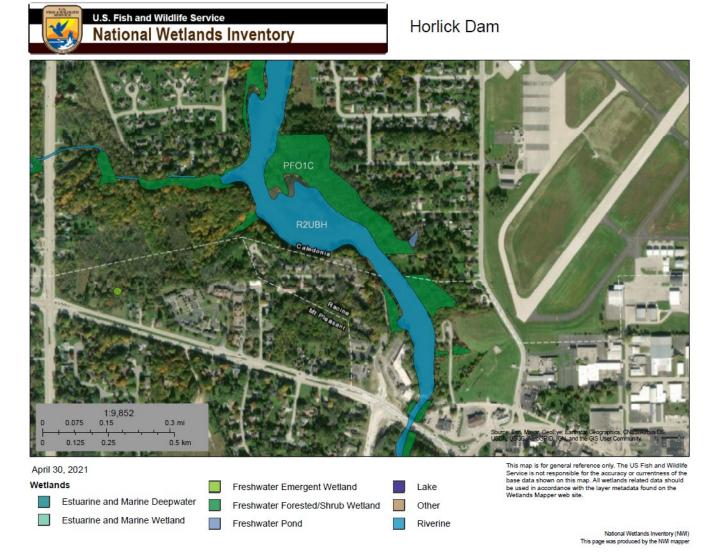
Figure 2: USFWS Wetland Inventory

The study area includes portions of 195 acres of riverine habitat classified as R2UBH by the U.S. Fish and Wildlife Service (USFWS) (Figure 2). R2UBH indicates the following:

Depending on final bank work areas, some of the boarder areas are classified as freshwater

forested/shrub wetland.
