Attachment 2: 1980's Feasibility Report
Geotechnical Appendix

GEOTECHNICAL INVESTIGATION
McCOOK LEVEE, McCOOK, ILLINOIS
FEASIBILITY STUDY

GEOTECHNICAL INVESTIGATION McCOOK LEVEE

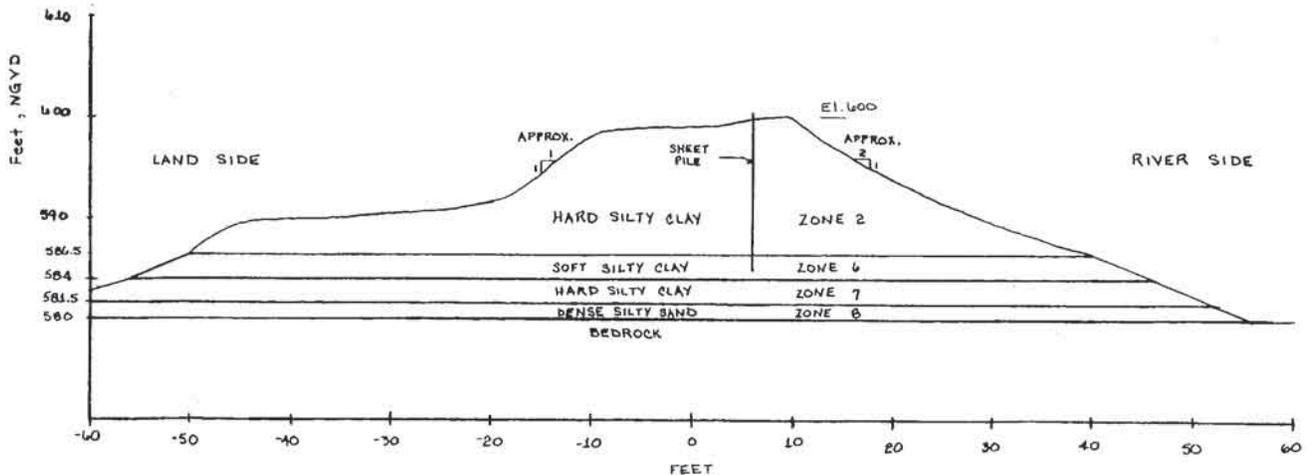
Figure C-1
Sta 11+25 - Existing Conditions
McCook Levee

31. Figure C-1 shows the existing condition at Sta. 11+25, which is typical for Reach B. It was decided that the river side slope should be checked by the infinite slope method due to the small area of levee riverward of the steel sheet piling. The factor of safety for the slope, assuming no horizontal seepage is 1.15. A factor of safety of 1.0 is sufficient for infinite slope, so the existing condition of the slope on the riverside is satisfactory. However, the existing crown at this section of the levee is EL. 600 which would be overtopped by a storm with a 25-year frequency or more (see table C-3).

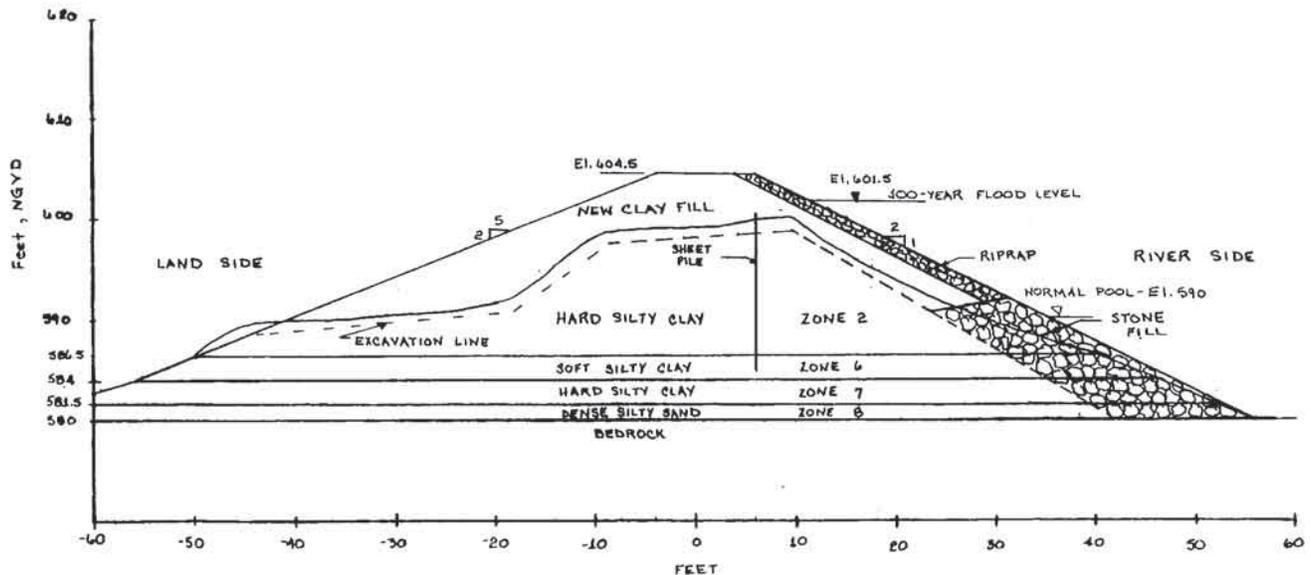
Figure C-2
Sta. 11+25 - Rehabilitation - Alternative I
McCook Levee

32. Figure C-2 shows the cross section recommended by the Geotechnical Branch to rehabilitate this section of the levee to withstand a river height up to the 100-year flood level. For the ease of comparison, only the 100-year flood level protection is discussed in this report; although other levels were examined. This plan, Alternative I, includes three feet of freeboard, a 2H:1V stone filled river slope and a 5H:2V land side slope. The cross section was analyzed for the Partial Pool case and End of Construction case.

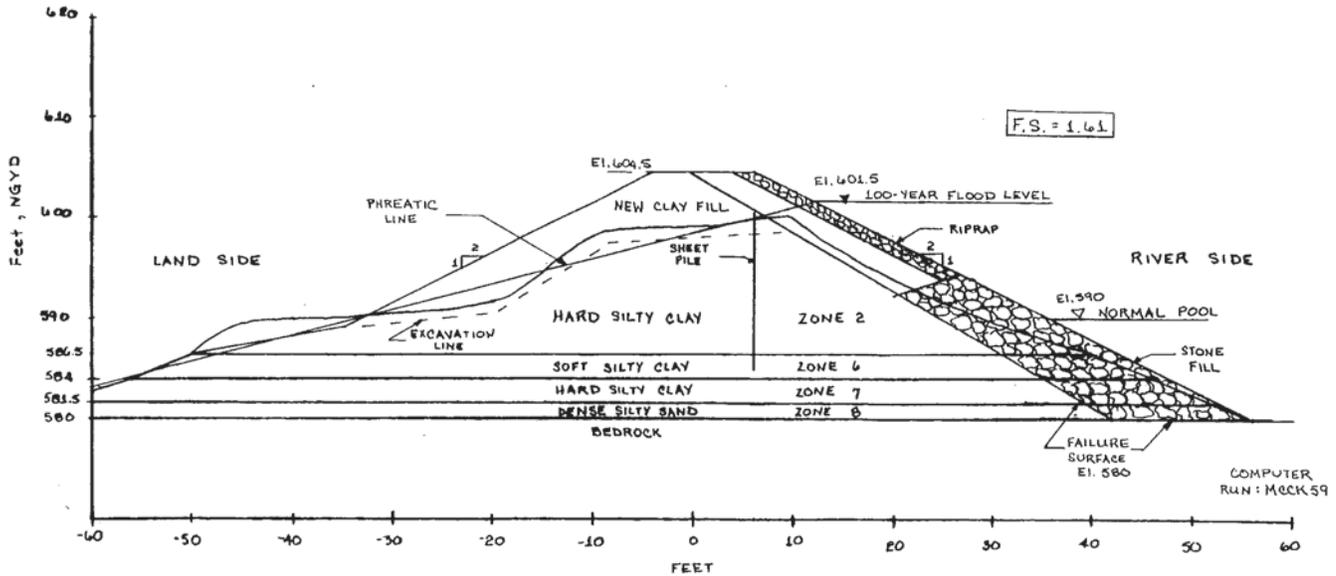
Figure C-3
 Sta. 11+25 - Partial Pool - Alternative I
 McCook Levee

33. The wedge method was used to check the river slope for Partial Pool and the factor of safety was found to be 1.61, as can be seen in figure C-3. The section checked for End of Construction (E.O.C.) on the river side, assuming the river was at normal pool (EL. 590), gave a factor of safety of 2.79, figure C-4 and land side a factor of safety of 2.63, figure C-5. Thus, this proposed cross section is stable.

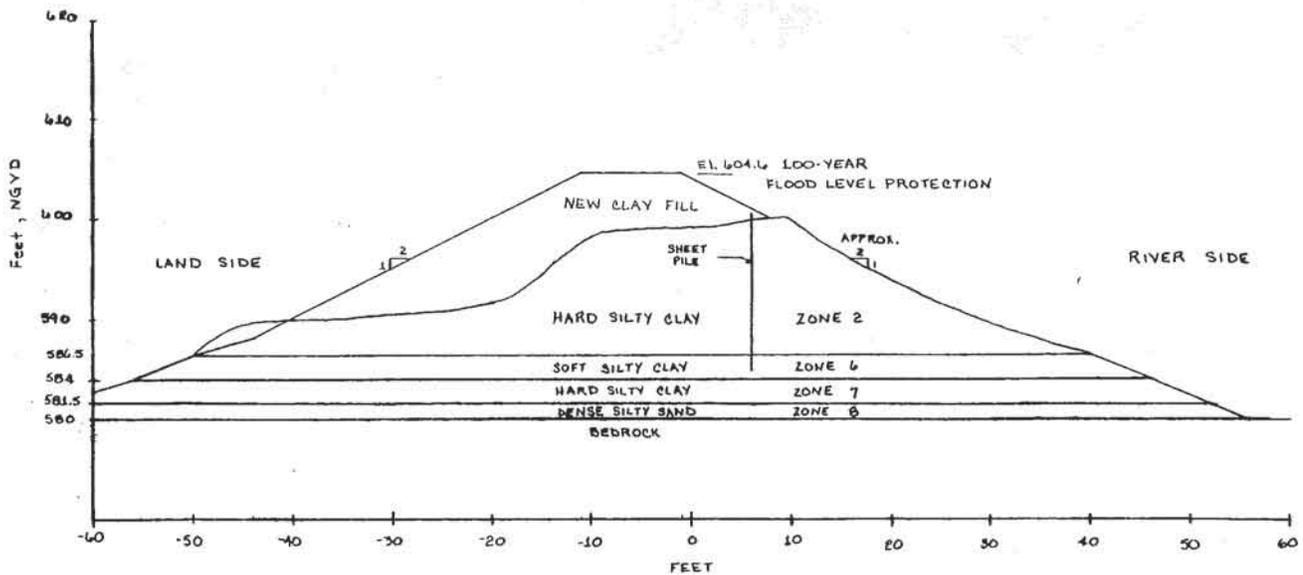
Figure C-6
Sta. 11+25 - Rehabilitation - Alternative II
McCook Levee

34. Figure C-6 shows a plan proposed by NCCPD-P in an attempt to avoid the rehabilitated levee from encroaching on the river channel. This proposed section, Alternative II, was analyzed the same as Alternative I. The factors of safety determined were as follows: Partial Pool - 2.06, figure C-7; EOC - River - 2.01, figure C-8 and EOC - Land - 2.04, figure C-9. This alternative is also considered to be satisfactory.

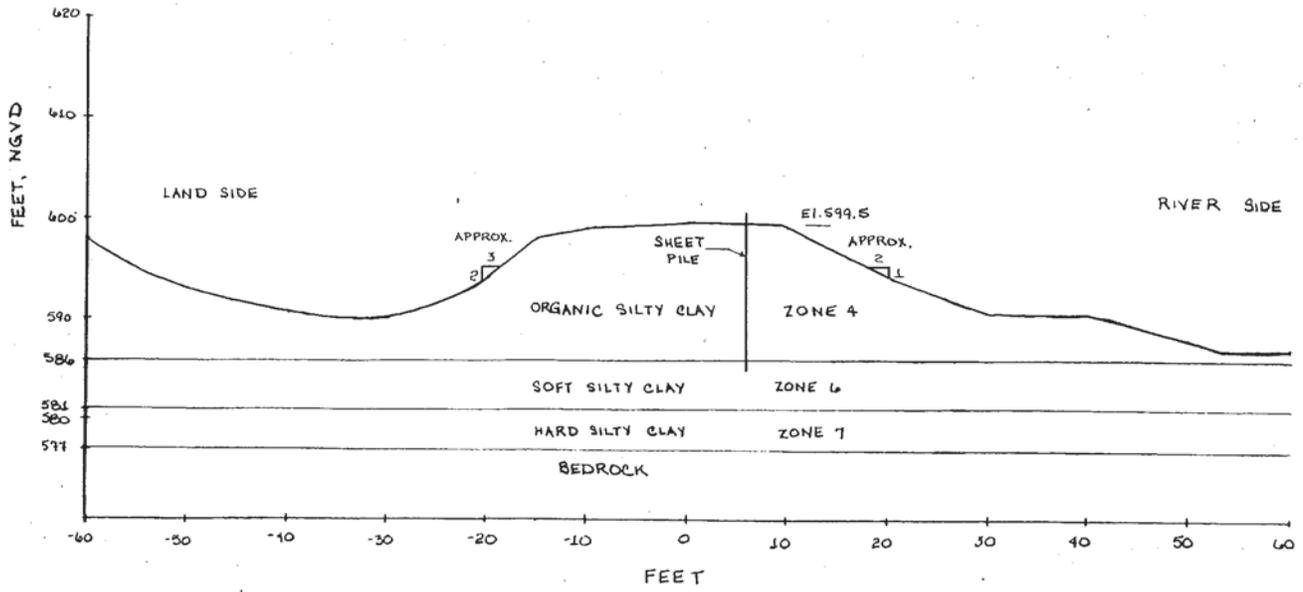
Figure C-10
 Sta. 23+00 - Existing Conditions
 McCook Levee

35. Figure C-10 shows the existing condition of Sta. 23+00, which is typical for Reach C. The river side slope was also checked on this section by the infinite slope method. The factor of safety equals 0.89, which is insufficient. Figure C-11 shows the proposed rehabilitation for this reach. The minimum factor of safety for the Partial Pool case was found to be 1.86, see figure C-12. Figures C-13 and C-14 show the End of Construction cases for river side and land side and the factors of safety were 1.18 and 1.07, respectively. 2H:1V slopes are therefore insufficient for Reach C.

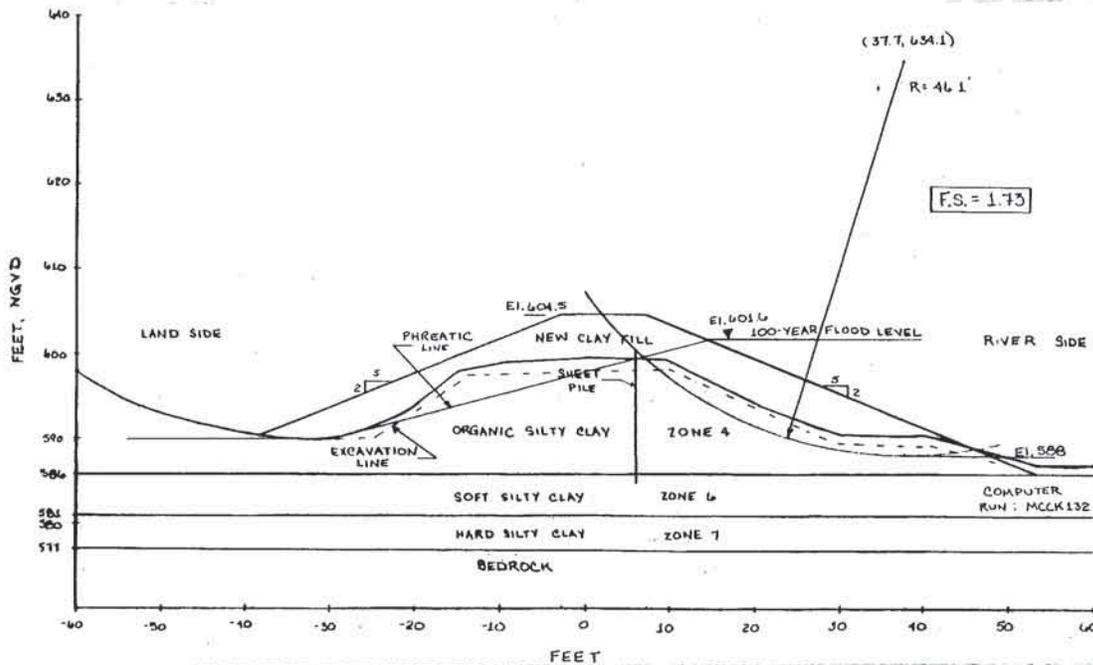
Figure C-15
Sta. 23+00 - Partial Pool - 5H:2V Slopes
McCook Levee

36. The cross section for Sta. 23+00 was revised to contain 5H:2V slopes both river and land side. Figure C-15 shows how this cross section withstands a Partial Pool condition with a river side circular arc failure surface. The factor of safety was found to be 1.73.

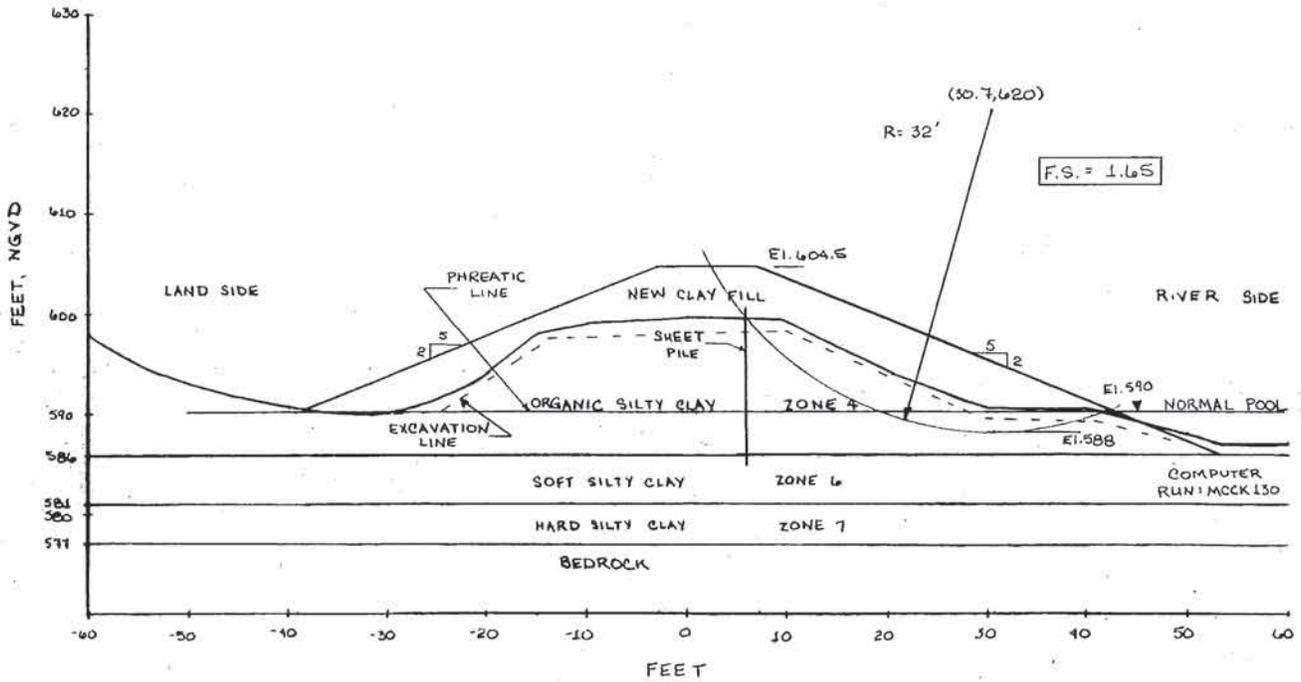
Figure C-16
Sta. 23+00 - End of Construction - River Side
McCook Levee

37. The revised cross section was also checked for End of Construction as in figures C-16 and C-17. The river side failure surface produced a 1.65, but the land side arc was determined to have an insufficient factor of safety of 1.23. Therefore a 5H:2V is needed for the river side slope of Sta. 23+00, but the land side slope will need a 3H:1V slope or an alternative rehabilitation.

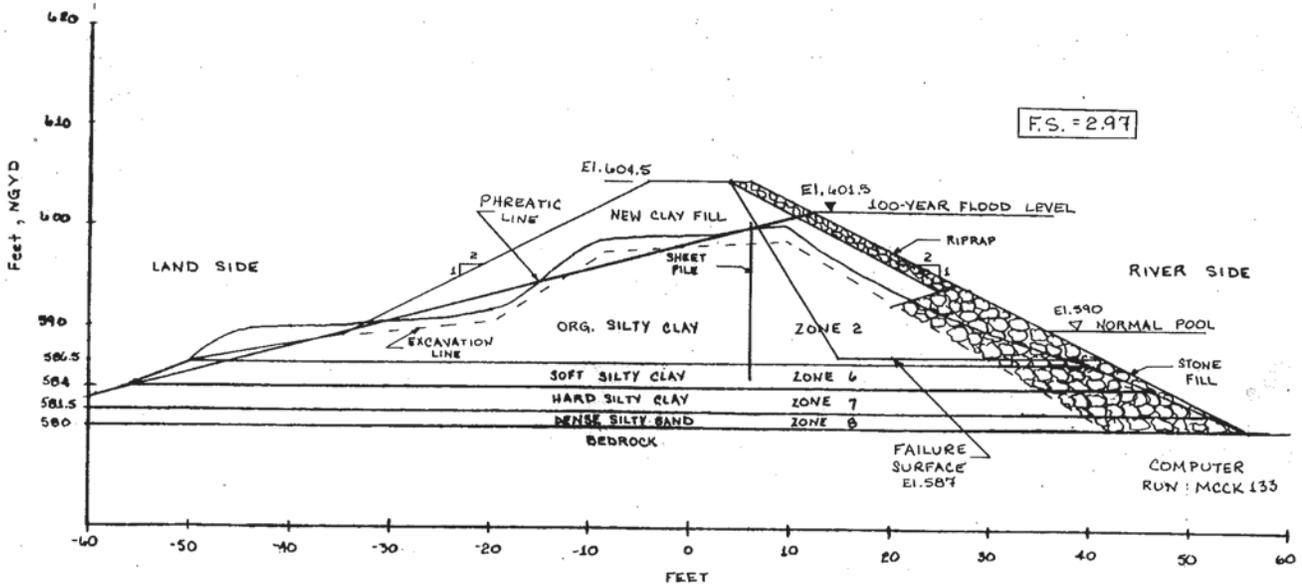
Figure C-18
Sta. 17+00 (Approx.) - Partial Pool
McCook Levee

38. The levee between Sta. 11+25 and Sta. 23+00 was not surveyed, but from the aerial photographs it appears that the cross section taken at Sta. 11+25 is very similar. This section is also very close to the river and, thereby restricted the same as Sta. 11+25 as discussed in paragraph 29. The soils are not the same as in Sta. 11+25 (see plate C-1), so as a worst case condition; the hard silty clay was replaced in the computer run with organic silty clay. Figure C-18 shows the rehabilitated levee with a 2H:1V stone-filled river side slope and the partial pool condition. A factor of safety of 2.97 was found for this case. A land side berm was added to the section to increase the stability of the levee on the land side and figures C-19 and C-20 show the levee with the End of Construction case for river side - F.S. = 3.70 and land side - F.S. = 1.84.

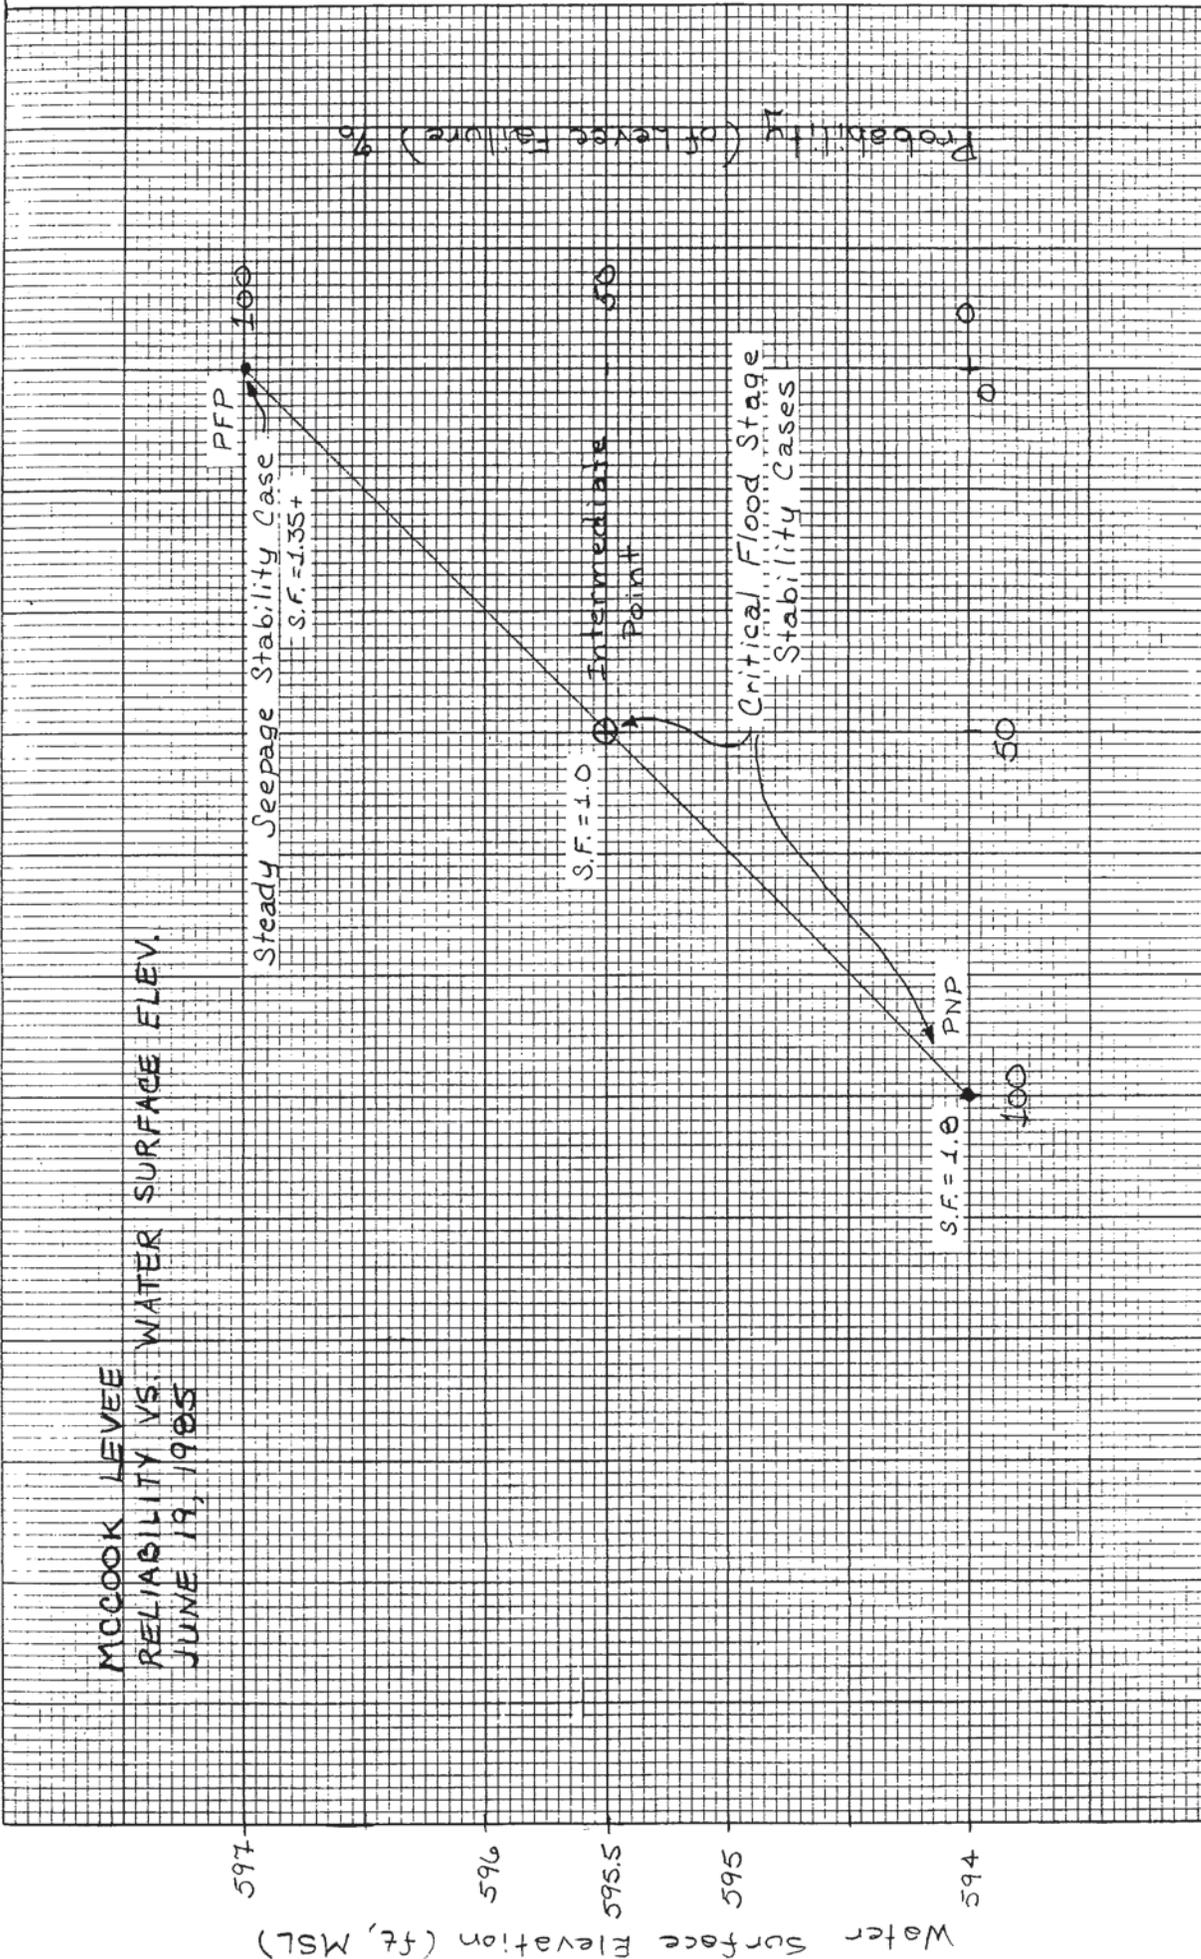
MCCOOK LEVEE
 RELIABILITY VS. WATER SURFACE ELEV.
 JUNE 19, 1985

48. The open circle shown on Figure C-21 was determined by the methods of stability analysis as described in paragraph 28. The stability case involved herein is defined as the "Critical Flood Stage", wherein the water surface elevation is varied on the riverward levee slope until the lowest safety factor is obtained. This provided a safety factor of 1.01 for a water surface elevation of 595.5. At a water surface elevation of 593.5, the corresponding safety factor increased to 1.8. For a water surface elevation of 596 the factor of safety was found to be 1.6. The accepted minimum factor of safety for this condition is 1.4. The other condition for analyzing the riverward slope is the "sudden drawdown" case; however, this was not considered appropriate since the stage-frequency curve indicates slowly falling water for mid-embankment elevations which the outer soil slope could probably adjust to, partly due to the steel sheet piling and soil types. The normal pool elevation for the Des Plaines River ranges between 590 and 593.
