Attachment 3: Fragility Curve Determinations

MEMORANDUM FOR PM-PL

SUBJECT: Fragility Curve Determination for McCook Levee North and South of 47th Street

SUBJECT: Levee Inspection on the Des Plaines River in the Vicinity of
Village of McCook, Cook County, Illinois

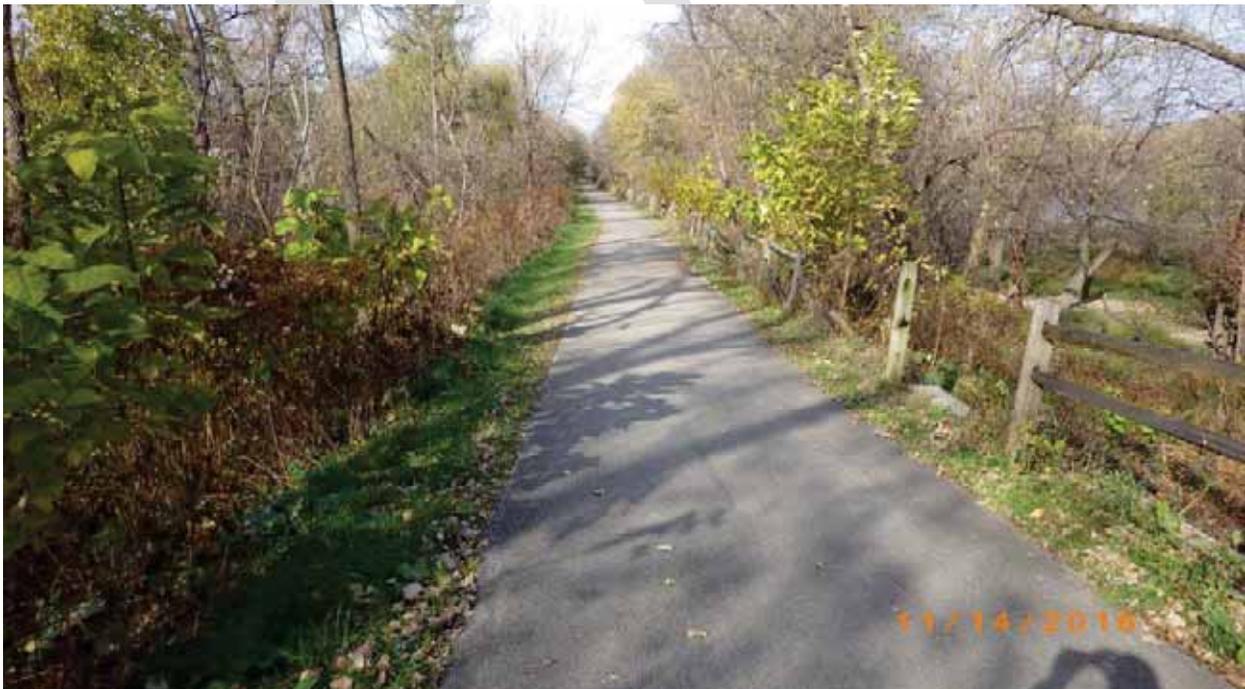
6. A field visit was completed on 14 November 2016 by Dan Ferris and Justin Griffeth to walk the levee north of 47th Street. As shown in the photo below, the crest of the levee has an asphalt bike path and wooden fence on the riverside. The slopes of the levee are covered in vegetation and some mature trees. The landside toe was investigated for features such as culverts, encroachments, etc. but none were identified. The date of construction is unknown, and there are no as-built drawings or soil borings available for the levee.

Figure 3: Typical photo of levee north of 47th St

9. The existing levee north of 47th Street was noted for the high amount of vegetation. This vegetation limited the inspection’s ability to note additional deficiencies such as animal burrows, erosion, depressions, etc. although none of these were noted. The vegetation can also increase the risk to the levee, as tree roots create seepage paths through the berm and it makes inspection and flood-fighting during events difficult. Also, trees can fall over and pull their root wad out of the levee, creating possible instability, seepage, and erosion issues.

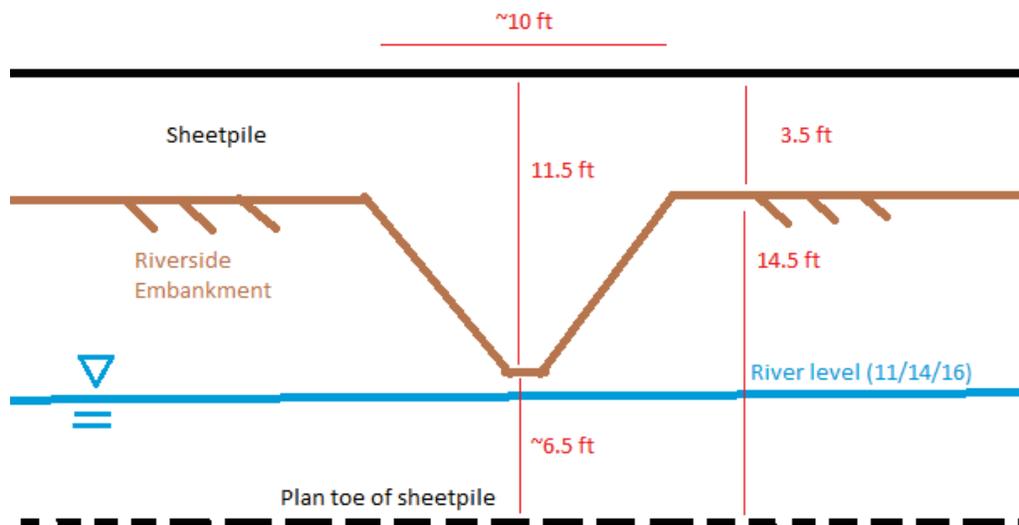
4. A field visit was completed on 14 November 2016 by Dan Ferris and Justin Griffeth, where the riverside slope was noted to have two locations that show significant erosion. The more extreme case was near Sta. 20+25 where about 11.5 ft of sheetpile was exposed, as measured from the top of sheetpile to exposed toe. Another location near Sta. 12+50 measured about 6 ft of exposed sheetpile. A drawing and photo of the more extreme case is shown below.

Figure 1: Drawing of worst erosion (Sta. 20+25) view from river

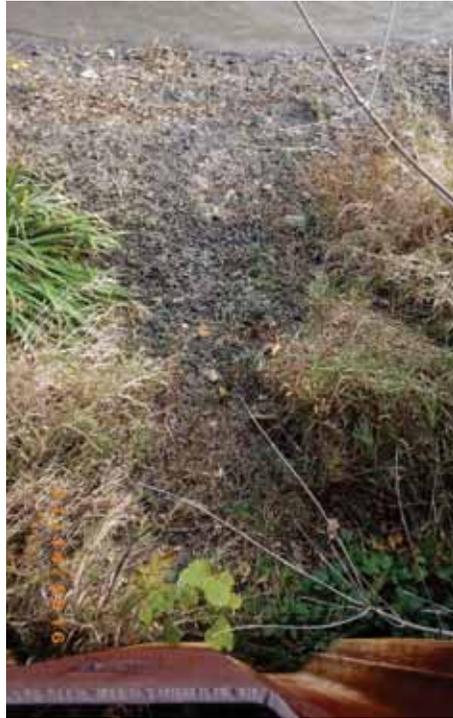
Figure 2: Photo of erosion near Sta. 20+25 with 11.5 ft dropoff from top of SSP to exposed toe

9. The vast majority of the wall does not have over 9 ft of exposed wall on the riverside. Only one spot was noted as having a greater amount of wall exposed, near Sta. 20+25 with around 11.5 ft exposed. This location is isolated, and the riverside slope immediately returns to normal grade around it. CWALSHT does not take into account any 3-D benefits that this location is likely receiving.
10. Another unknown failure mode is deflection. The plans call out sheetpile PSA-23, but this is a flat sheetpile type. The sheetpile onsite is a U-shape, which after measuring in the field it most closely resembles JSP-2. CWALSHT estimates the deflection of JSP-2 to be about ½ inch for the case at Sta. 20+25 Refer to Wall7_R (Ref 3). This is acceptable.

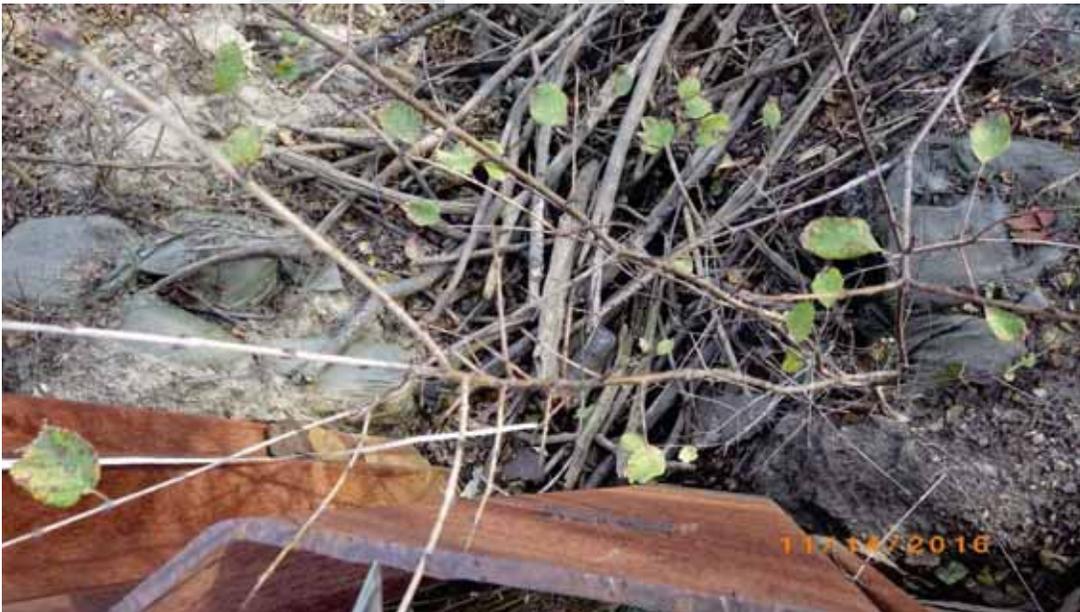
5. The less extreme erosion point with a dropoff of about 6 ft is noted for the sandbags along the riverside of the floodwall. It is unknown why these sandbags are here, but it is possible they were placed there to reduce riverside erosion during a flood.

Figure 3: Photo of erosion near Sta. 12+50 with 6 ft dropoff and sandbags

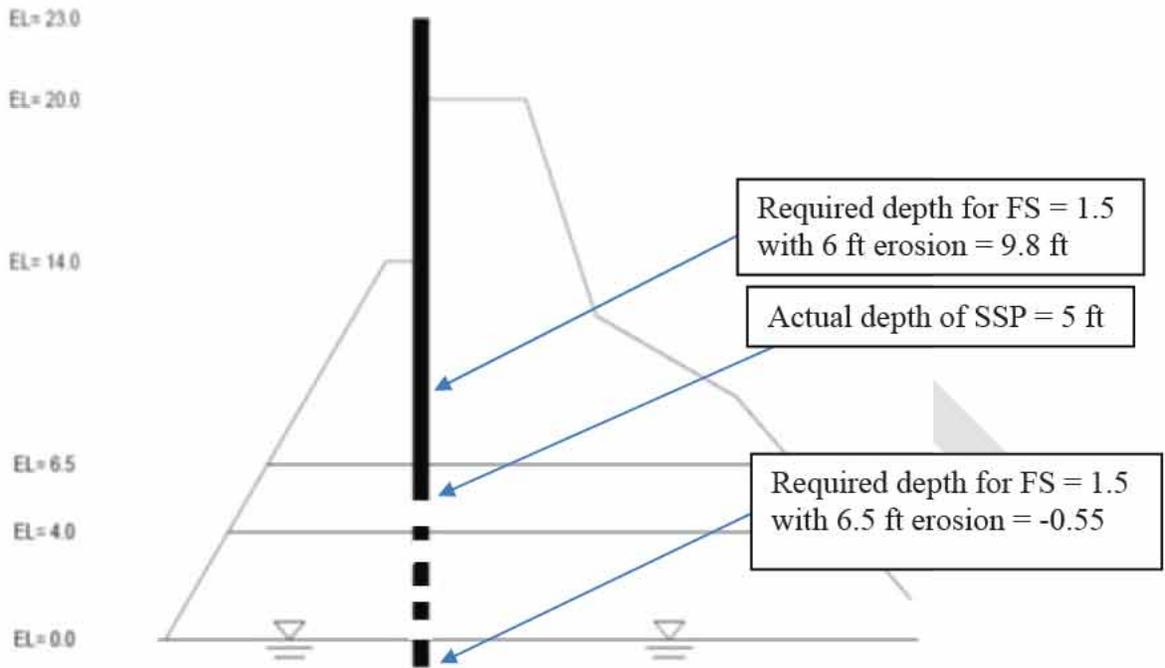
7. Results from each run can be found in the referenced excel file. The critical height on the riverside occurs when between 6 and 6.5 feet of material has eroded, creating about a 9-foot drop from the sheetpile top tip to the exposed sheetpile toe. Refer to Wall5 and Wall6 in the analyses (Ref 3). This critical height was determined by running the case with 6 ft of erosion and inserting a minimum factor of safety = 1.5. The program calculated the sheetpile embedment depth in order to meet this factor of safety, which was above the actual embedment depth. Then, the case with 6.5 ft erosion was run under the same conditions, which resulted in a required embedment depth deeper than the actual condition. Therefore, it can be assumed that the existing sheetpile wall has a FS = 1.5 somewhere between 6 and 6.5 ft of erosion.

8. Figure 5 below is the output from CWALSHT, with the actual sheetpile depth and the minimum calculated depths to meet factor of safety = 1.5 based on different riverside erosion heights.

Figure 5: CWALSHT representative cross section with calculated and actual tip elevations

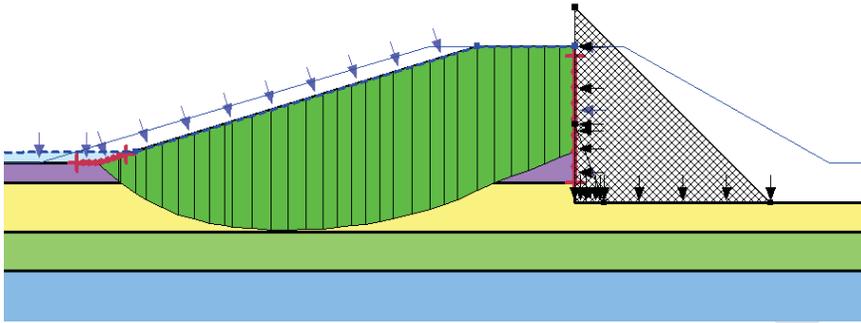
14. Since the total height of the floodwall greater than Z_0 ($20 > 8$), the potential gap extends just 8 ft below the top of the levee (elevation 592 ft). The tip elevation is 584 ft, so there is 8 ft of active earth pressure acting on the bottom portion. The cross section was drawn without the floodwall and river side soils to determine how a saturated gap would act on the land side soils. A load of 62.4 psf was applied to represent the water, while a load of 749.6 psf was applied to represent the active earth pressure. The protected side is considered to be completely saturated to be overly conservative. Based on these characteristics, the gap analysis produces a factor of safety of 1.146, which is greater than the recommended 1.0. It is shown below, at Sta. 23+00. Refer to the Fragility Curve Analysis for soil cross section and properties.

Figure 7: SLOPE/W gap analysis result

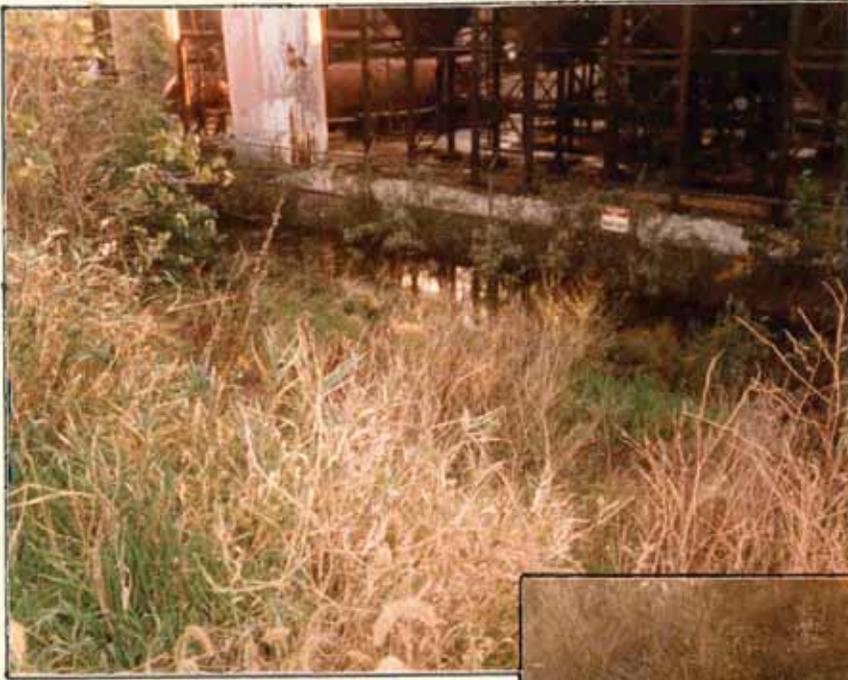
Ponded area on
landward side of
levee between 47th
St. and R.R. tracks

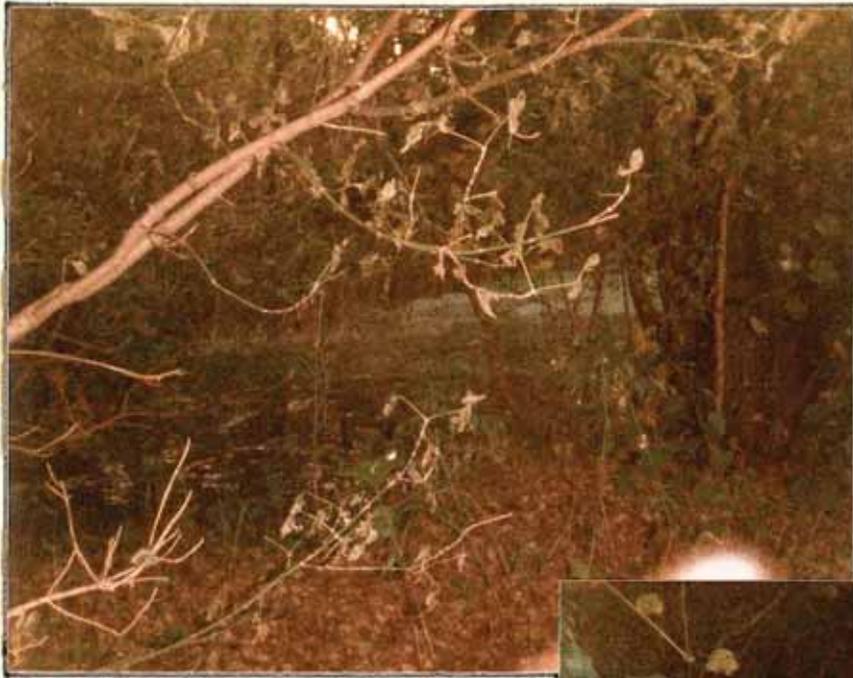
Crown of levee near
Sta. 30+00. Concave
top allows ponded
water.

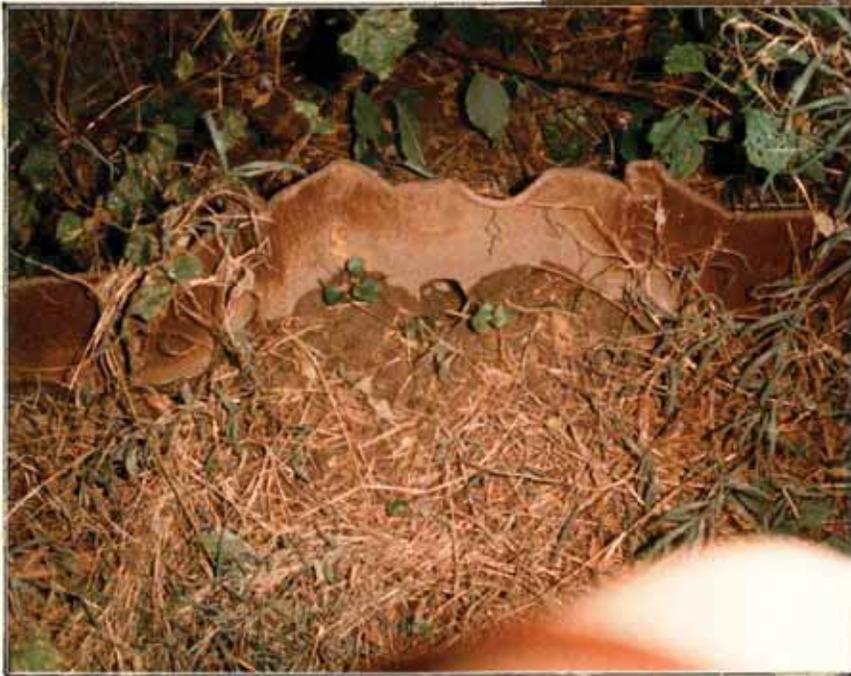
Erosion on landward
side of levee

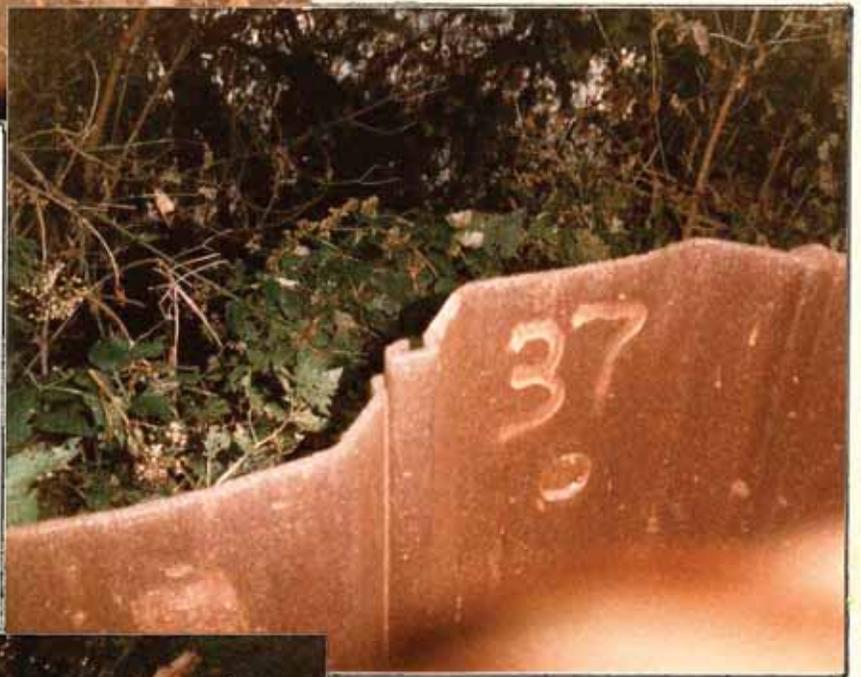
(6) At one location an 8 inch diameter tree trunk or limb had fallen and was lying across the sheet pile wall. There was no damage or reduced sheet pile wall effectiveness noted.

Small tree fallen
across steel sheet
pile

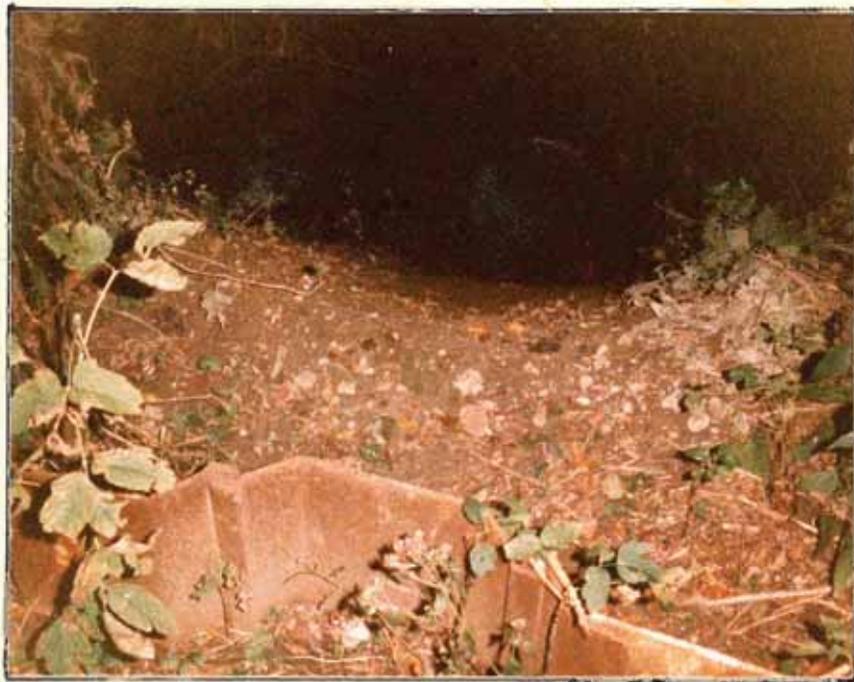
Erosion on river
side of levee near
Lawndale Ave.

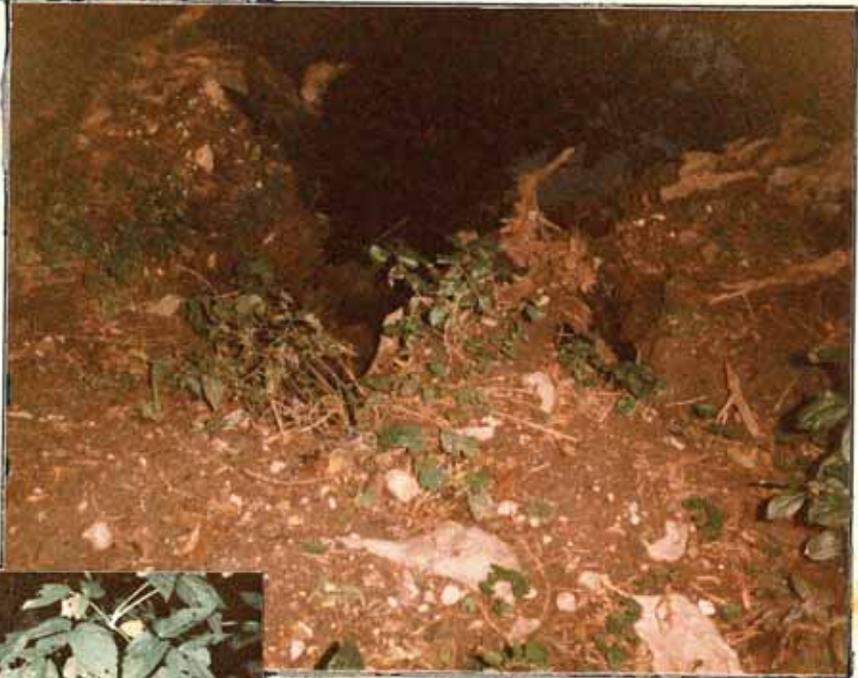
Seepage on landward
side near Sta. 3+60
thru 4+50. Standing
near drainage ditch,
looking toward levee.

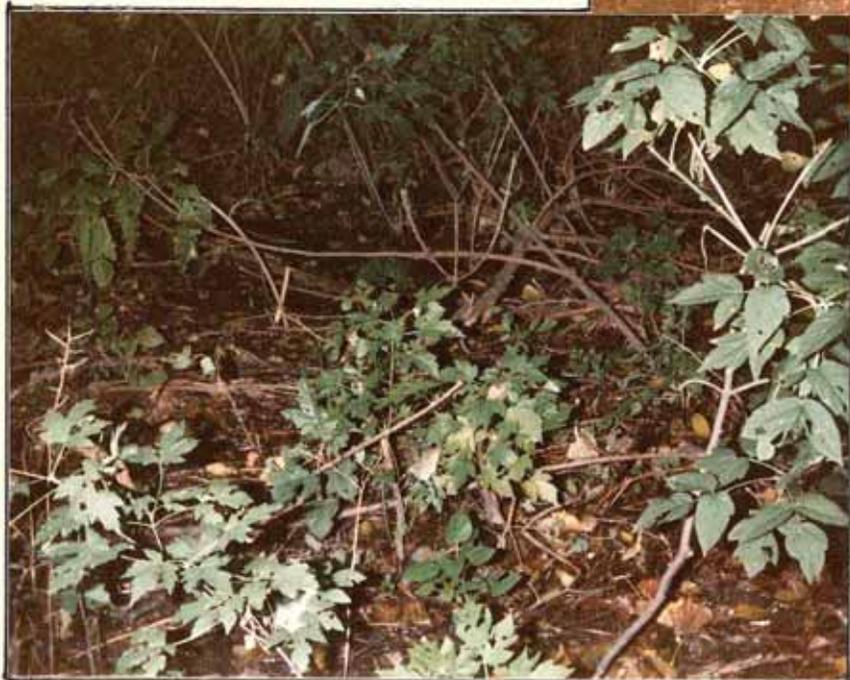
(4) Water was noted to be ponding on the landward toe about (station 3+50 as marked on the sheet pile wall) 1,000 ft. from the Lawndale avenue end in one 25 foot area. Leaves were seen floating but no pin boils, bubbling or signs of uplift were observed. This could indicate that some limited underseepage (1-2 gpm) could be taking place. This area should bare watching if an increased differential head develops.

Seepage Sta. 3+60 thru
4+50. Looking toward
levee on landward side

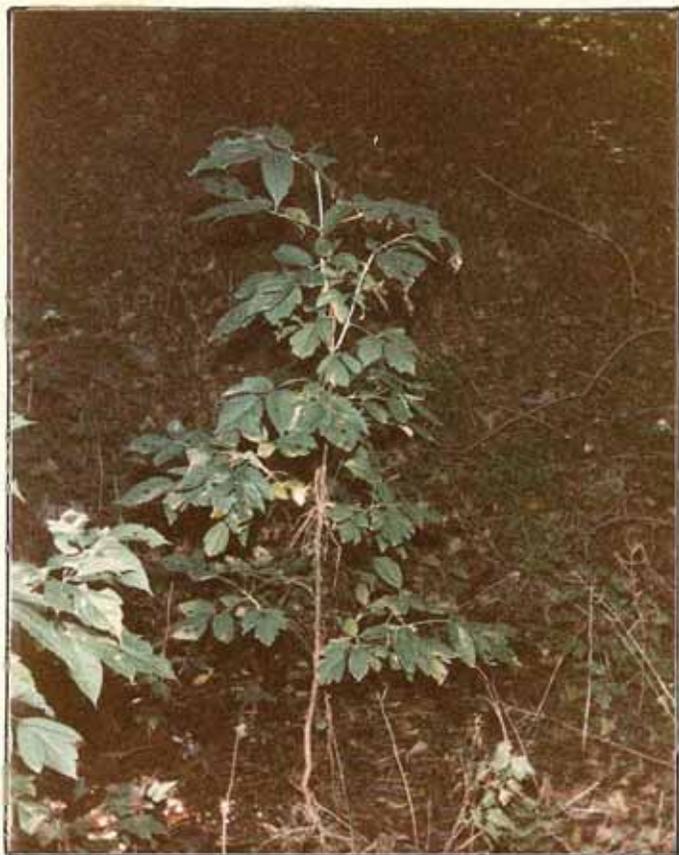
Seepage exit to drainage
ditch ~ Sta. 3+60 thru
4+50. Drainage ditch in
upper left hand corner
of photo.

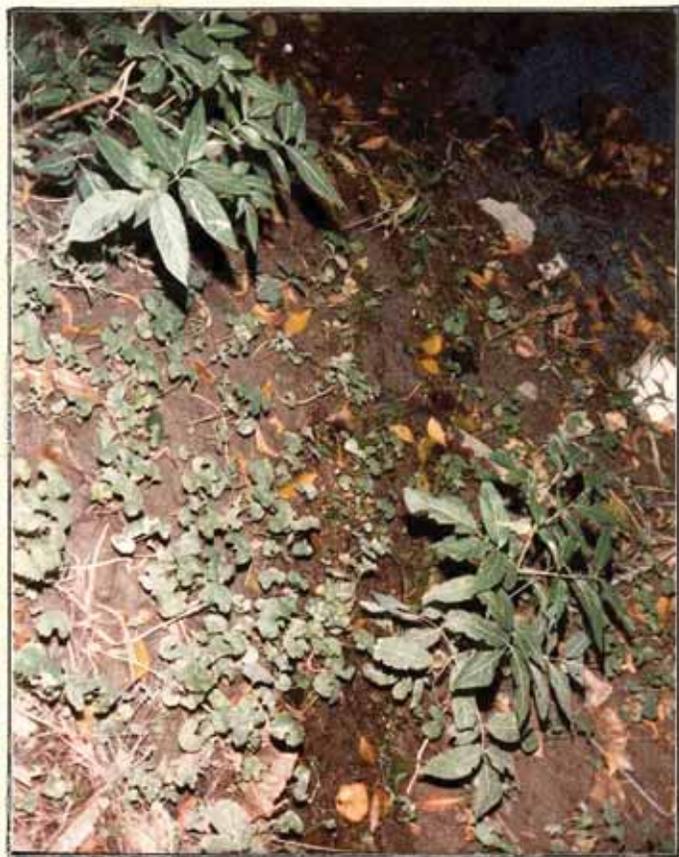
Seepage area,
Sta. 3+60 to 4+50
landward side

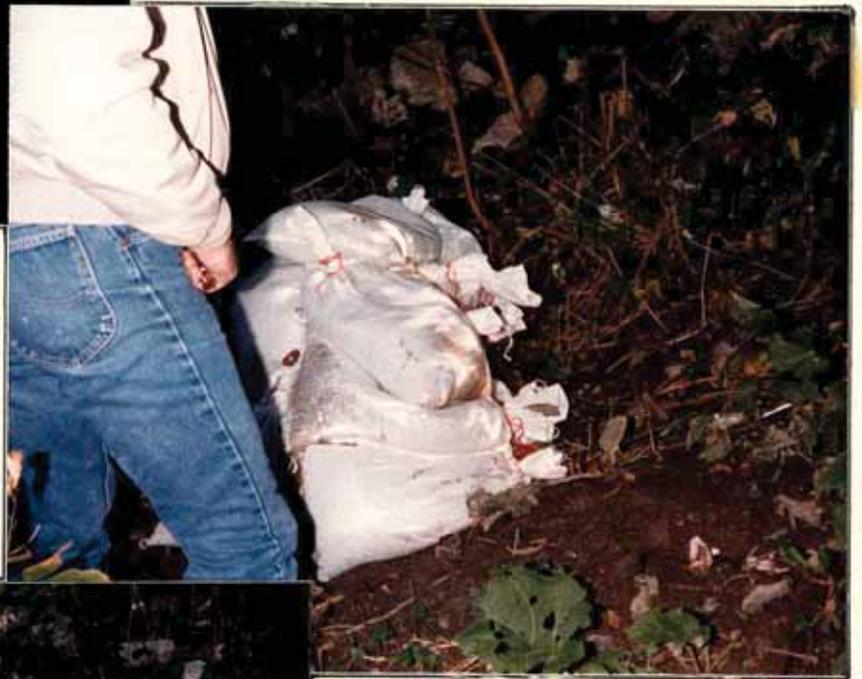
Sand bag filled blow
out section on land-
ward side of levee
slope just south of
Lawndale Ave.

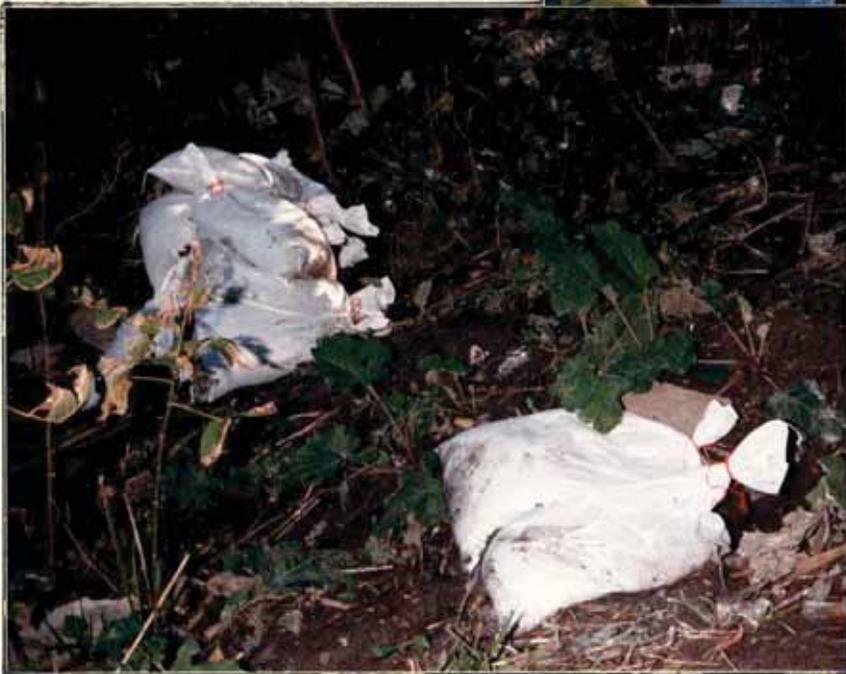
Area where sandbags
were filled for over-
topped levee south
of I-171

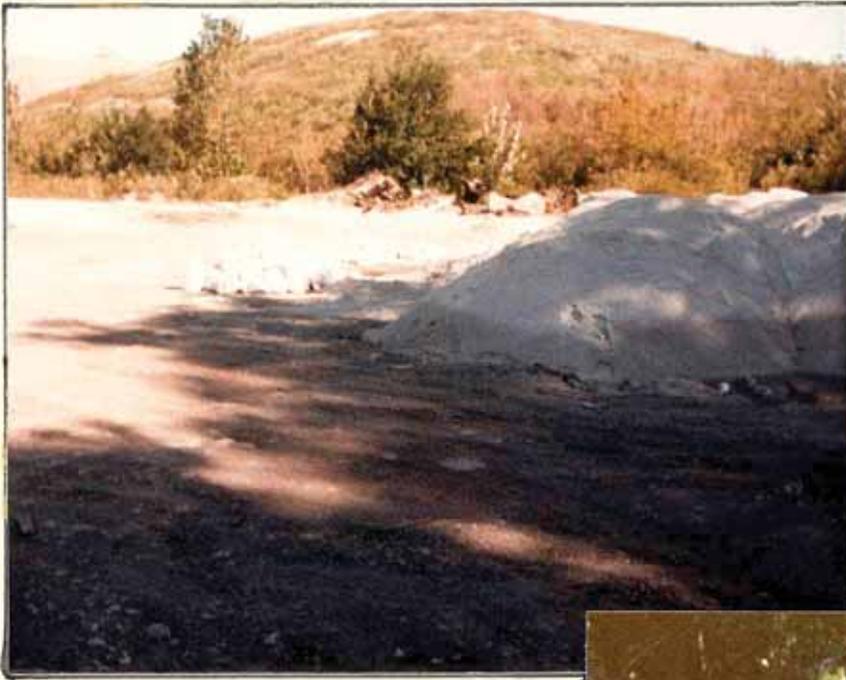
Temporary rubble
levee placed by front
end loader to control
overtopping. Looking
toward Des Plaines R.

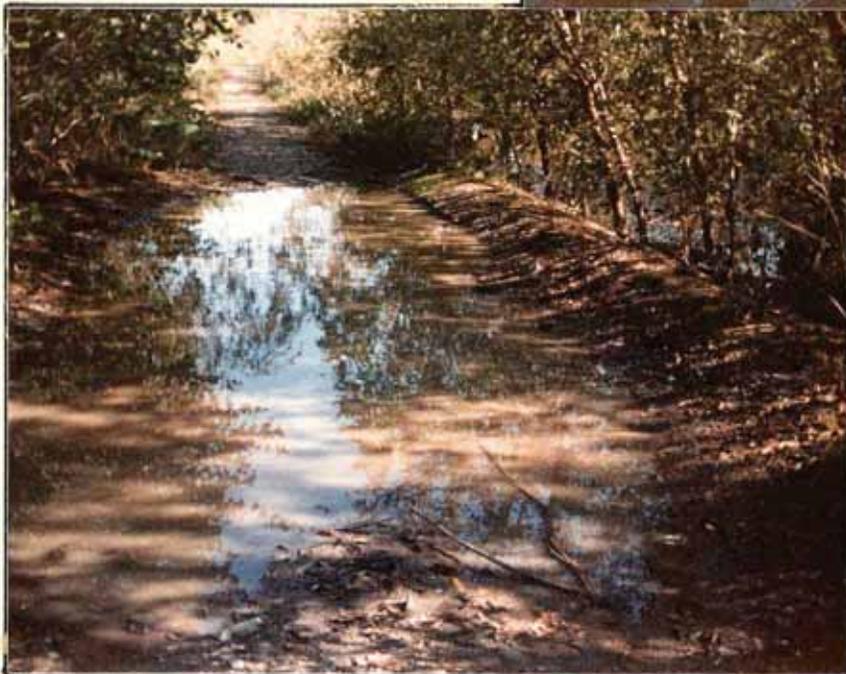
Standing water
on crown of levee.
River on right
side of photo.
