Saganashkee Slough - McMahon Woods Section 506 Great Lakes Fishery & Ecosystem Restoration Study

Appendix E – HTRW

SUBJECT: Supplemental HTRW Review for McMahon Fen Ecosystem Restoration Project Area

**HAZARDOUS, TOXIC, AND RADIOACTIVE WASTE (HTRW)
AND NON-HTRW INVESTIGATION**

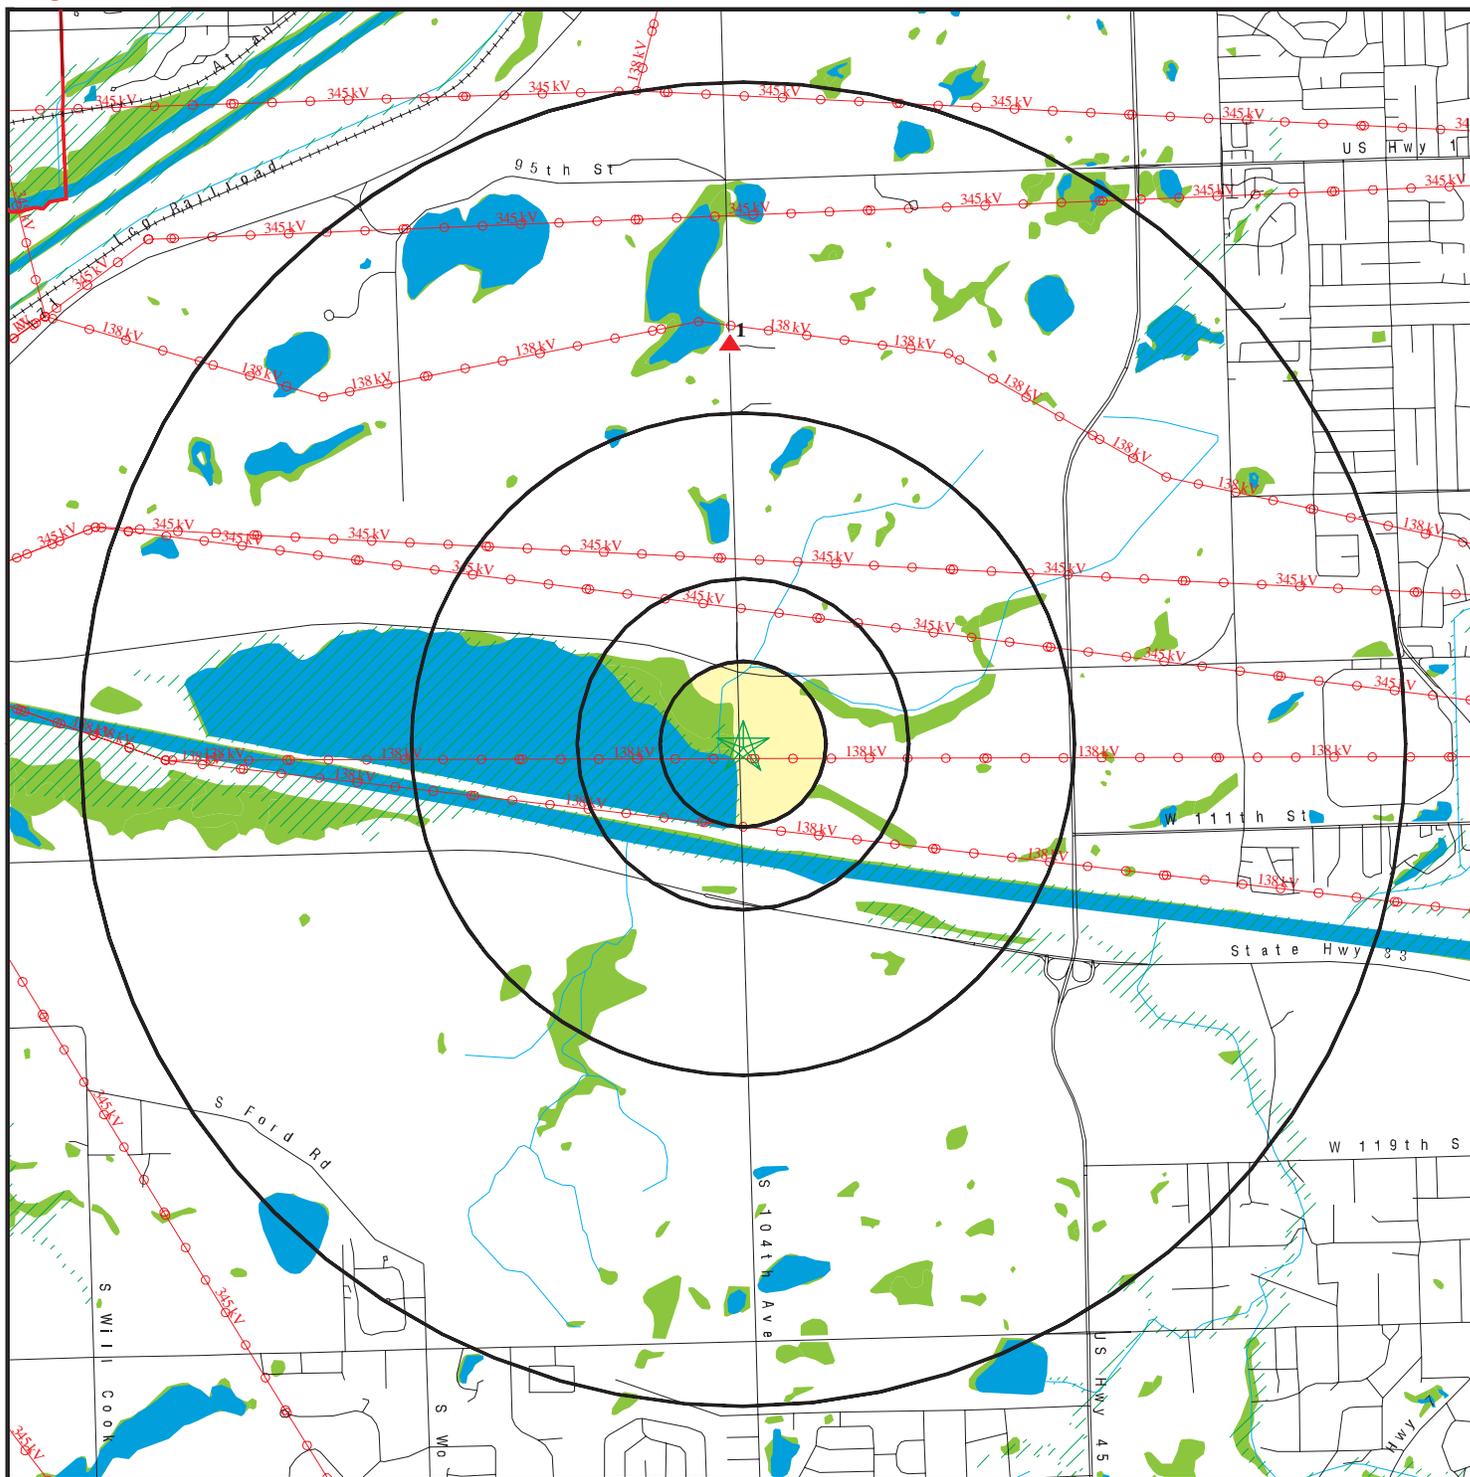
Figure 3 : EDR Radius Map OVERVIEW MAP - 3477867.2s

3. Review of environmental records provided in the EDR database search (Attachment A) suggests that there is one Resource Conservation and Recovery Information System (RCRIS) site within the recommended ASTM search distance to the additional project area (see Figure 3). The Resource Conservation and Recovery Information System (RCRIS) lists sites which generate, transport, store, and/or dispose of hazardous waste defined by the Resource Conservation and Recovery Act (RCRA). The Forest Preserve District of Cook County, EDR Site #1, located ½ to 1 mile to the northwest of McMahon Fen, was listed as a small quantity generator in 2002 and is no longer active. The generator does not have any past violations; therefore, there is no reason to suspect that activities at this location have impacted the project area. Review of environmental records provided in the database search indicates no RECs on the property or in the surrounding areas that will impact use of the site.

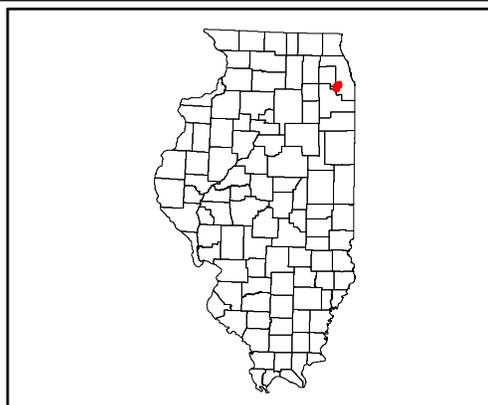
Figure 4: IEPA TMDL

Tampier Lake/Saganashkee Slough Watersheds Land Use

The Saganashkee Slough watershed (Figure 4) is located in northeastern Illinois, southwest of the city of Chicago. The watershed is approximately 3,658 acres in size and flow is generally directed south toward the lake. Elevation in the Saganashkee Slough watershed ranges from 747 feet above sea level in the northern part of the watershed near Route 45 to 584 feet near the slough. Land use data for the Saganashkee Slough watershed was extracted from the Illinois Gap Analysis Project Land Cover data layer for development of the TMDL. Over half of the Saganashkee Slough watershed is covered by upland forest, while another 15 percent of the watershed is comprised of surface water and surrounding marshes, and 9 percent of the watershed is urban area. Table 1 summarizes the land cover and land use throughout the watershed.

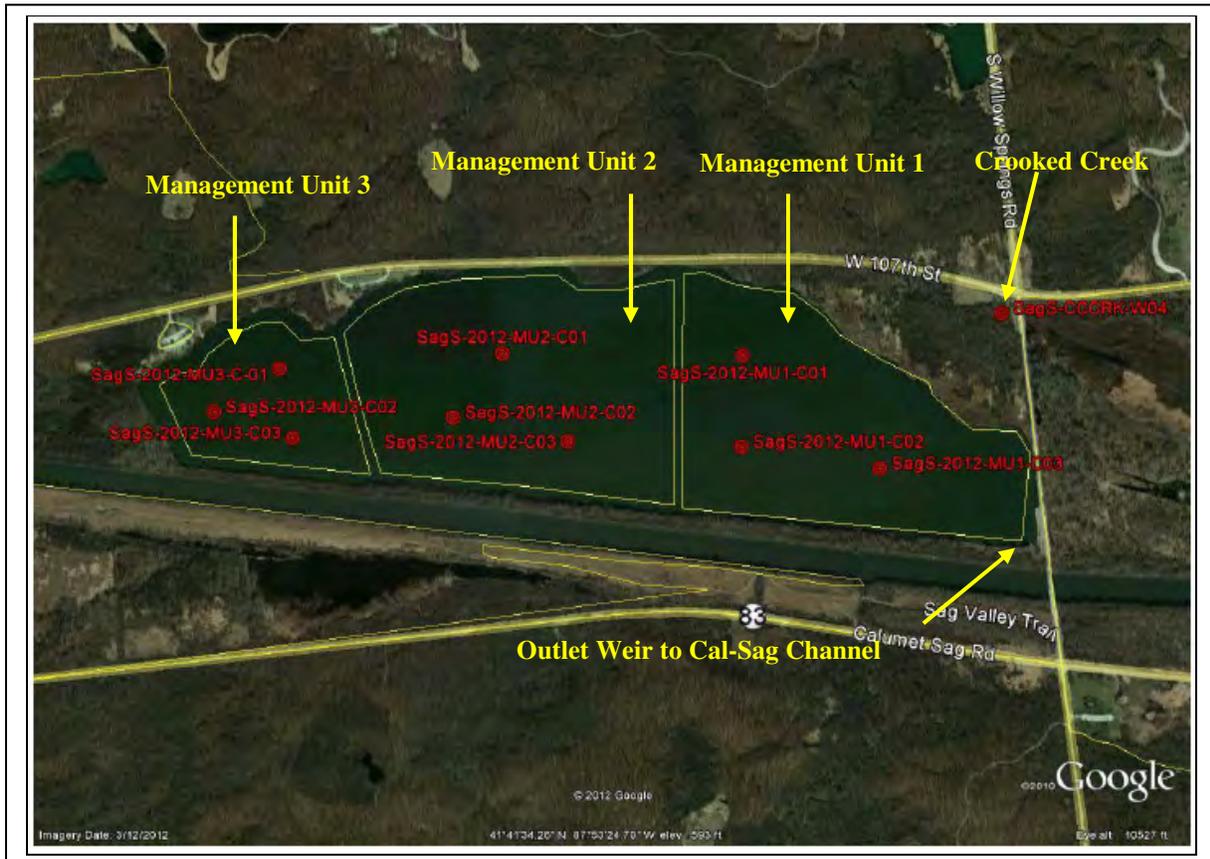
Figure 6: Aerial Photograph – Saganashkee Slough, Illinois Sampling Locations

Results of 2012 sampling are summarized in Tables 4 and 5. Sediment sampling results are compared to the TACO standards, established background concentrations of metals in soils found in metropolitan statistical areas (MSAs), and ecotox sediment values. Water quality sampling results are compared to the Illinois water quality standards and the ecotox values for surface water. In general, sediment sampling results suggest that concentrations of metals found in the sediment are below the established background concentrations of metals in MSAs, TACO standards, and the ecotox benchmark values. PCBs, SVOCs, and pesticides were not detected in sediment samples. Phosphorous concentrations in the Saganashkee Slough and Crooked Creek exceed the state water quality standard and the ecotox threshold value; ammonia concentrations found exceed ecotox threshold values. The concentrations of dissolved oxygen measured in Saganashkee Slough exceed the state standard (3.5 to 6.0 mg/L). Contaminants, such as SVOC, BTEX, and oil& grease, were not detected.

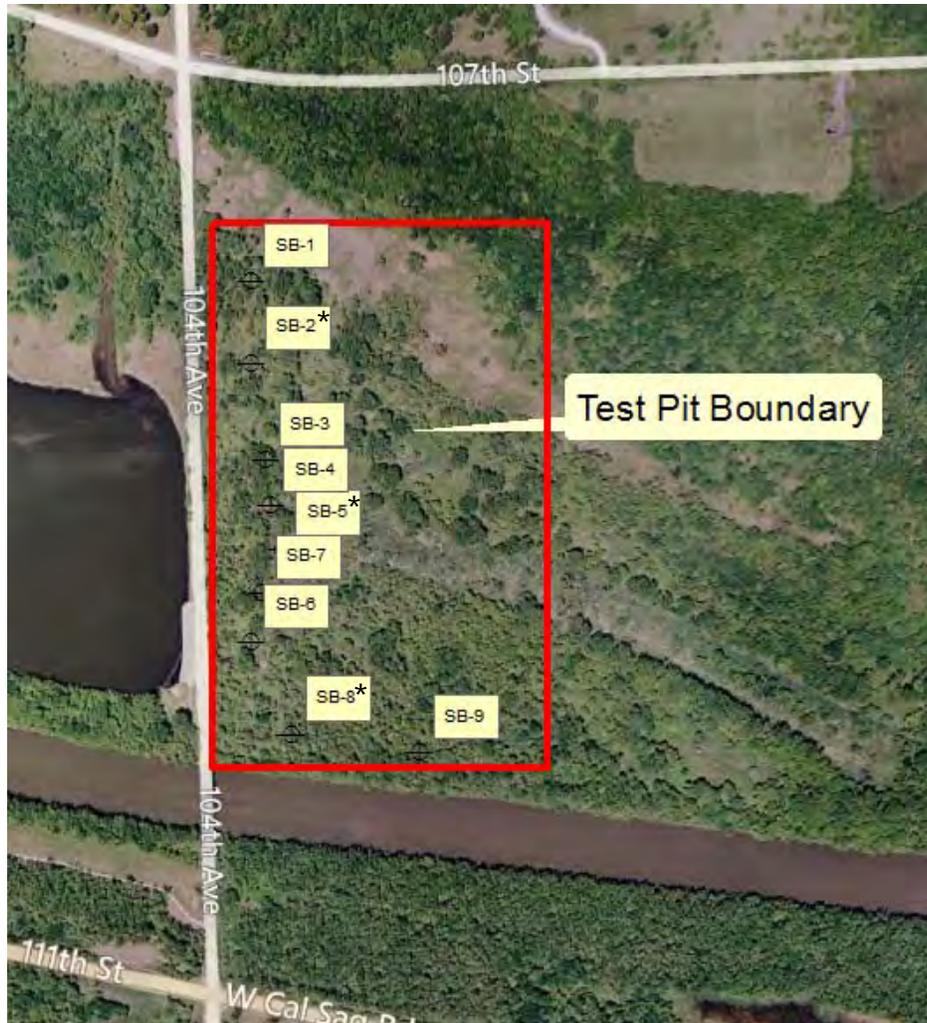
Figure 7: McMahon Fen Fill Stockpile Sampling Locations
(* denotes environmental sample location)

Review of current soil sampling results conducted on the McMahon Fen fill pile suggests that, in general, fill materials consist of brown clay, gray and brown silt, and silty sand. Stockpiled soils do not contain VOCs, SVOCs, PCBs, pesticides and herbicides. Arsenic, beryllium, cadmium, chromium, copper lead, nickel, zinc and mercury were found in most soils samples, but results are within background and IEPA TACO standards. Fill material removal, management, and placement restrictions, and associated water quality impacts, will be addressed in the 404(b)(1).

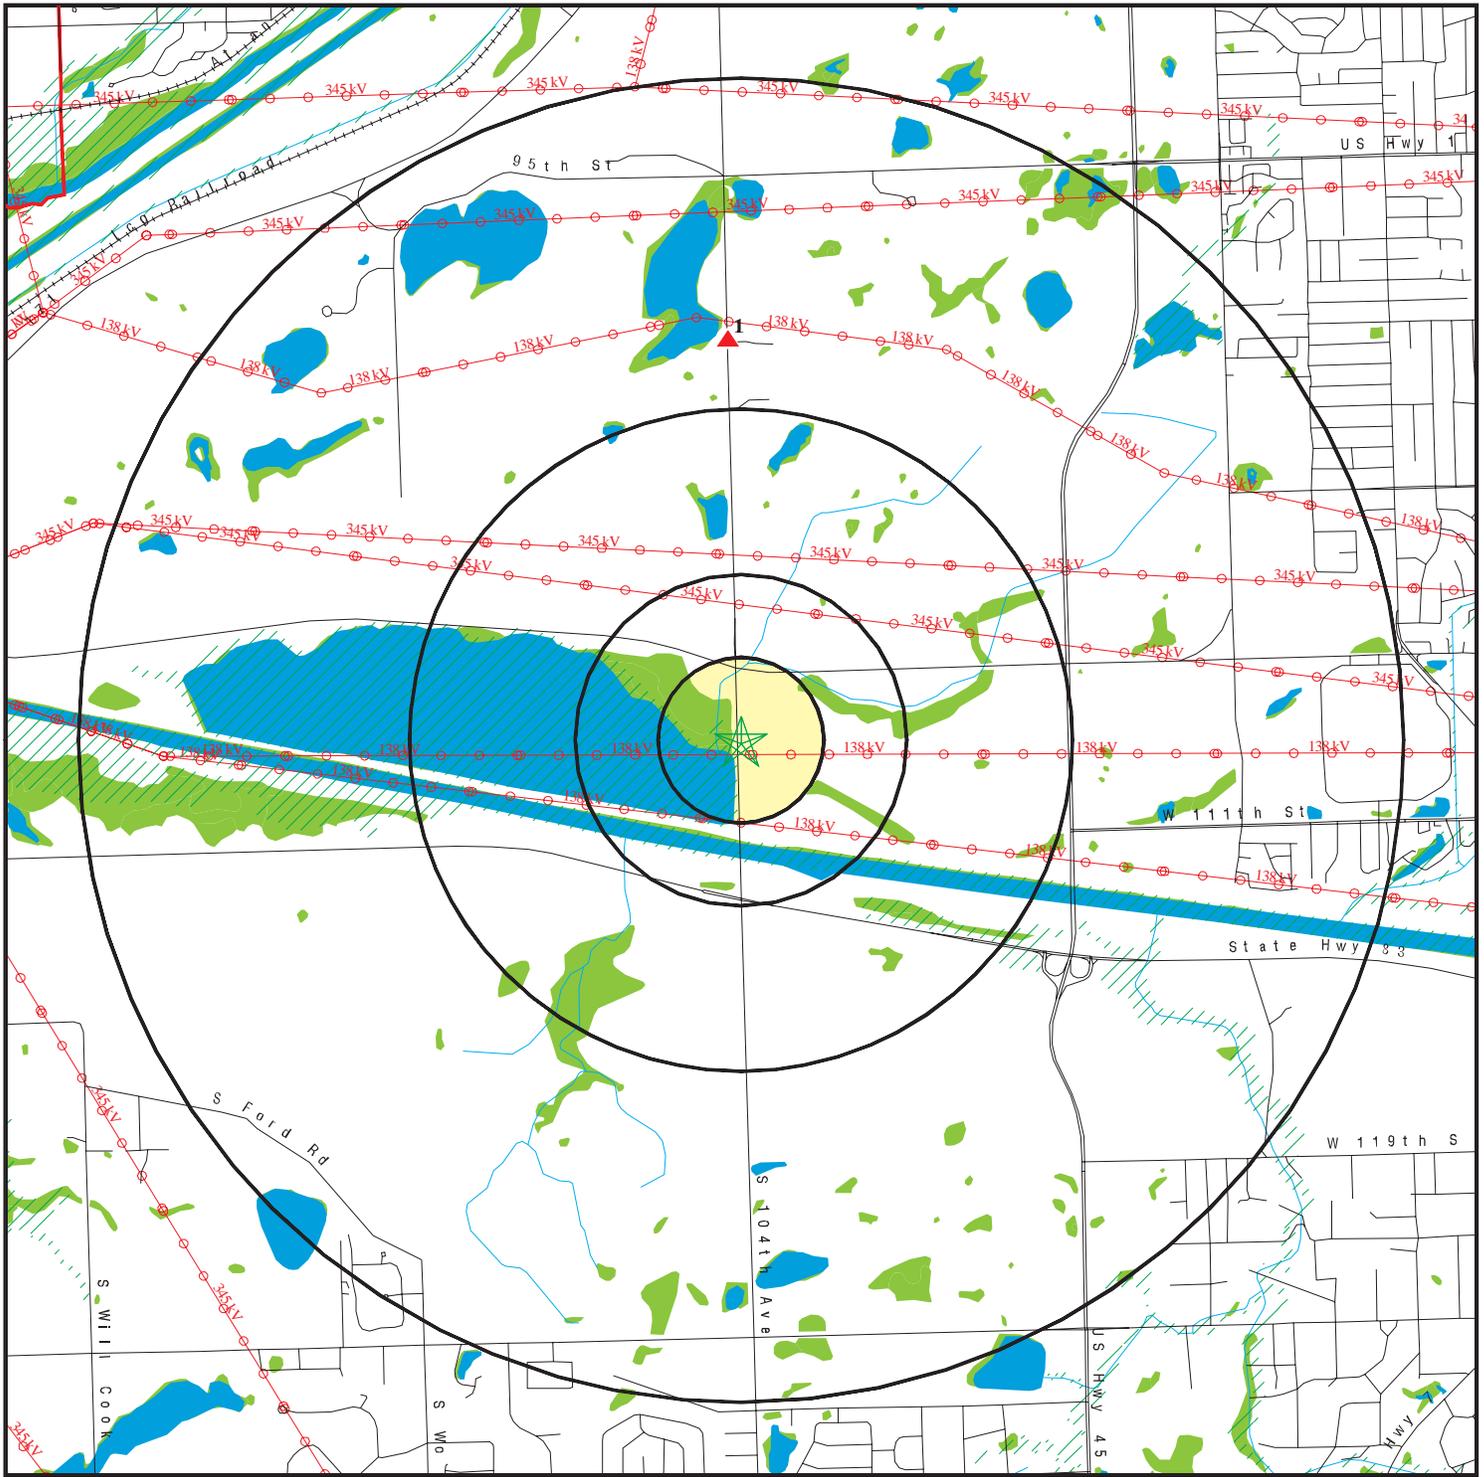
Figure 9: EDR Radius Map **OVERVIEW MAP - 3477867.2s**

A search of available environmental records was conducted utilizing Environmental Database Resources, Inc. (EDR) online. EDR searched federal and state databases using the minimum search distances issued in the ASTM E 1527-00 guidelines. Table 7 notes the recommended ASTM search distance for federal and state databases and the actual search distances used for the subject site. The standard search was extended at least 1 mile to accommodate the size of the project site. The EDR overview map displaying the project area and the search results are given in Figure 9. The comprehensive EDR database report is provided as Attachment B.

The database search located one RCRA SQG within the search distance. The Forest Preserve District of Cook County, located ½ to 1 mile to the north, is listed as a small quantity generator and does not have any current or past violations; therefore, there is no reason to suspect that activities at this location have impacted the project area.

Review of information presented in the EDR database search report suggests that there is one regulated environmental facility within the recommended ASTM search distance. The Forest Preserve District of Cook County, located ½ to 1 mile to the north, is listed as a RCRA small quantity generator. The facility does not have any current or past violations and is not considered a REC.
