Contract Report 2012-02

Continued Operation of a 25-Raingage Network for Collection, Reduction, and Analysis of Precipitation Data for Lake Michigan Diversion Accounting: Water Year 2011

FINAL REPORT

U.S. Army Corps of Engineers, Chicago District

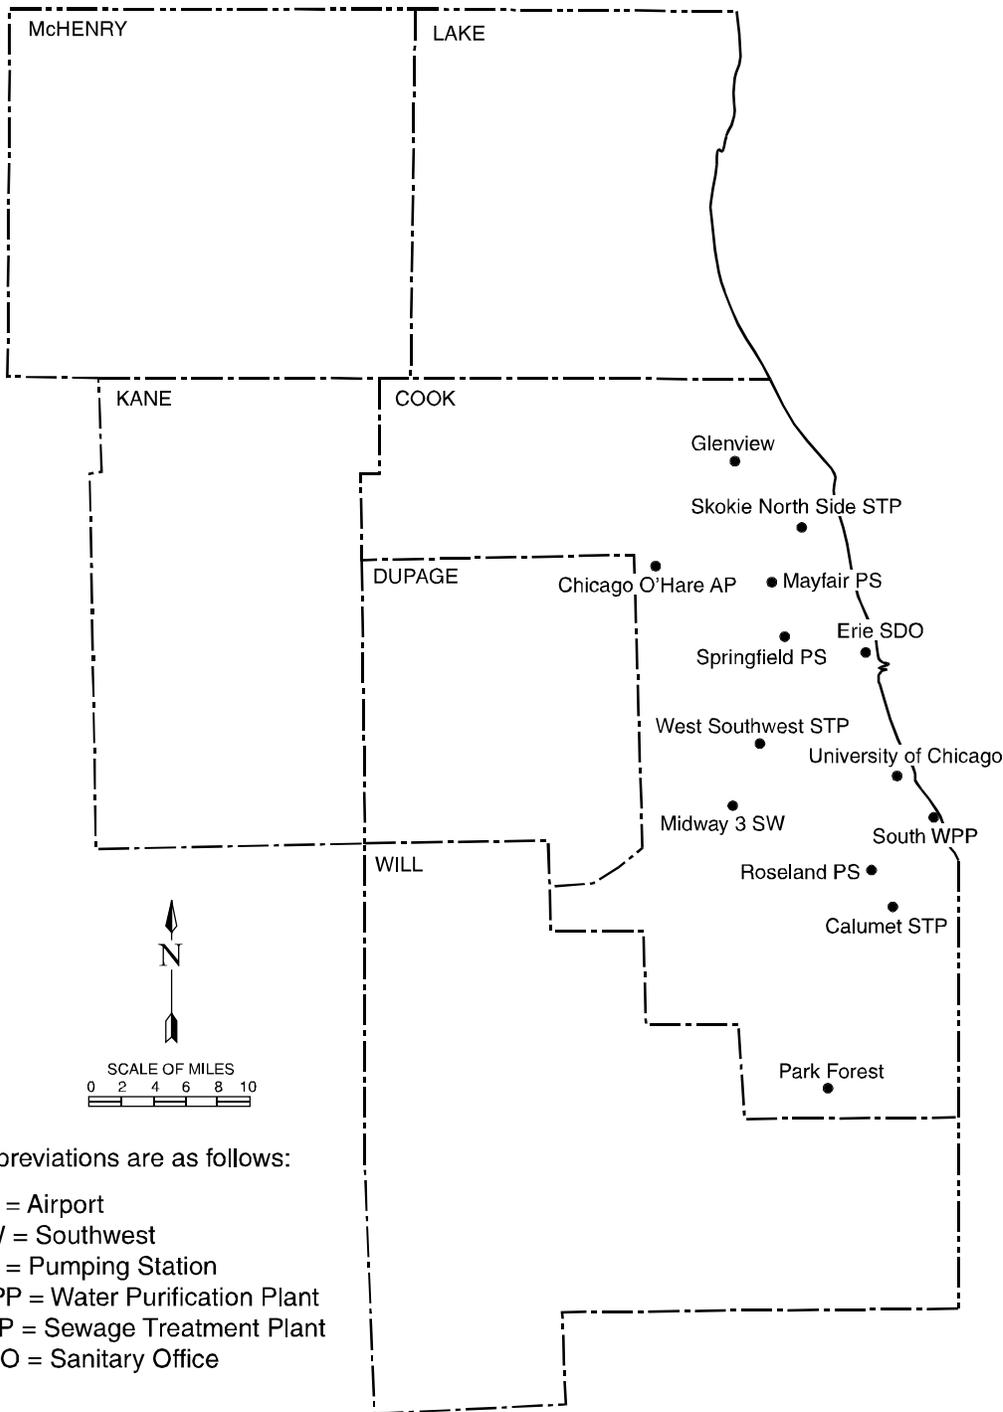
Figure 1. Raingage locations used for diversion accounting purposes prior to Water Year 1990. These include National Weather Service gages located at Chicago O'Hare AP, Midway 3 SW, University of Chicago, and Park Forest; City of Chicago gages located at Mayfair PS, Springfield PS, South WPP, and Roseland PS; and Metropolitan Water Reclamation District of Greater Chicago gages located at Glenview, Skokie North Side STP, Erie SDO, West Southwest STP, and Calumet STP.

The unusual patterns were caused by abnormally low precipitation totals at a select number of the 13 sites used by the accounting procedure (Figure 1). Inspection of these sites (Vogel, 1988), which are irregularly distributed over the region, revealed that low precipitation totals were caused by 1) inadequate raingage exposure (e.g., gages situated on rooftops or too near natural or artificial air flow-restricting

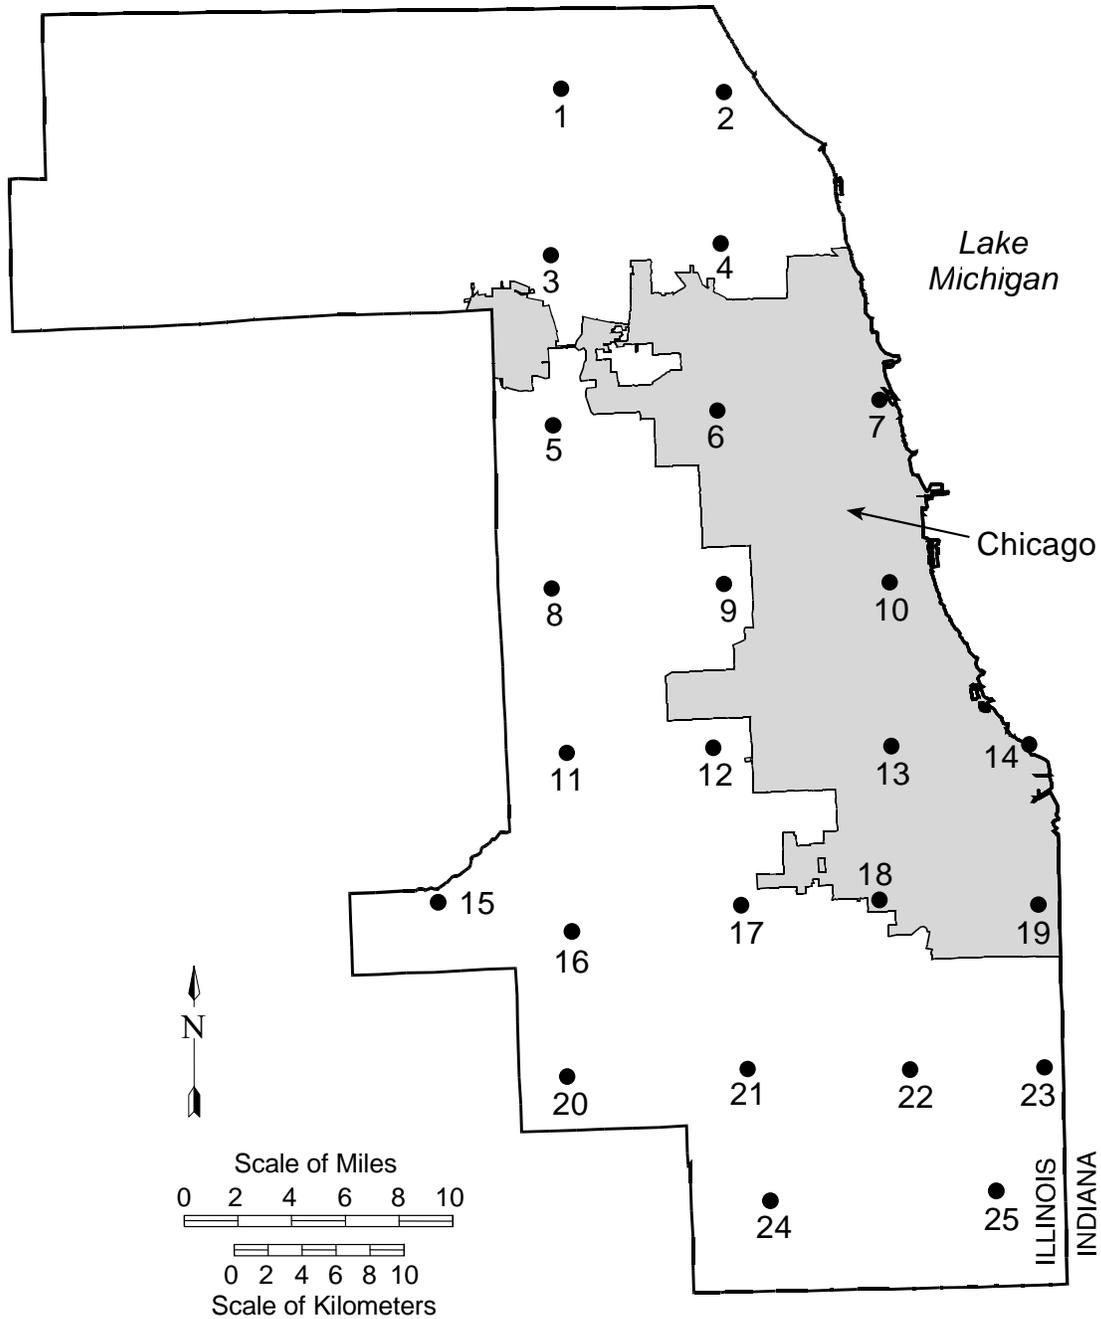
Figure 2. The Cook County 25-site raingage network for Water Years 1990–2011

The largest precipitation amounts during Water Year 2011 occurred in the central portion of the network (sites #9, #10, #11, #12, and #18, Figure 3). See Figure 2 and Appendix I for site information. The lightest amounts occurred in the eastern and southern portions of the network (sites #4, #7, #21, #23, #24, and #25). The heaviest precipitation in the network during Water Year 2011 fell at site #10 (48.42 inches), while the lightest fell at site #23 (36.56 inches).

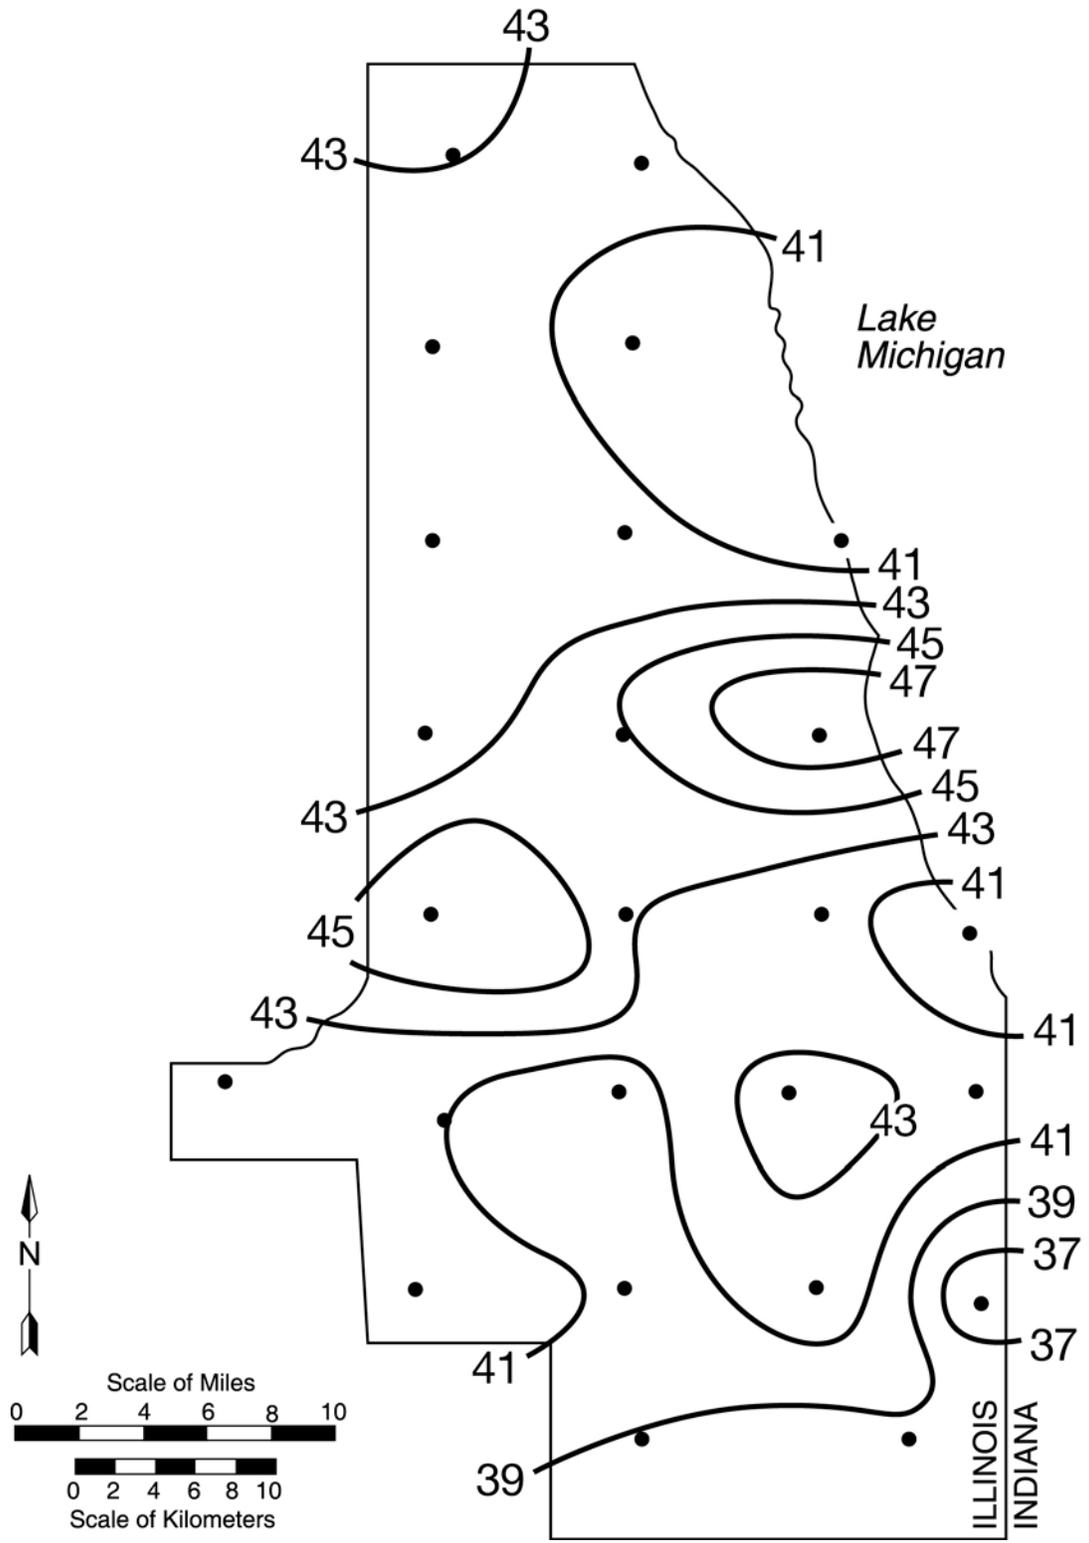
Figure 3. Precipitation pattern (inches) for Water Year 2011

As in the case of the other network water year patterns, the spatial pattern for Water Year 2011 (Figure 3) does not contain the anomalies found in an analysis using sites operated by the MWRDGC, the NWS, and Cook County for Water Years 1984–1989 (Vogel, 1988; Peppler, 1993b). Gradients of 15 to 20 inches were common in those analyses. Precipitation data from those sites were the input for diversion accounting before construction of the present network (Peppler, 1993b). For Water Year 2011, there was a 9-inch gradient between Sites #7 and #10.

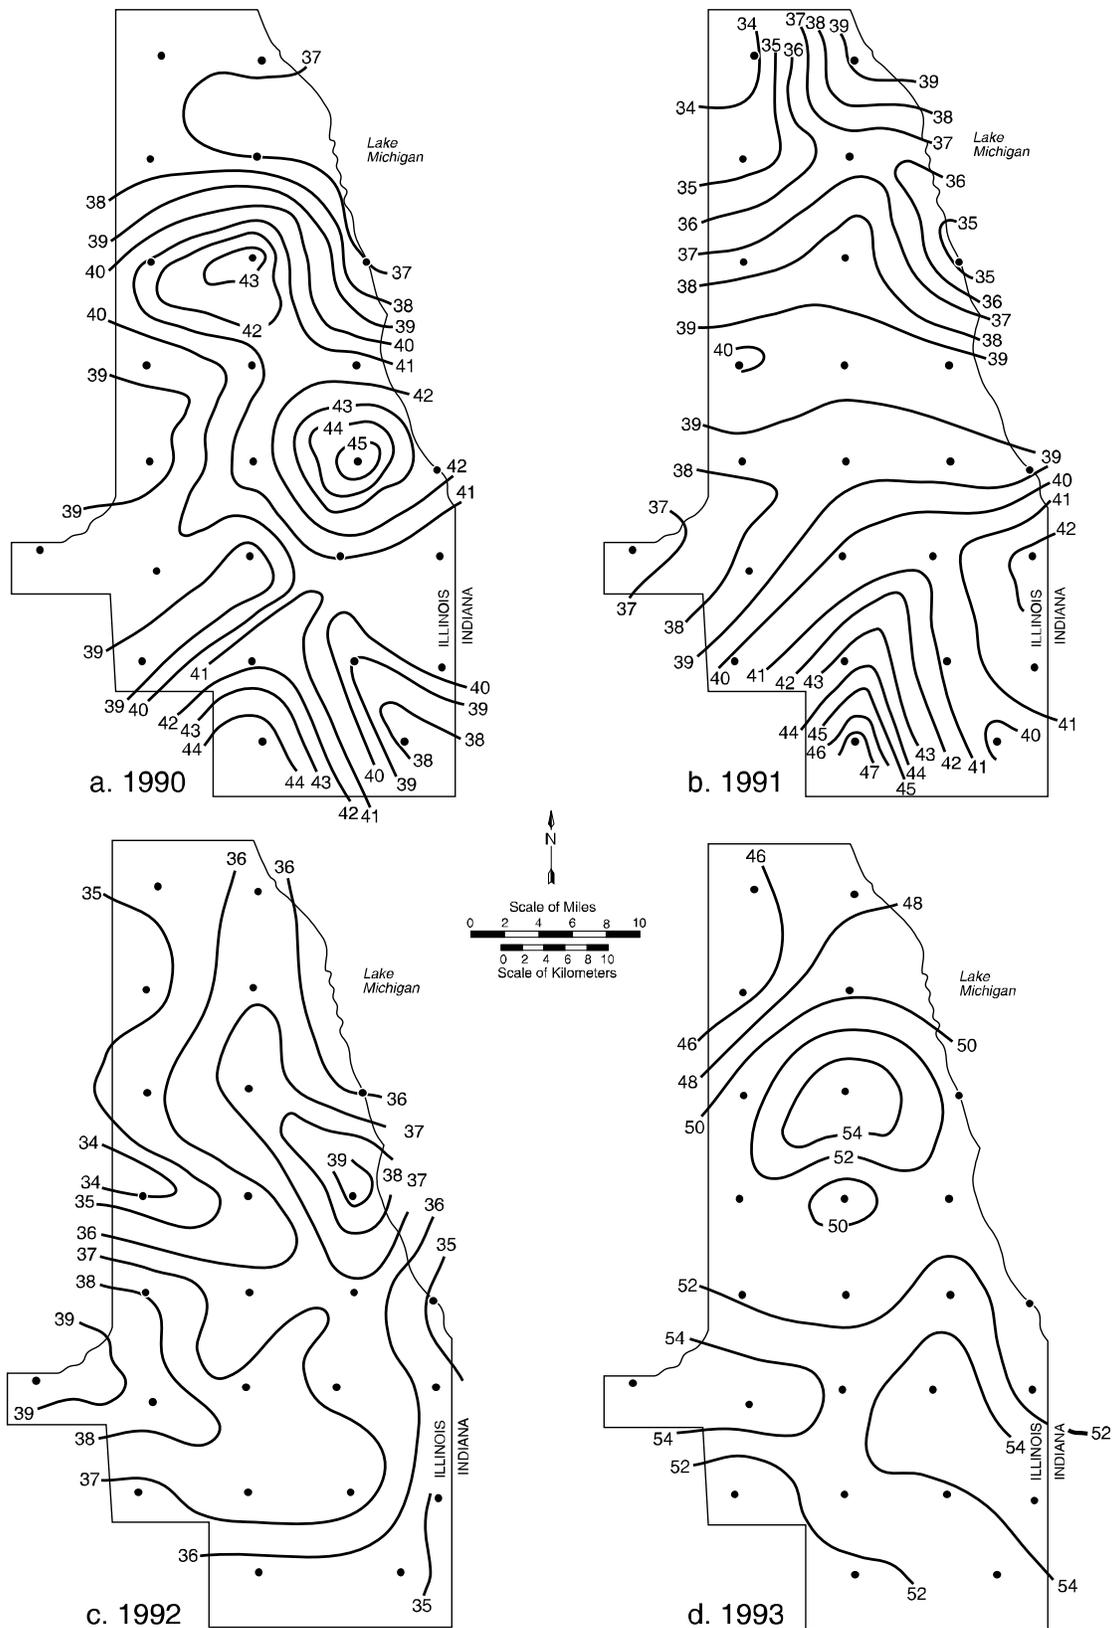
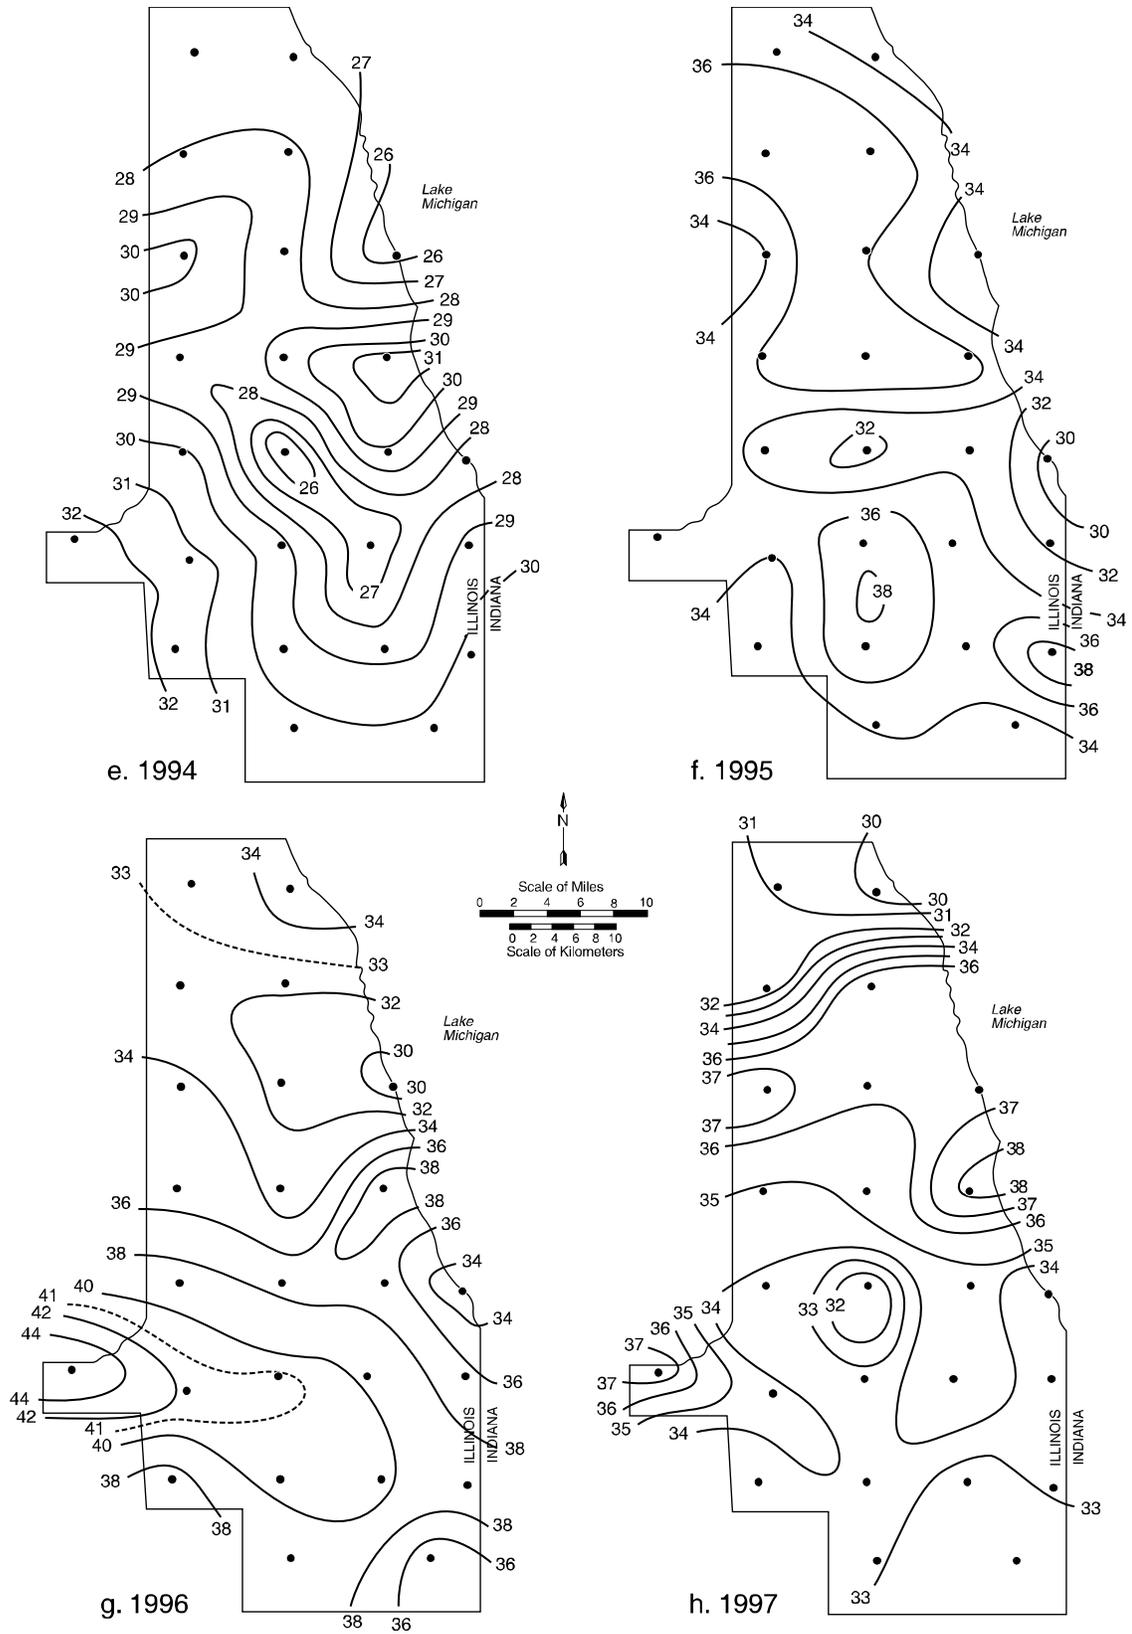
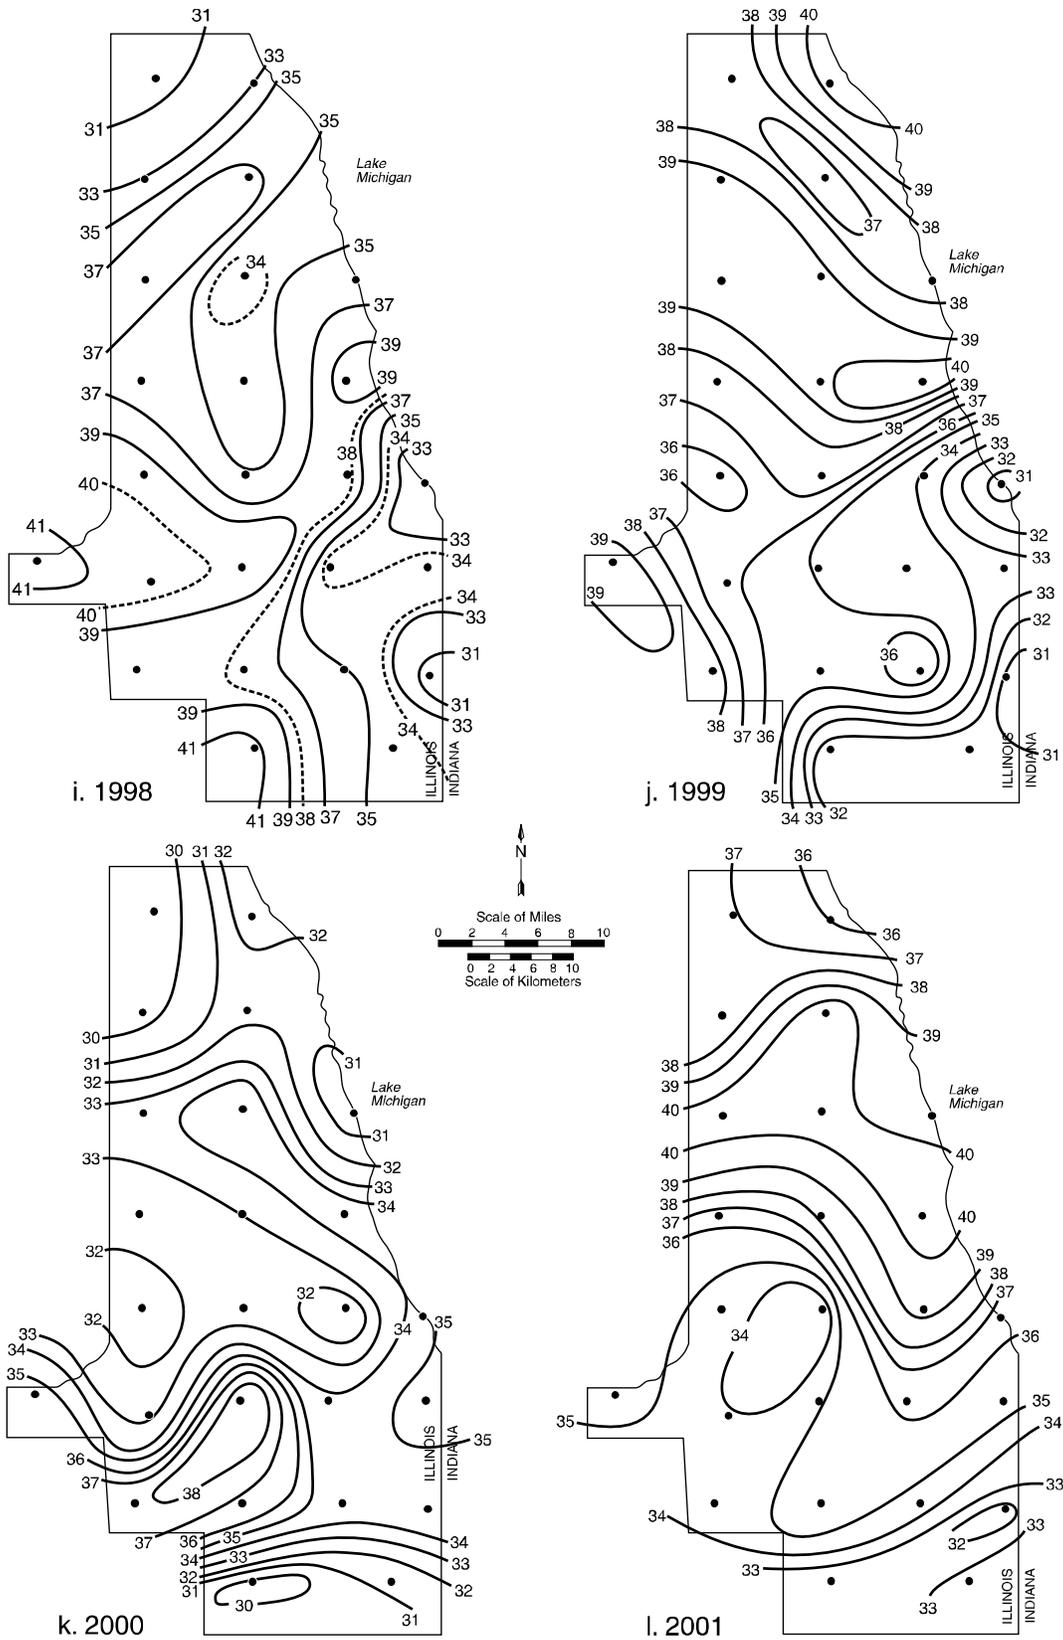
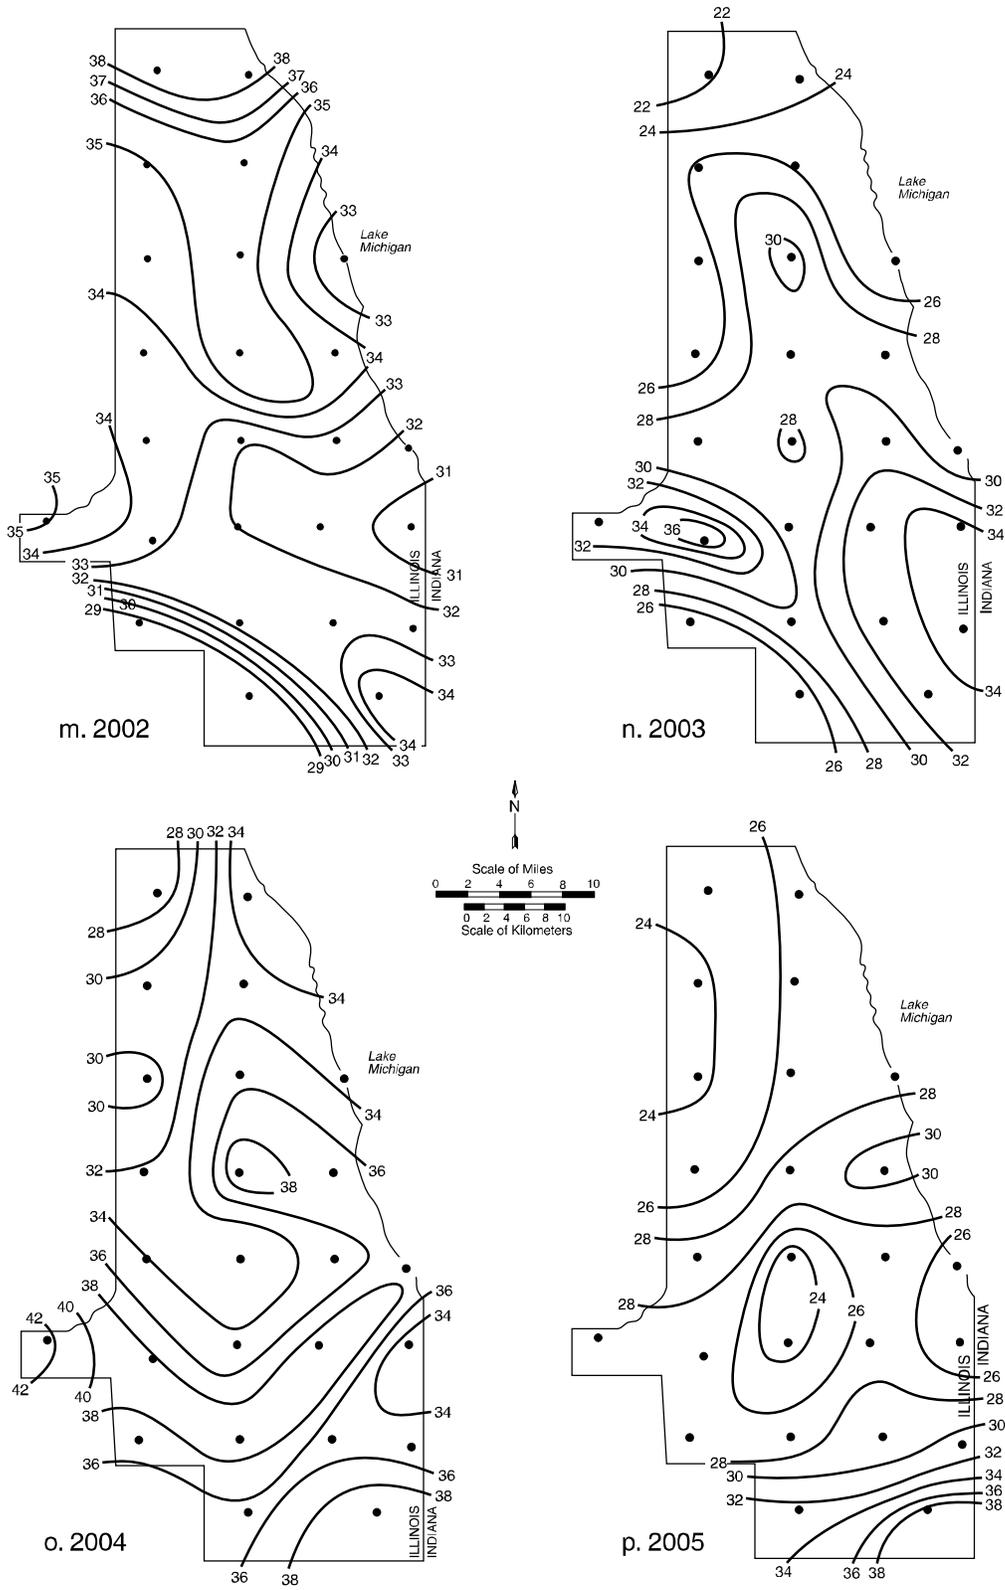
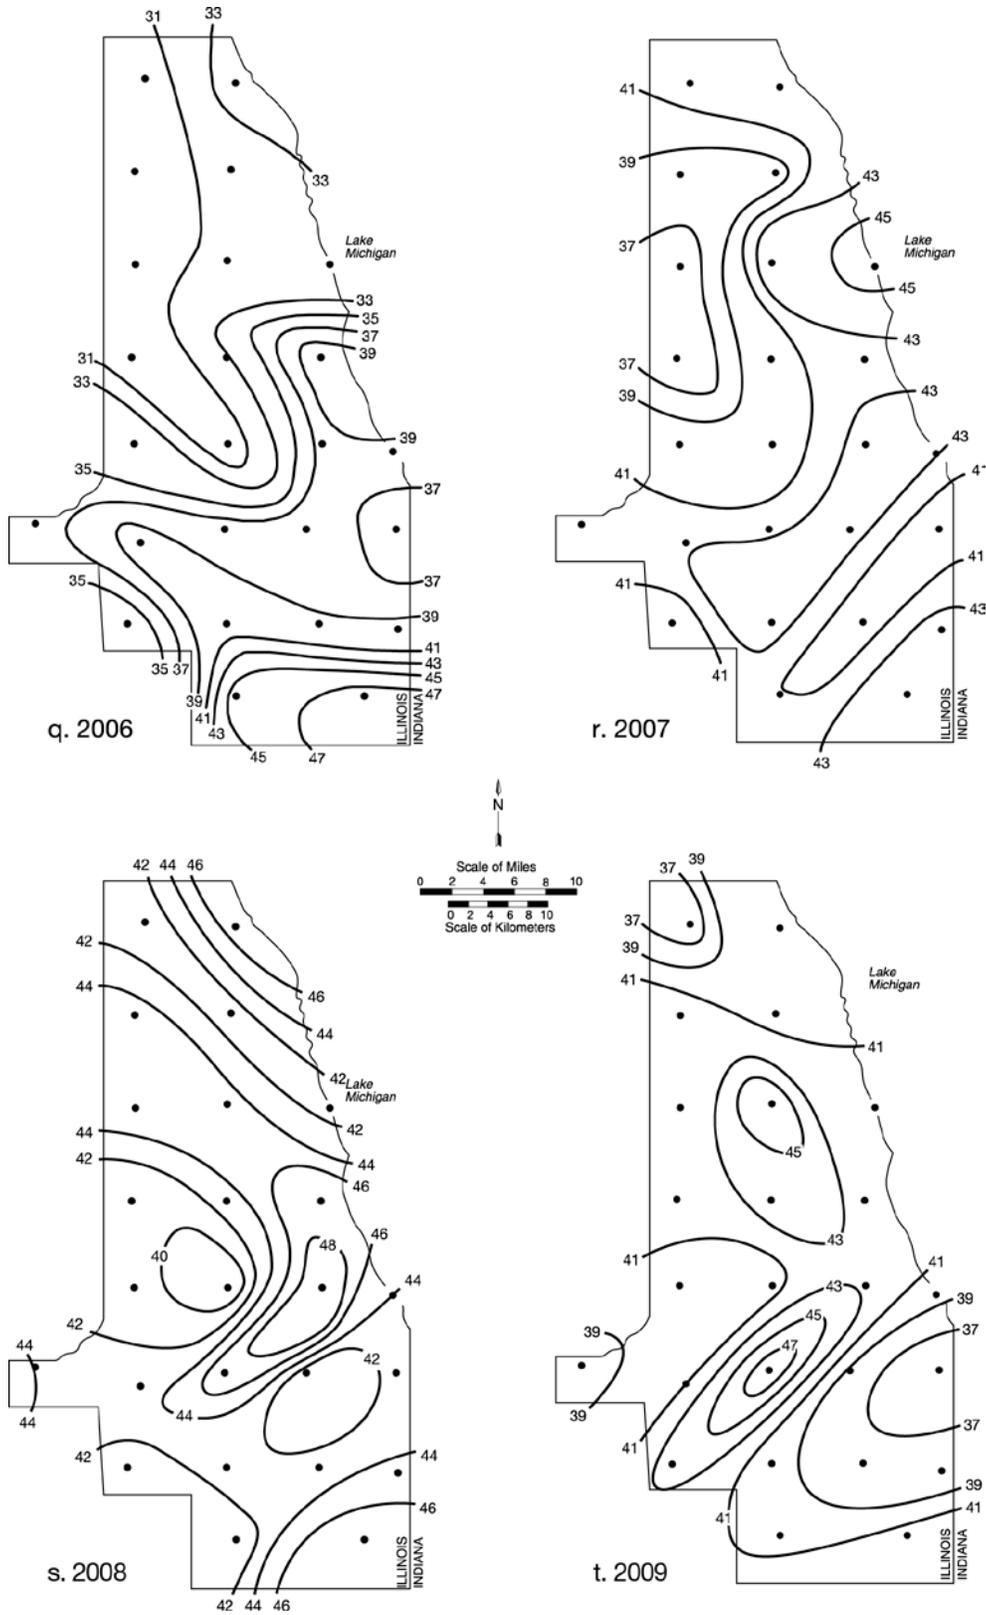
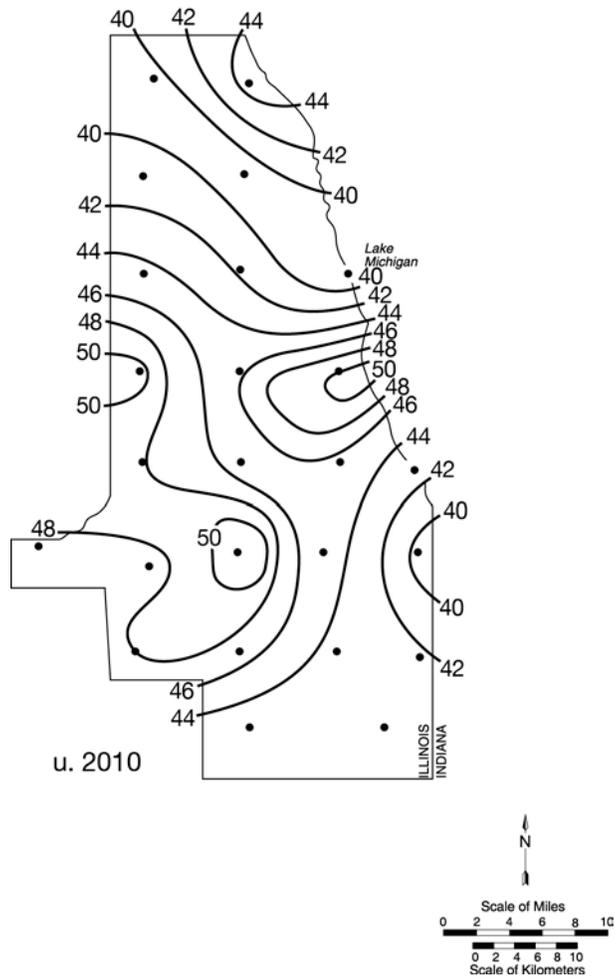
Figure 4. Precipitation pattern (inches) for Water Years 1990–2010

Figure 4 provides maps of precipitation amounts for individual Water Years 1990–2010. The general pattern of high values for Water Year 2011 is similar to that of 1998 and 2010, with the largest precipitation in the central region and the lowest precipitation to the north and south.

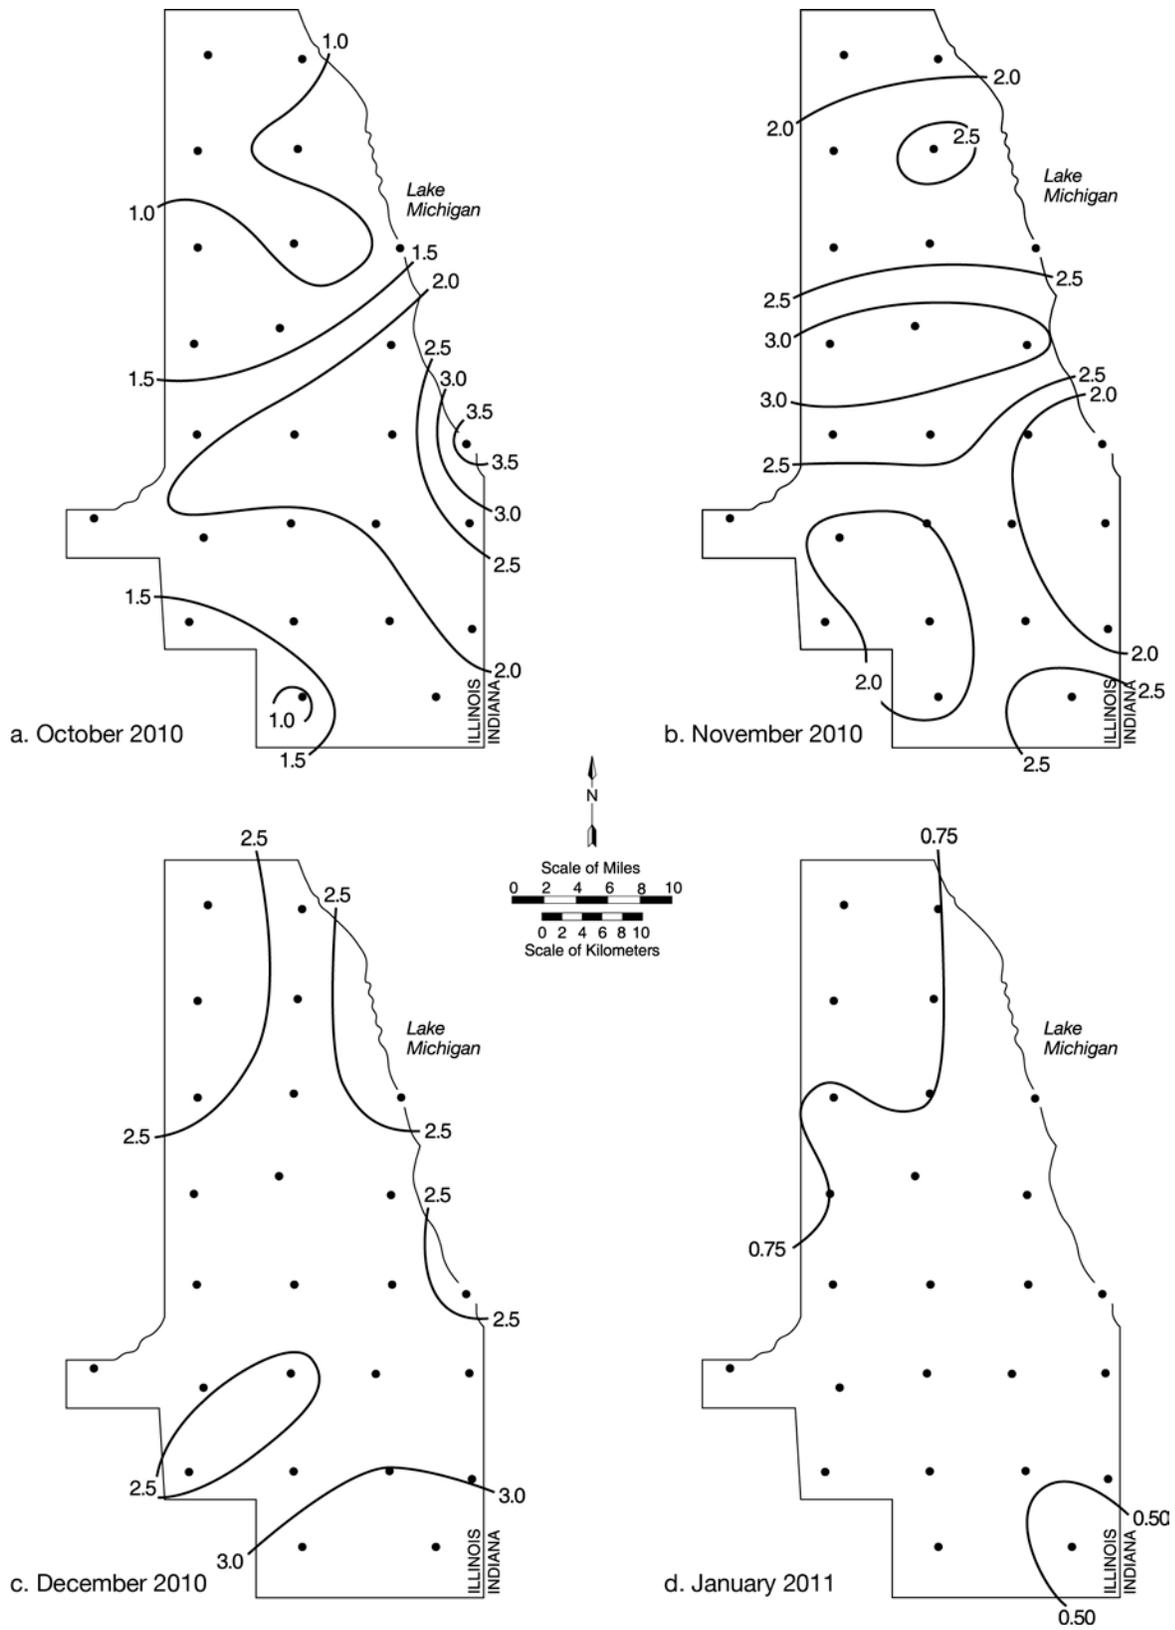
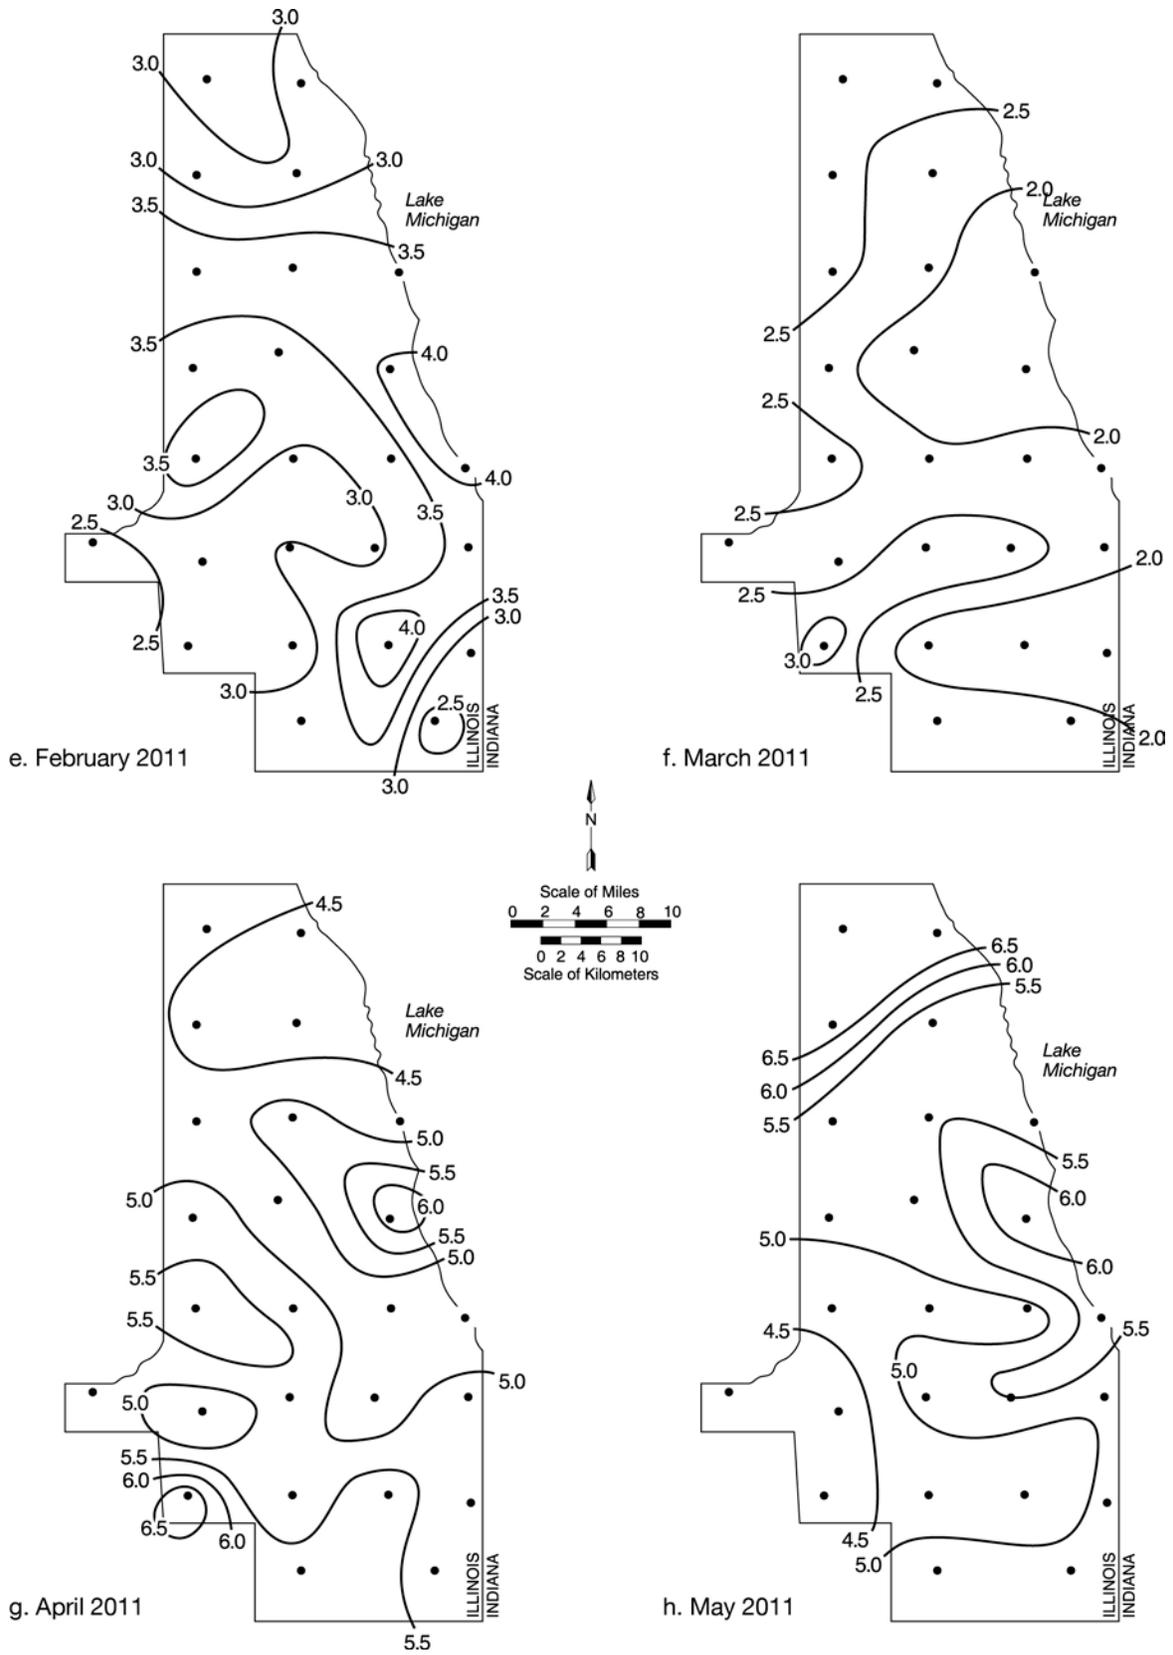
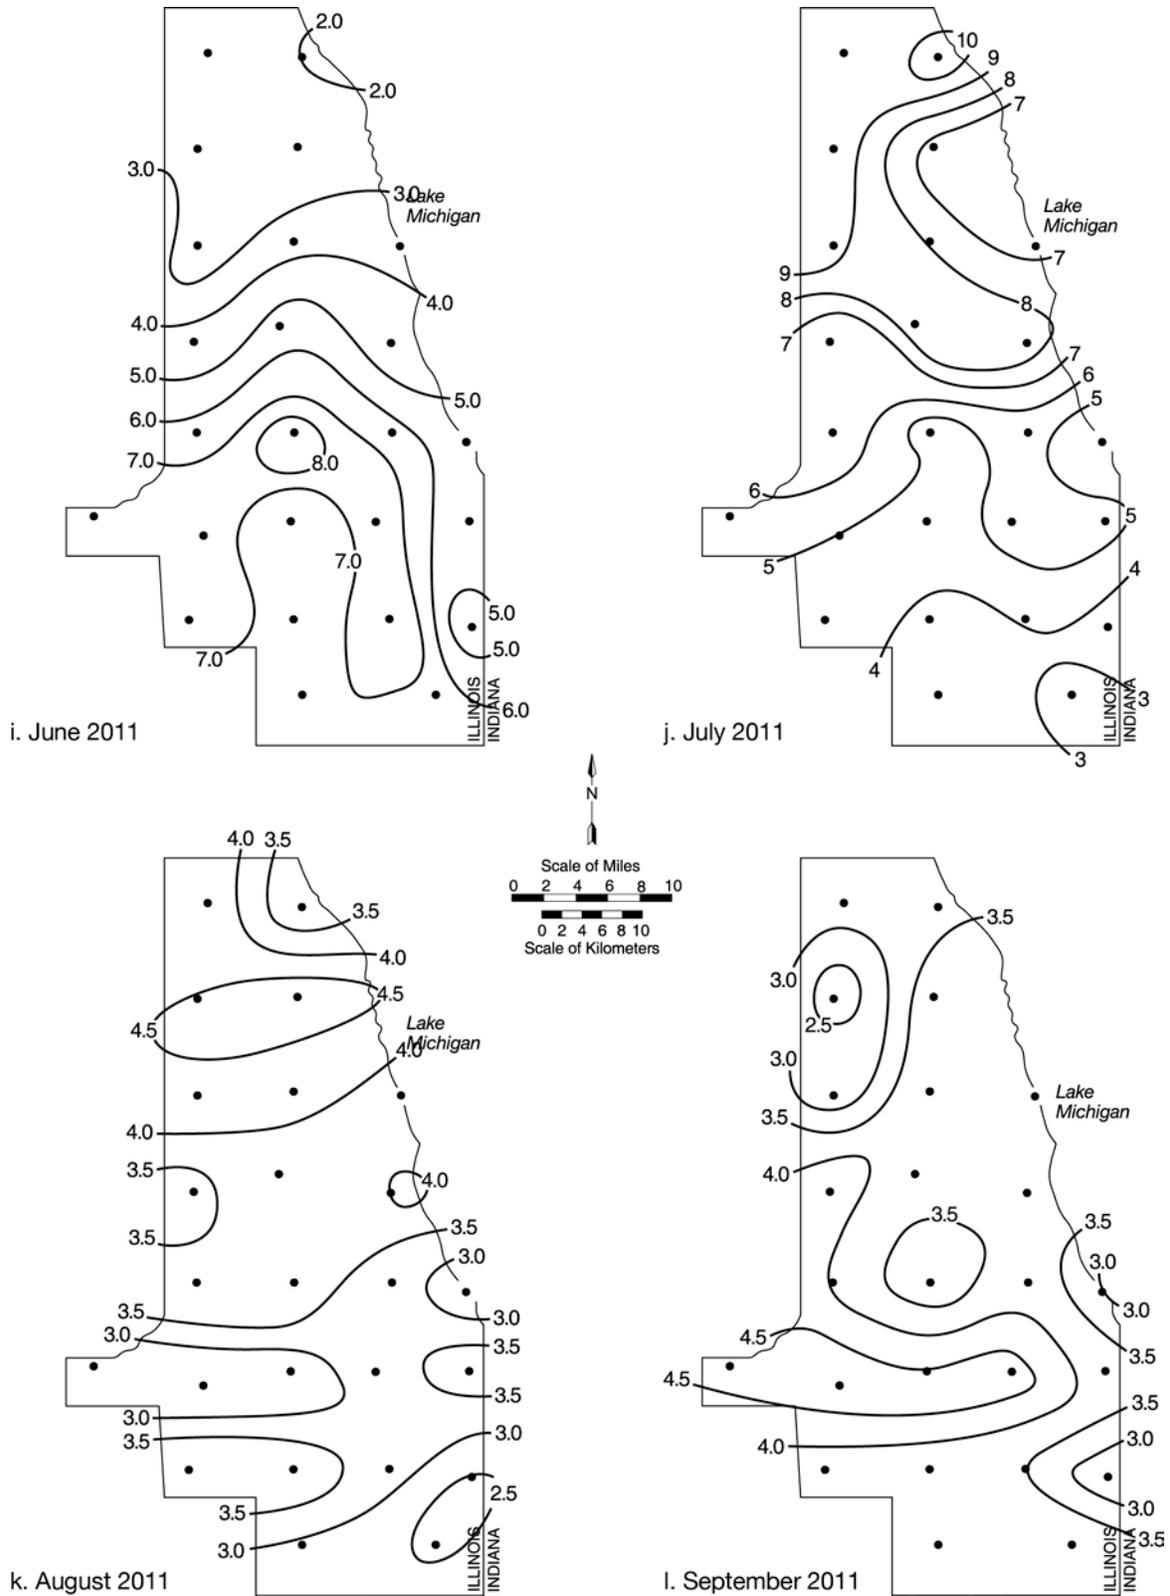
Figure 5. Precipitation pattern (inches) for October 2010–September 2011

Figure 5 presents monthly precipitation patterns for Water Year 2011. Monthly network precipitation amounts were 65 percent or less than the 21-year average in October 2010 and in January 2011. Amounts were at least 135 percent of the 21-year network average during October and December 2010 and February, April, June, and July 2011. Less than 2.0 inches of precipitation fell in October 2010 and January 2011. Five inches or more of precipitation fell each month from April 2011 through July 2011.

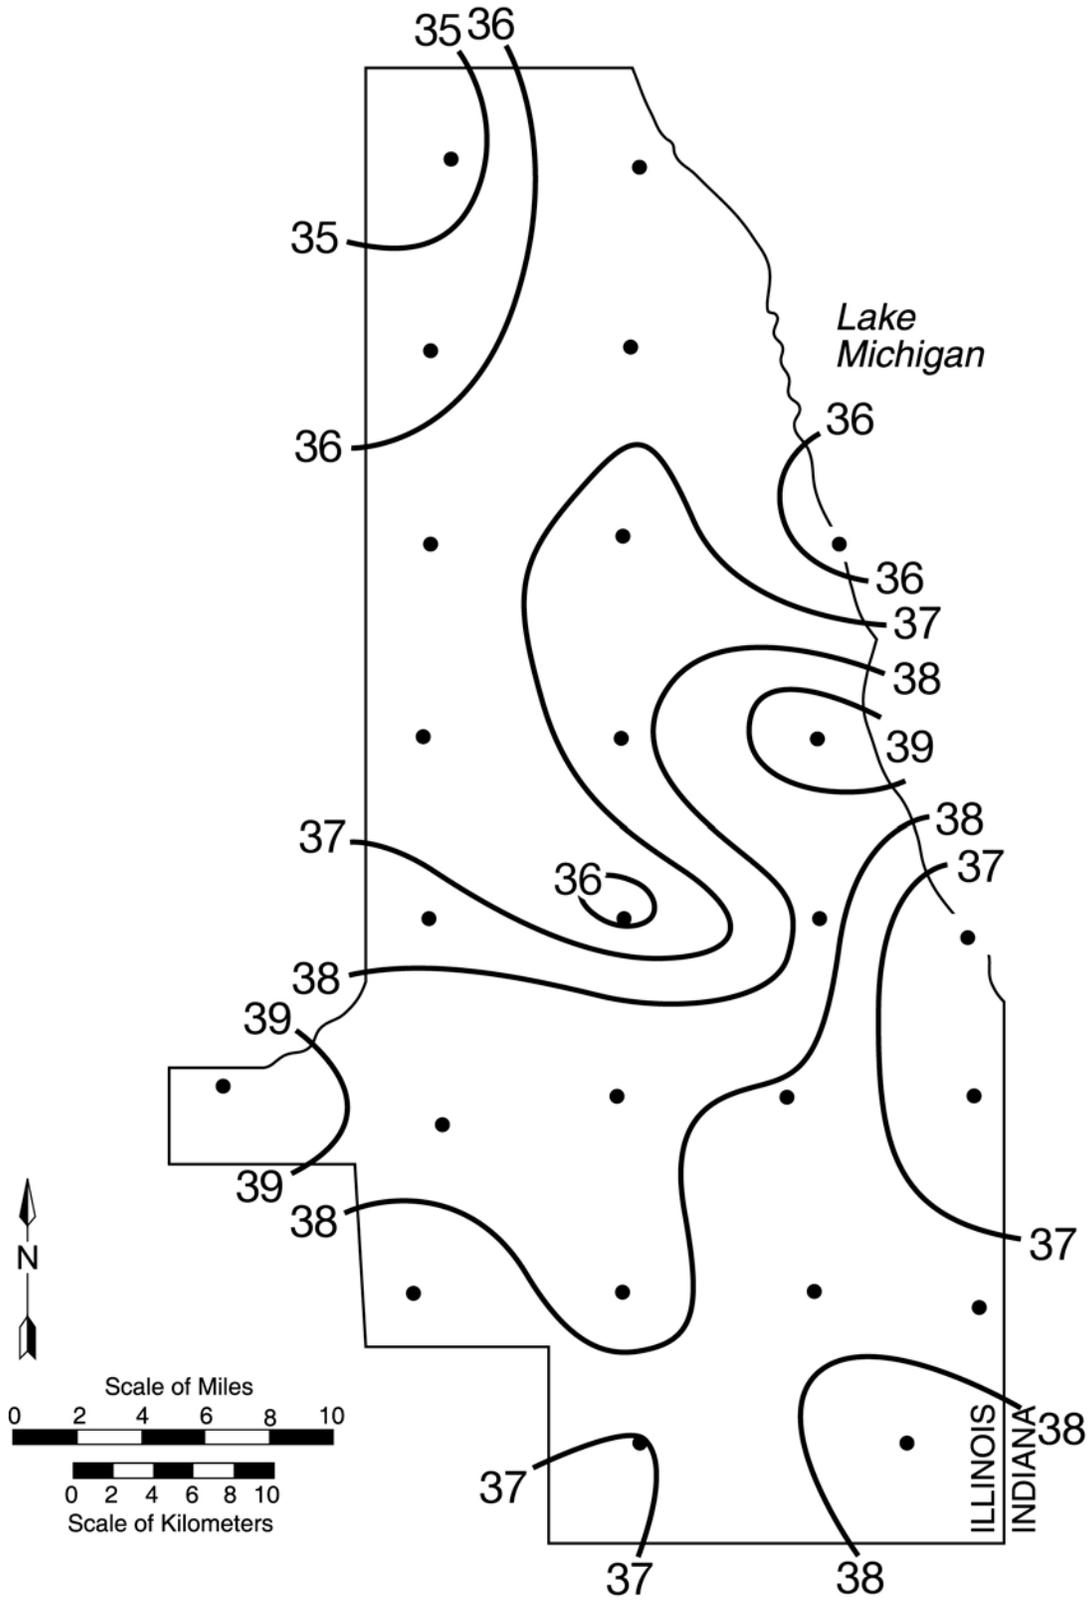
Figure 6. The 22-year average precipitation pattern (inches), Water Years 1990–2011

The 22-year (1990–2011) average precipitation pattern (Figure 6) shows, as in previous years, an area of higher values across southwestern Cook County (sites #15, #16, and #17), to the south at sites #21 and #25, and northward at Chicago sites #10 and #13. Lower values are found at northern sites #1, #2, #3, #4, #5, #7, and #8 and at southern sites #12, #14, #19, and #23. The 22-year network-wide average is 37.16 inches.
