**DUPAGE RIVER, ILLINOIS  
FEASIBILITY REPORT AND  
INTEGRATED ENVIRONMENTAL ASSESSMENT**

**HTRW Phase I Environmental Site Assessment  
Appendix F**

HAZARDOUS, TOXIC, AND RADIOACTIVE WASTE (HTRW)  
PHASE I ENVIRONMENTAL SITE ASSESSMENT  
DUPAGE RIVER FLOOD RISK MANAGEMENT STUDY

Hydraulics and Environmental Engineering Section (TS-DH)  
US Army Corps of Engineers, Chicago District

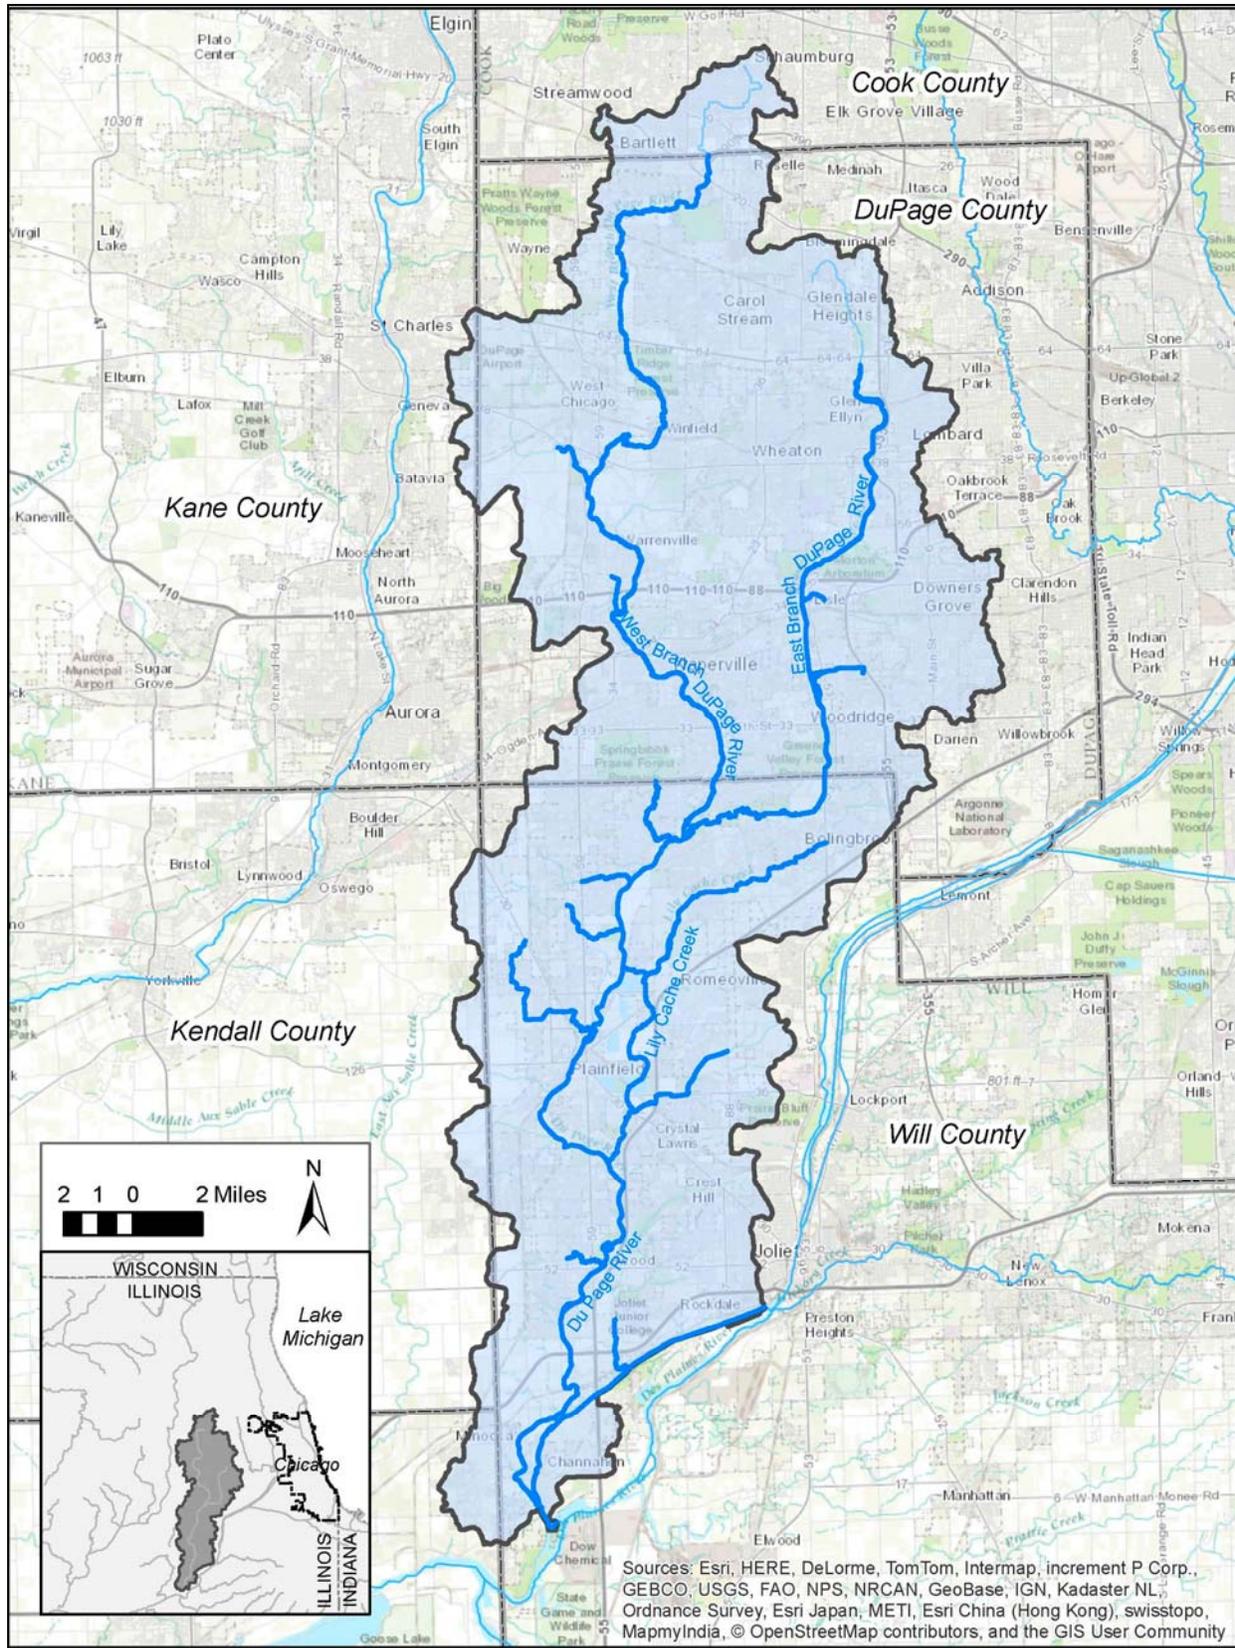
Figure 1 – DuPage River FRM Study Area

The DuPage River watershed, shown in **Figure 1**, drains approximately 378 square miles in DuPage and Will Counties, Illinois. The East and West Branches of the DuPage River lie primarily in DuPage County and flow south towards Will County where they meet to form the mainstem of the DuPage River. The mainstem flows south to its confluence with the Des Plaines River. Several areas within the DuPage River watershed experience damage from overbank flooding, damaging isolated structures and infrastructure. Communities within DuPage County where flood risk management alternatives were evaluated as part of the feasibility study include Bloomingdale, Lombard, Lisle, Winfield, Warrenville, Naperville, Milton Township, and Lisle Township. Communities within Will County include Bolingbrook, Joliet, Romeoville, Crest Hill, Plainfield, Minooka, Channahon, Plainfield Township, and Wheatland Township.

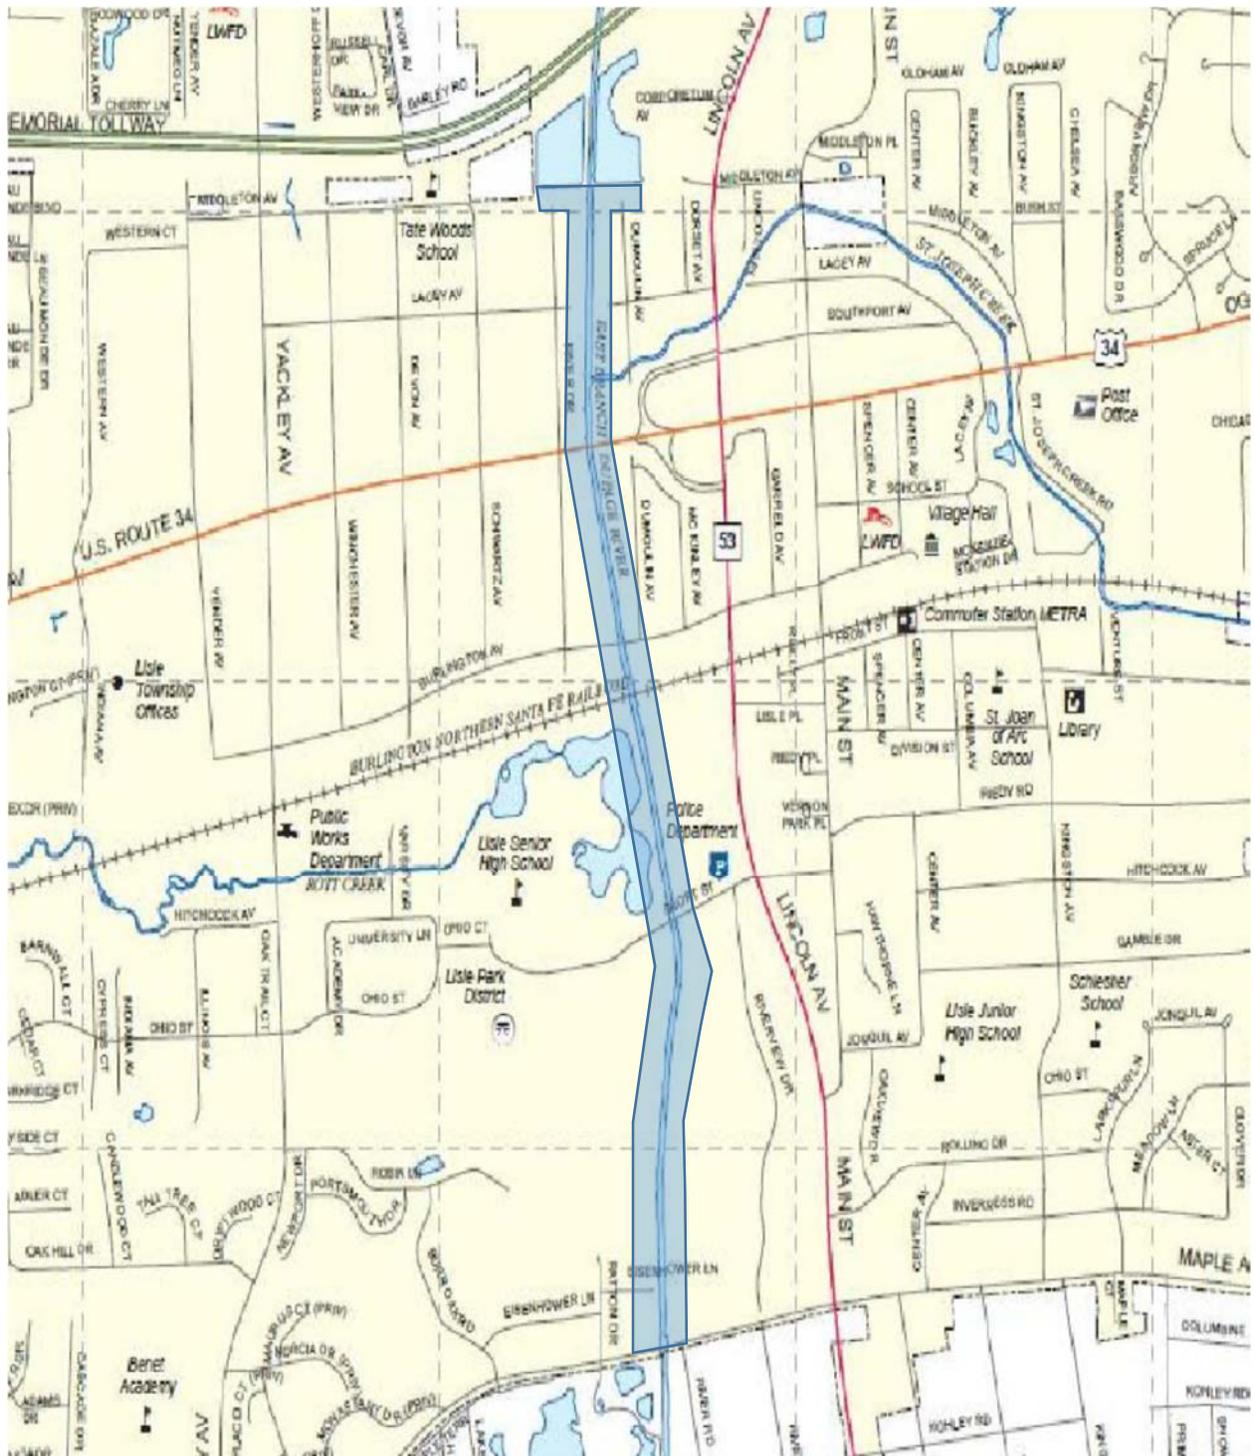
Figure 2 – Lisle Levee Project Area

The Lisle Levee project is a proposed levee improvement project located along the East Branch DuPage River between I-88 and Maple Avenue in Lisle, DuPage County, Illinois (**Figure 2**). The area surrounding the existing levee is residential between I-88 and the BNSF railroad, and a combination of residential, commercial, and park between the BNSF railroad and Maple Ave. There are several auto repair facilities in the area of Ogden Ave. Current aerial images indicate the area also contains land disturbing activities located adjacent to the East Branch DuPage River, on the eastern bank. The project may include the following levee improvement activities: bank protection/stream bank stabilization measures, reinforcement of the embankment foundation, removal of miscellaneous structures such as power poles, fences and staircases, vegetation removal for repair of existing levee, regrading/fill for elevation and reseeding, and replacement of existing pump station.

Preliminary screening-level HTRW review of the study area suggests that there are no RCRA, NPL, TSCA, Brownfields, ICIS-AIR, TRI, or RADinfo sites along the banks of the East Branch DuPage River between I-88 (northern boundary) and Maple Avenue (southern boundary). Current aerial images suggest that the areas adjacent to the East Branch DuPage River are primarily vegetated, and consist of residential, commercial, or recreational uses (parkland). There are two areas along the east bank where significant land disturbing activities are noted, it is unknown what activities are being conducted on the properties (fill, excavation, or otherwise): 1) east bank south of the St. Joseph Creek near Lisle Auto and Tire, and 2) east bank between railroad and Short Street, entrance from Lincoln Avenue. A complete Phase I ESA for the Lisle Levee project area is included in this report.

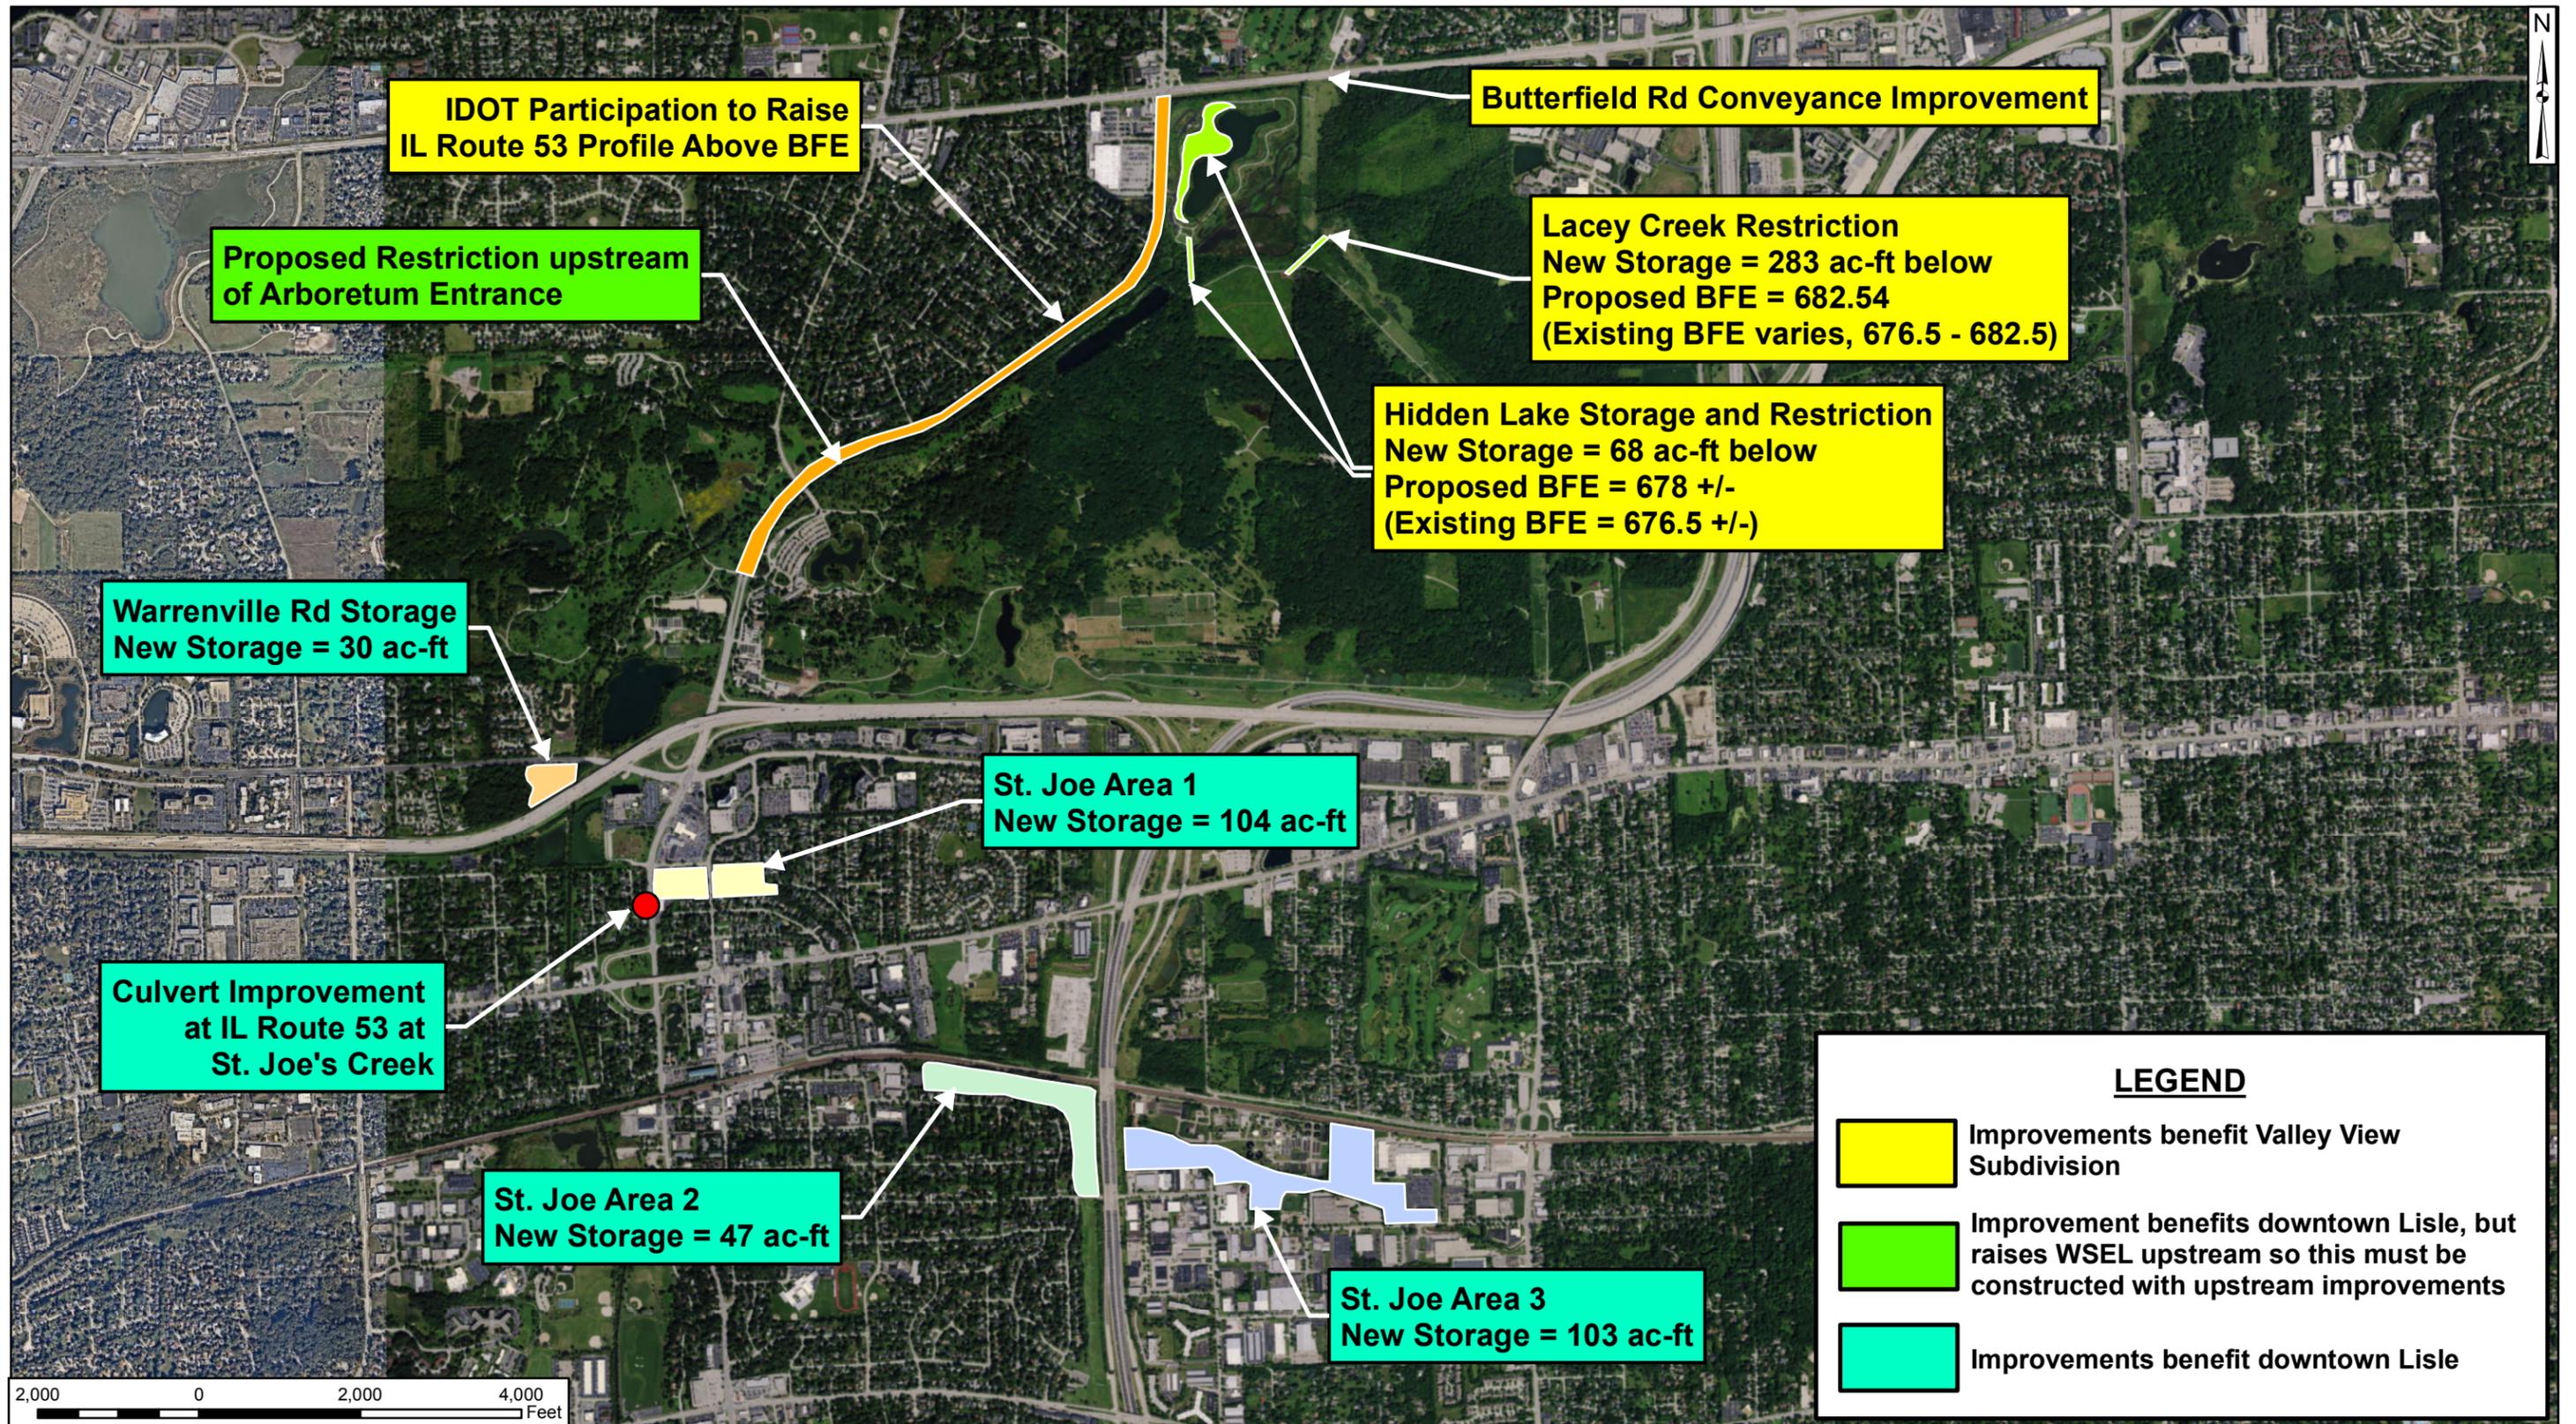
Figure 4 – St. Joseph and Valley View Storage Areas

The St. Joseph Creek storage project is located on the East Branch DuPage River and St. Joseph Creek in Lisle, Illinois. The project may consist of creation of storage adjacent to St. Joseph Creek; multiple storage areas and project features were considered. Potential project areas are shown on **Figure 4**. The HTRW assessment of each of the St. Joseph storage project areas is limited to a preliminary screening. If any of the potential projects are selected for implementation, a complete Phase I ESA is recommended.

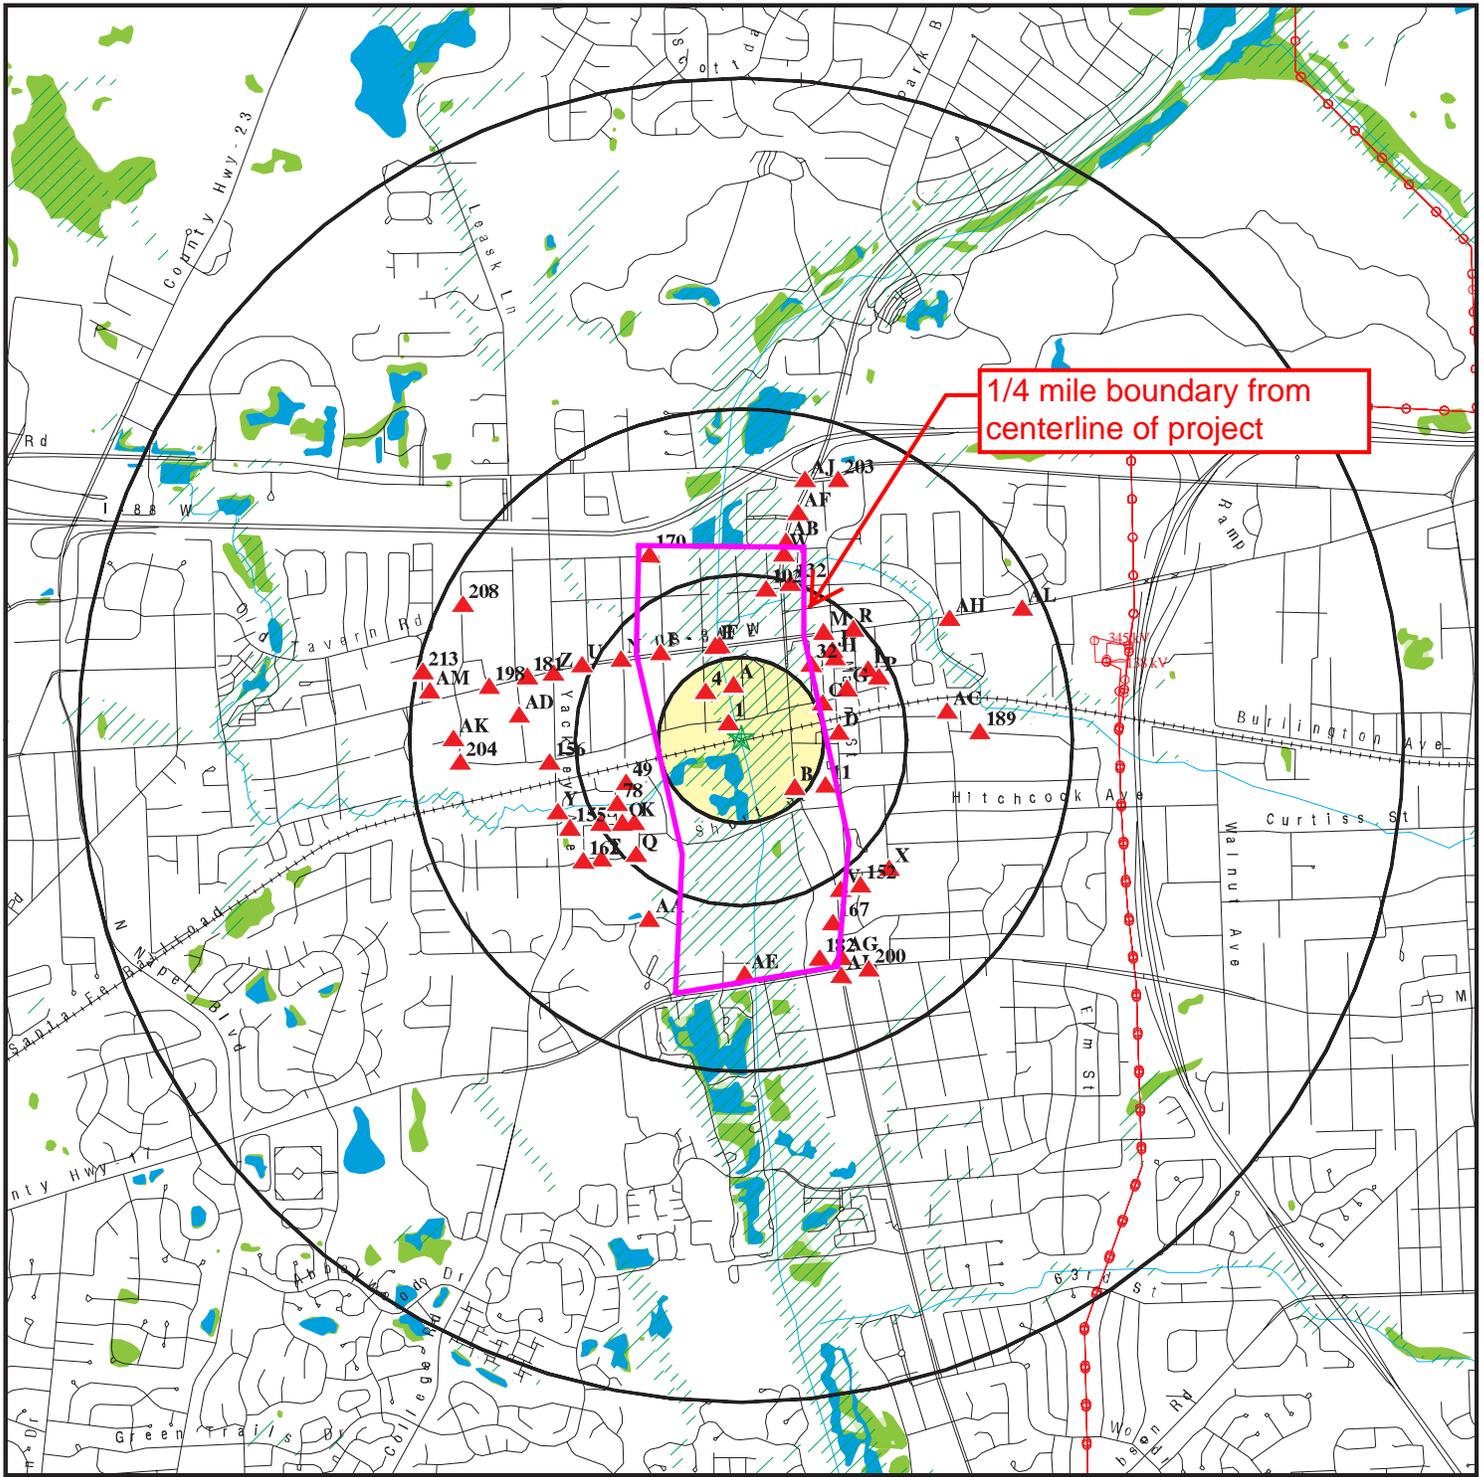
Figure 7 – Lisle Levee EDR Radius Map **OVERVIEW MAP - 5157919.2S**

A database report for the Lisle Levee project site is included in **Attachment 7**. The database search for Lisle Levee was extended ½ mile beyond the recommended ASTM search distances to accommodate the length of the project area. As a result, the database report contains an excessive number of returns. Only facilities that are on, adjacent, or within ¼ mile of the levee area project area are reviewed as part of this report; results are shown in **Figure 7** and summarized in **Table 8**. In general, there are several entries in the EDR report that are directly adjacent to the project area with little to no information of

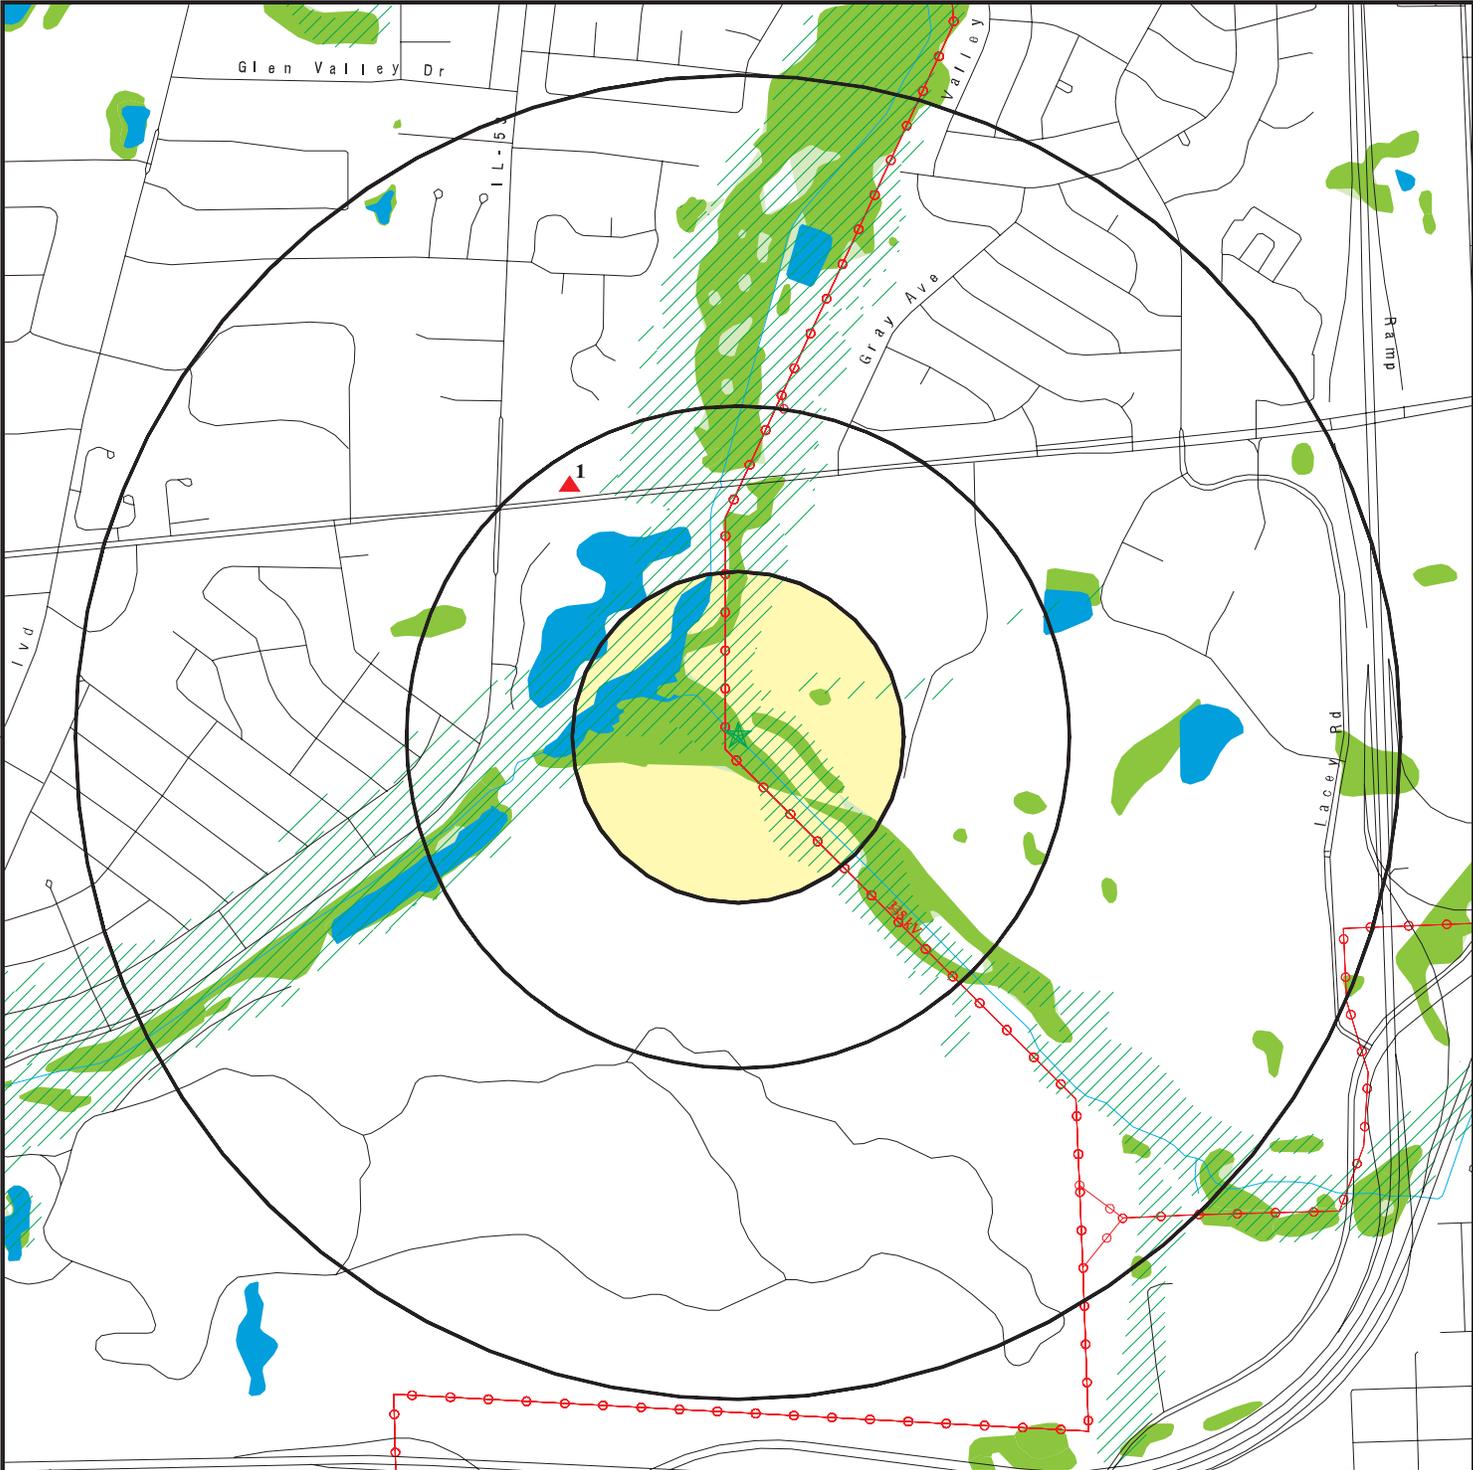
Figure 8 – Lacey Creek EDR Radius Map **OVERVIEW MAP - 5269518.2S**

The recommended ASTM search distances were used for the Lacey Creek restriction project site; a database report is included in **Attachment 8**. Results are shown in **Figure 8** and summarized in **Table 9**. In general, it appears that there are very few regulated environmental facilities on or near the project area. One LUST, registered for Shell Oil Product, U.S., is located ¼ to ½ mile north northwest of the project site. A NFA/NFR letter dated December 6, 2004 signifies no further action is required for the reported release at the facility.

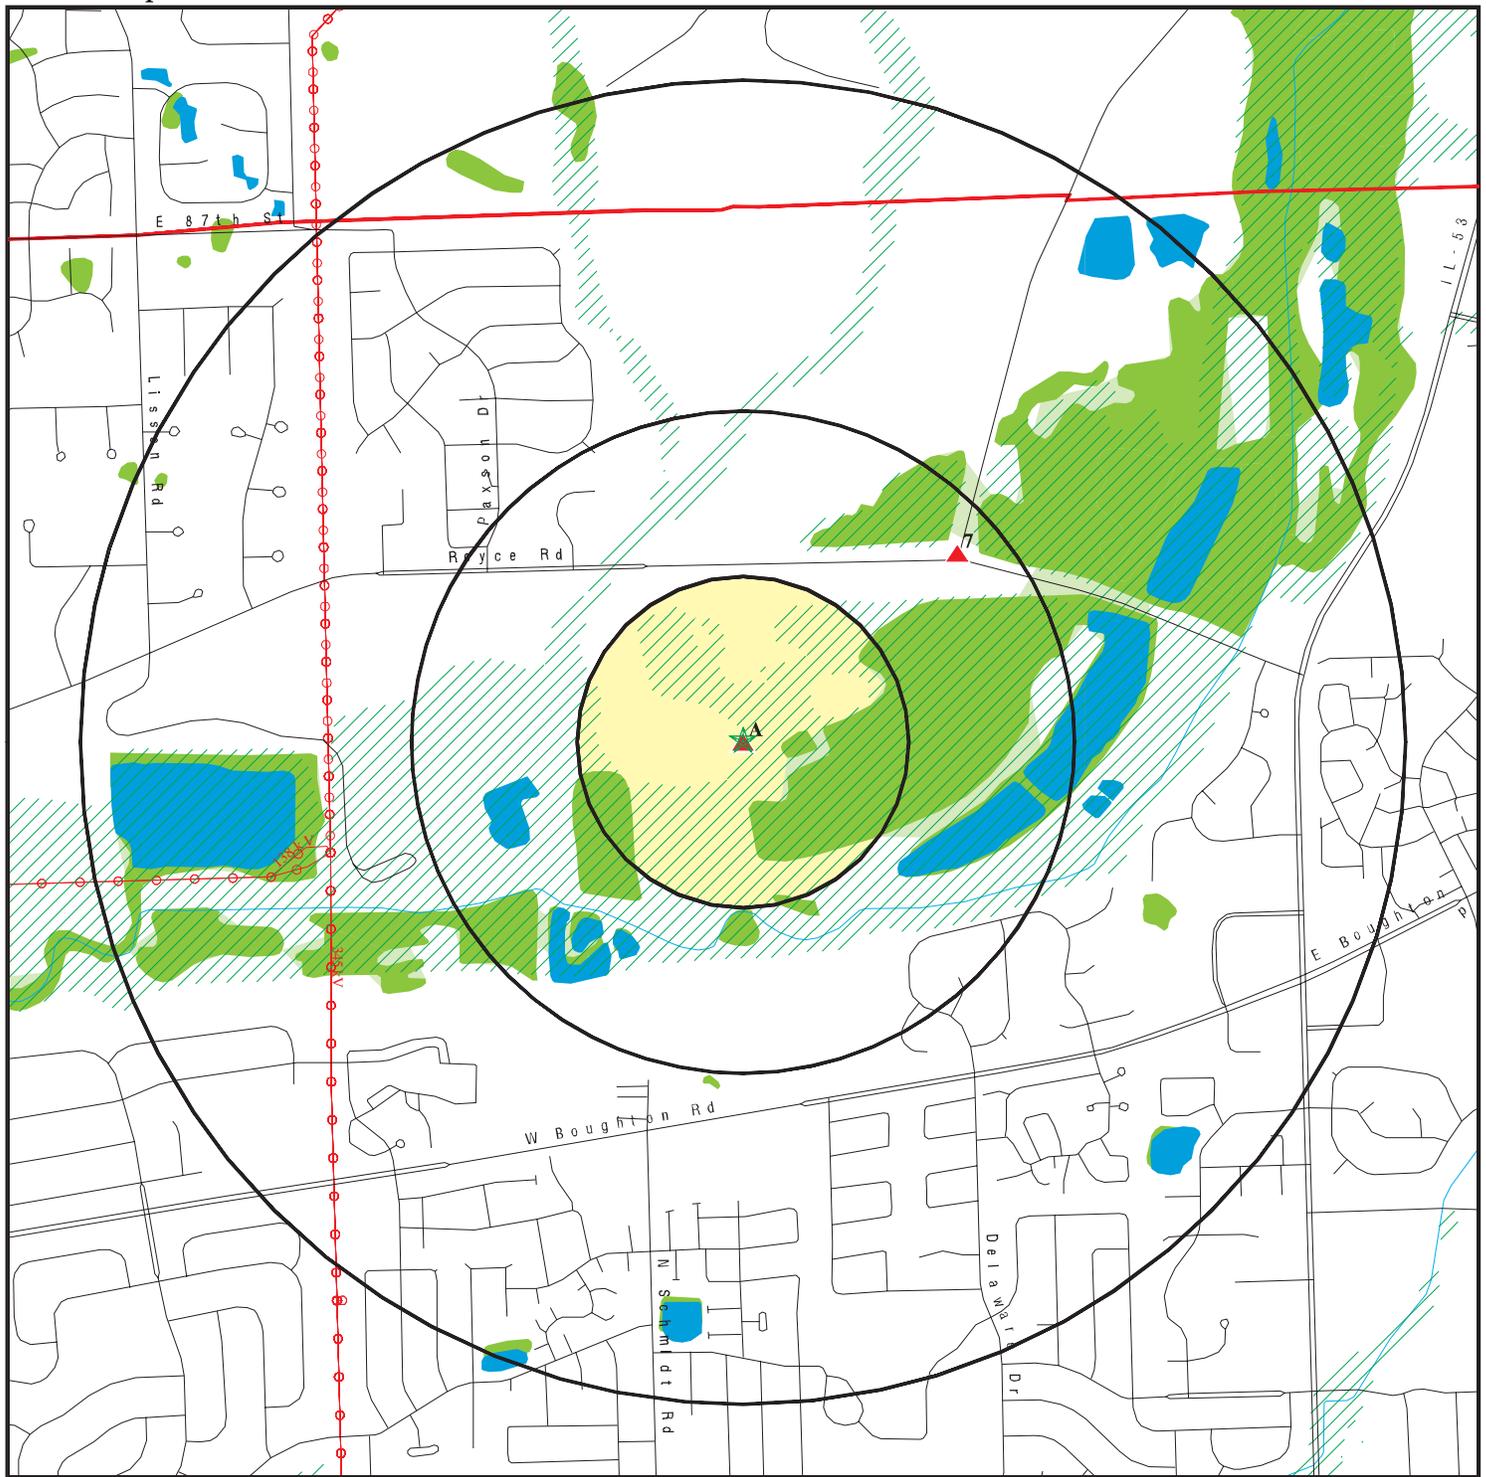
Figure 9 – Bolingbrook Quarry EDR  
Radius Map

The recommended ASTM search distances were used for the Bolingbrook Quarry site; a database report is included in **Attachment 9**. Results are shown in **Figure 9** and summarized in **Table 10**. In general, results suggest that the quarrying operation has obtained permits required to operate, including NPDES water and AIR permits, with no indication or records of uncontrolled releases or permit violations. According to TIER2 database, the facility appears to store chemicals onsite. Database returns also indicate that fly ash may be present onsite; it is unknown if fly ash was used as fill onsite after quarrying or if the material is used for processing. The site is also registered as a CCDD disposal facility, which suggests that recent fill placement at the site may be “clean” material. The nature and extent of chemical storage, waste materials, and/or fly ash presence on the site should be confirmed during site reconnaissance and/or during interviews with the site owner.

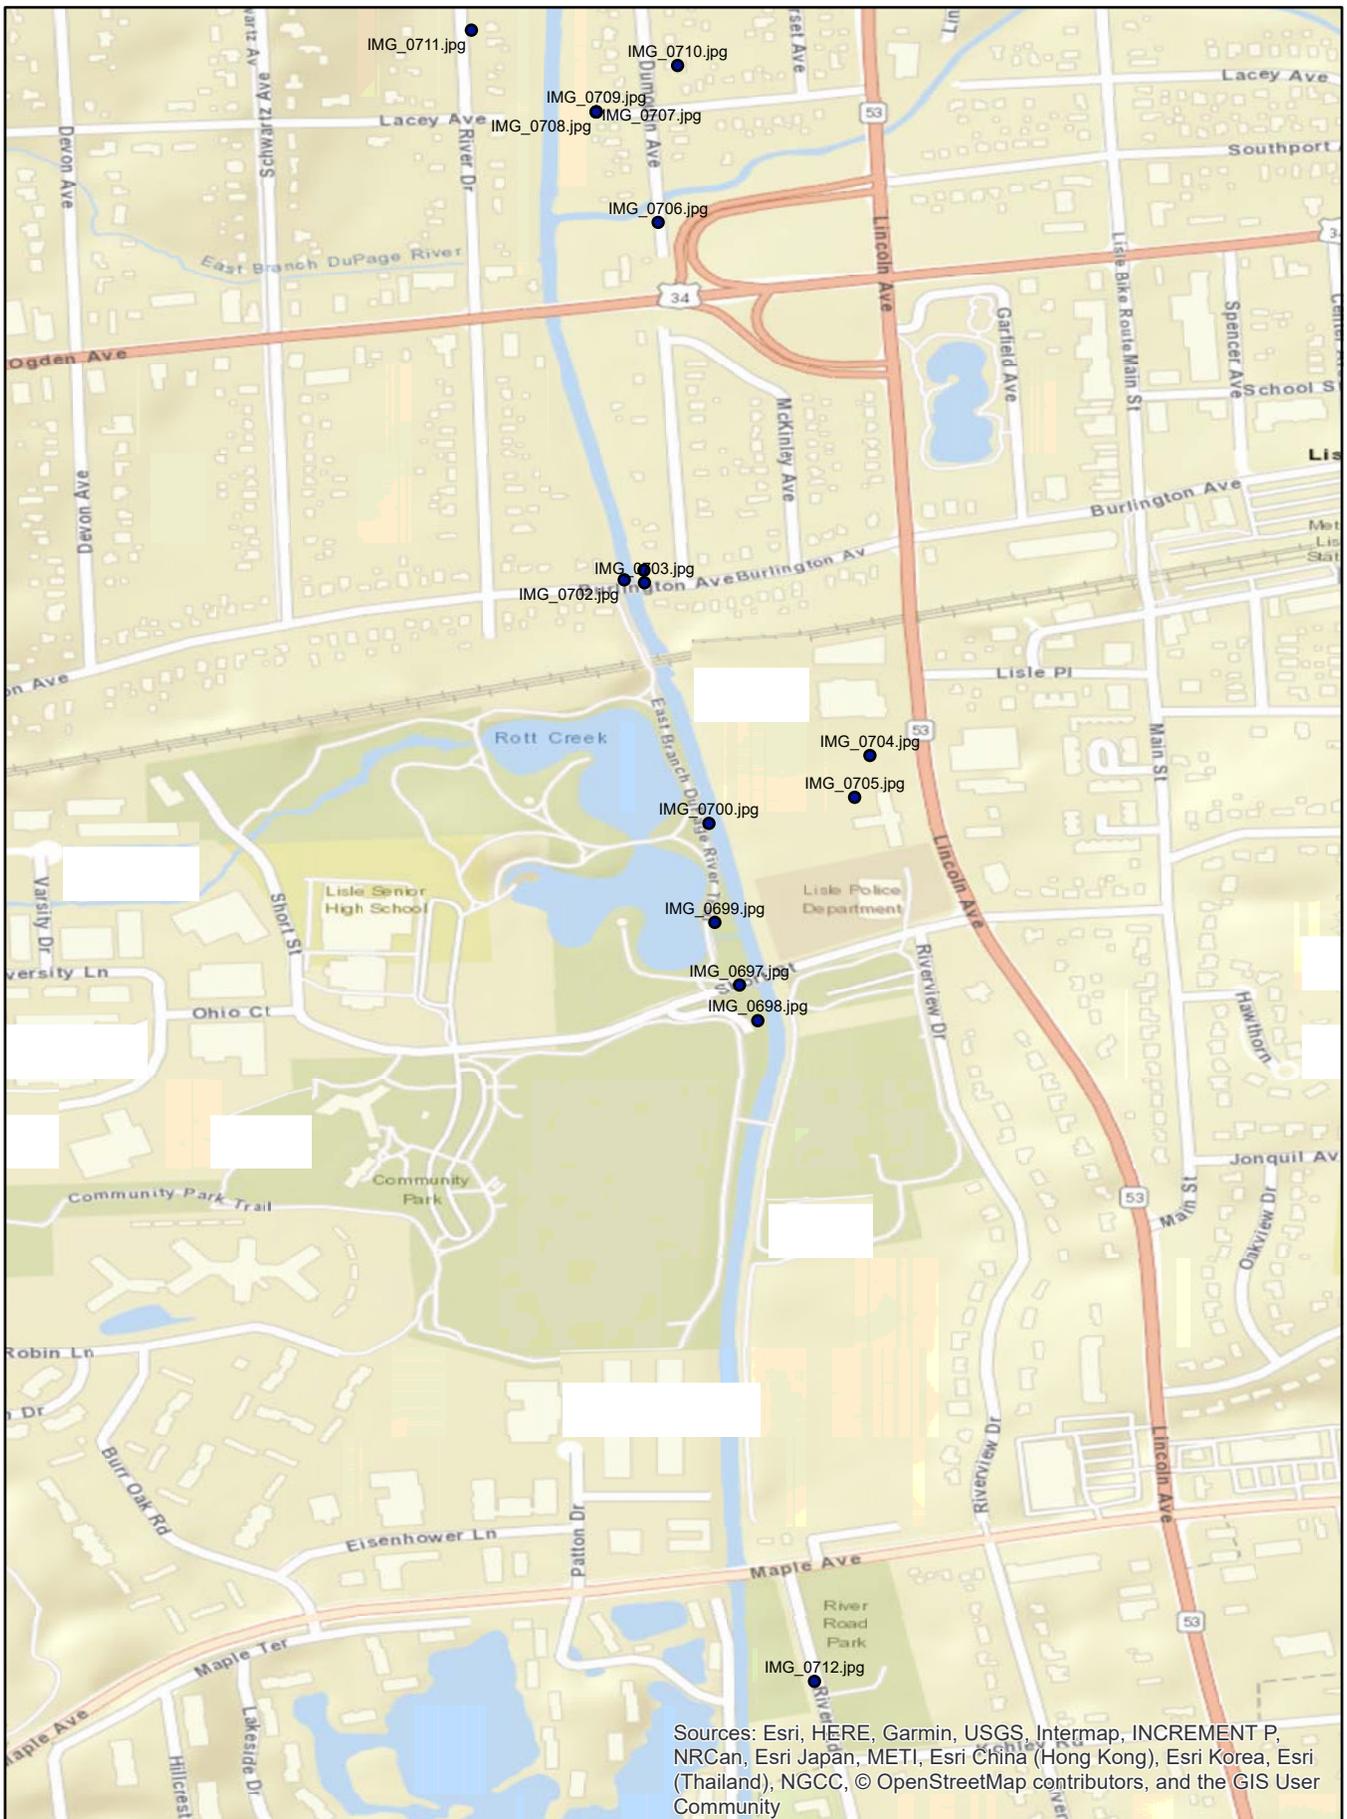
Figure 10 – Lisle Levee Site Visit Photograph Locations

- IMPDMENT, EDR Site #AE187 is registered to the DuPage County of Public Works, and is adjacent to the project area along the west bank. The facility is listed as a municipal impoundment, oxidation treatment. This site could not be located as mapped in the EDR report, which did not include an address. However, a public works building was located near the river at a community park, investigated because it is listed as a “sewage disposal area” in the 1962 topographic map, south and east of the project area. The area was in good condition (image 712). There were no visible signs of HTRW in the area.

- housed a structure or business. A wetland may be present between the concrete pad and the river. Historical use of the property is unknown.
- East bank south of the St. Joseph Creek near Lisle Auto and Tire is disturbed in recent aerial images. No topographic changes are noted in historical maps in these areas, but there are portions of the areas that are currently unvegetated. Portions of the property are visible from Dumoulin Avenue. Unvegetated areas appear to be gravel lot for the current business (image 706). It is unclear if site activities encroach on the existing levee.
