Dispersal Barrier Efficacy Study

Efficacy Study Interim IV, Chicago Sanitary and Ship Canal Dispersal Barriers Risk Reduction Study

June 2019

US Army Corps
of Engineers
Chicago District

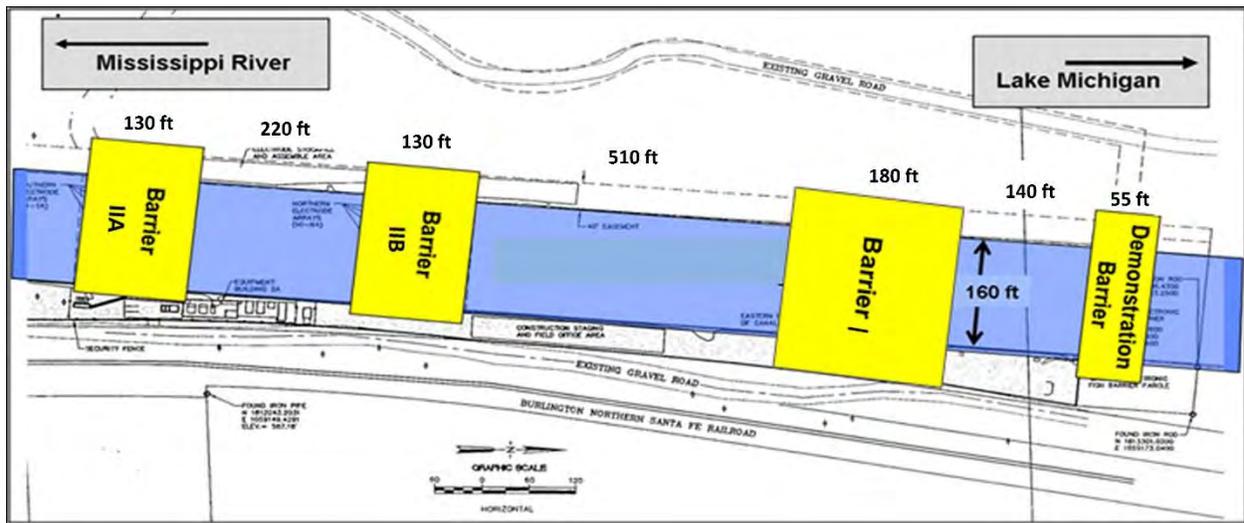
Figure 10 – Schematic of Electric Dispersal Barriers Project.

The operating parameters for both Barrier IIA and Barrier IIB were changed to $IWFS_0 = 2.3$ V/in, 30 Hz, 2.5 ms in October 2011 after research indicated these parameters should be even more effective for deterring Asian carp. Since then the pulse parameters have been changed multiple times in response to further research results and concerns about interference with a nearby railroad crossing signal. The current operating parameters for both Barrier IIA and Barrier IIB are 2.3 volts per inch, 34 Hz, 2.3 milliseconds. Further information on the effectiveness of barrier operating parameters is contained in *Chapter 5, Effectiveness of the Barriers*. The Electric Dispersal Barrier System is the fourth largest power user among all USACE projects.

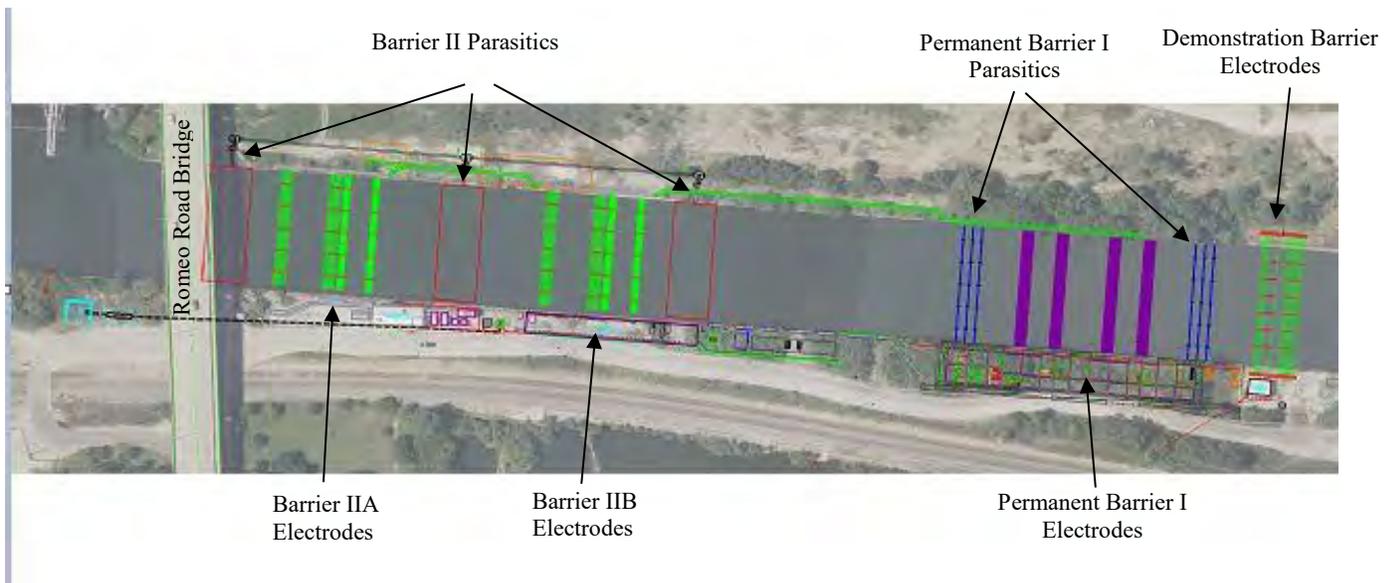
Figure 15 – CSSC Barrier System Electrode Arrays and Parasitics

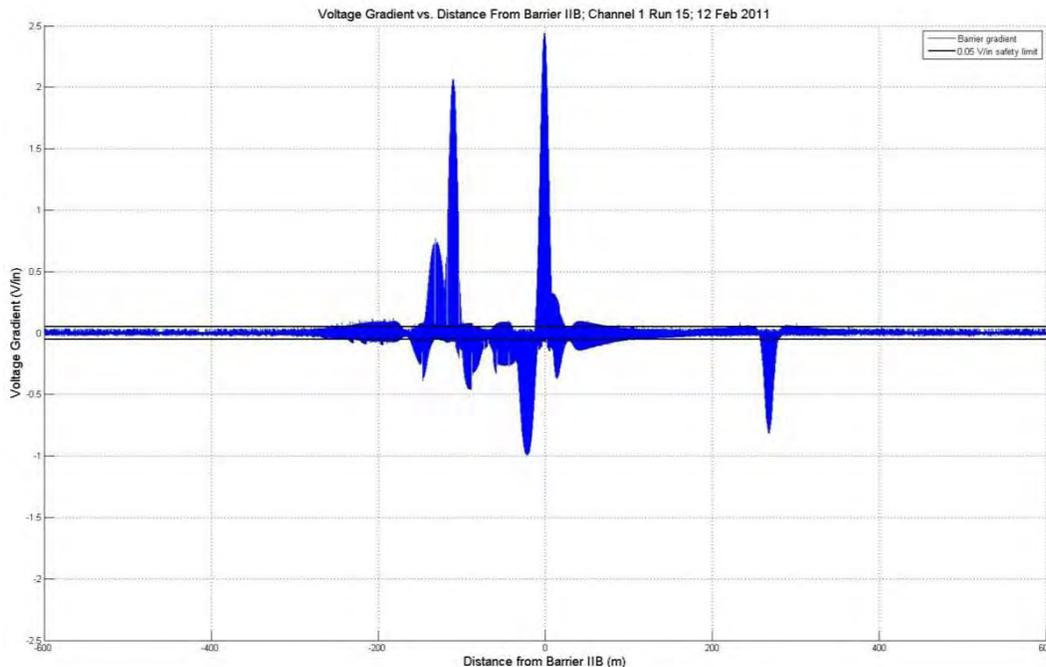
Figure 16– An electric field strength plot geo-referenced with respect to the center of the high field of Barrier IIB.

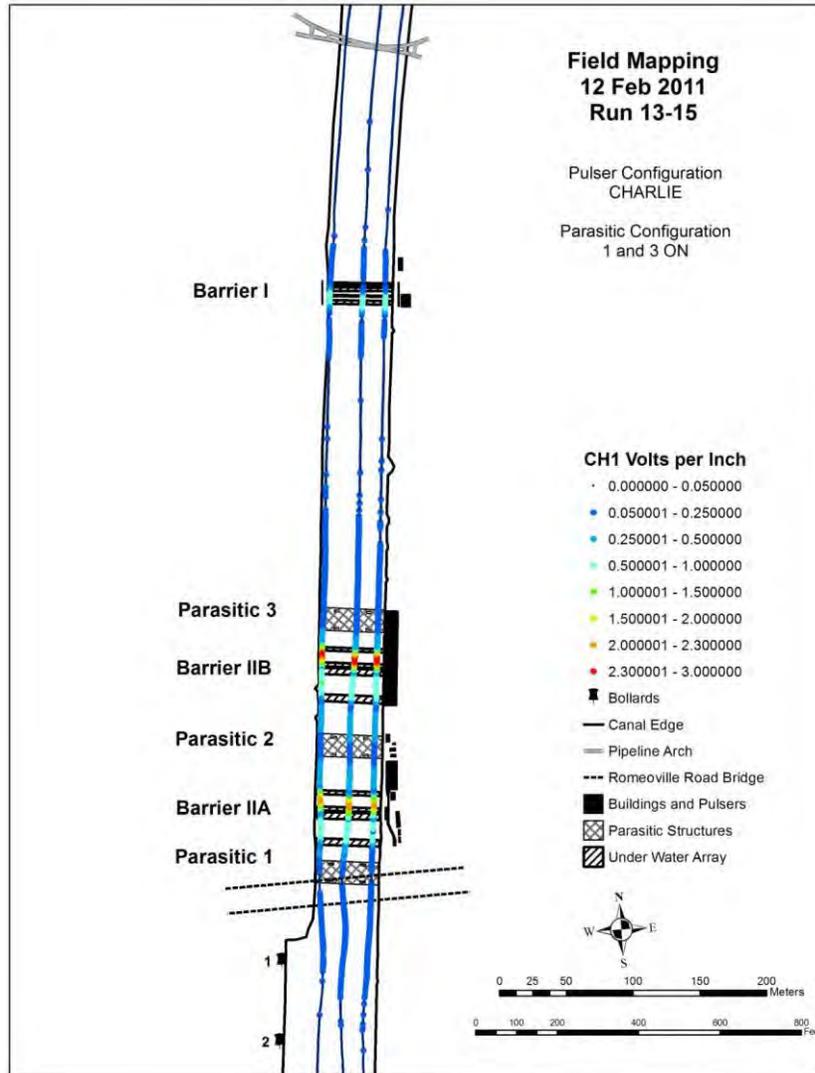
Figure 17– A plan view electric field strength plot.

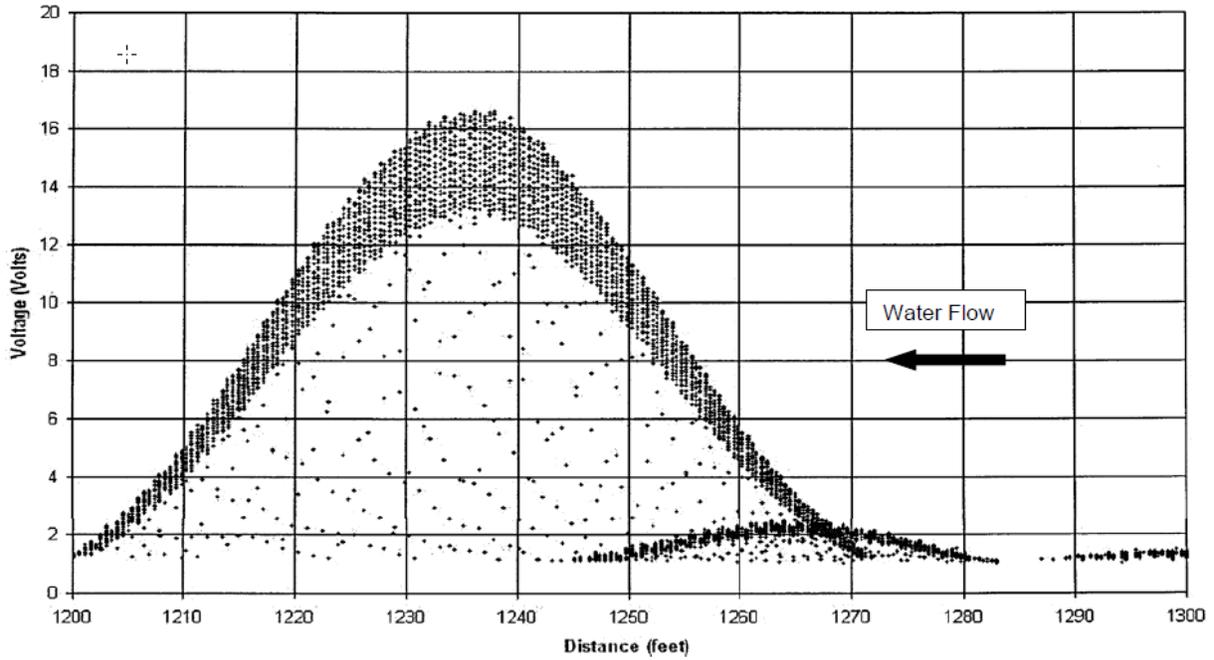
Figure 18– Example of distribution of electric field generated by the Demonstration Barrier at the water surface.

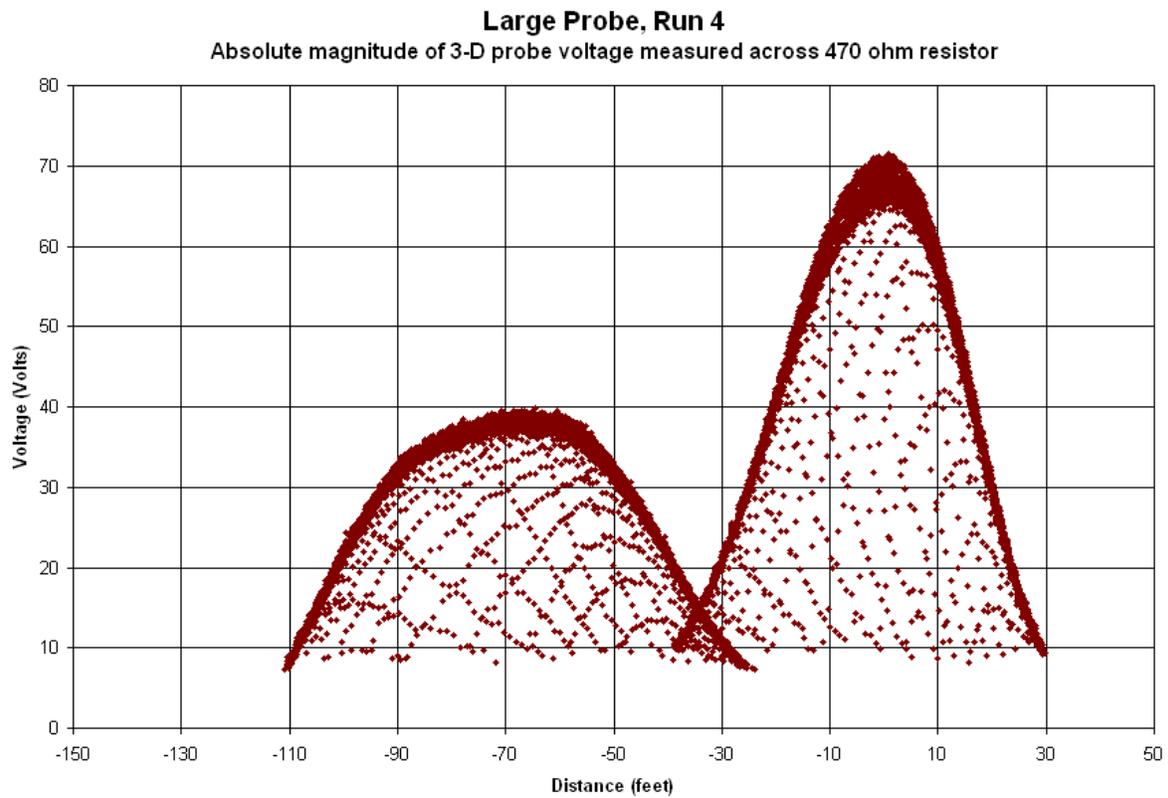
Figure 19 – Example of distribution of electric field generated by Barrier IIA or Barrier IIB at the water surface. Water flow would be from right to left. The wider but lower voltage part

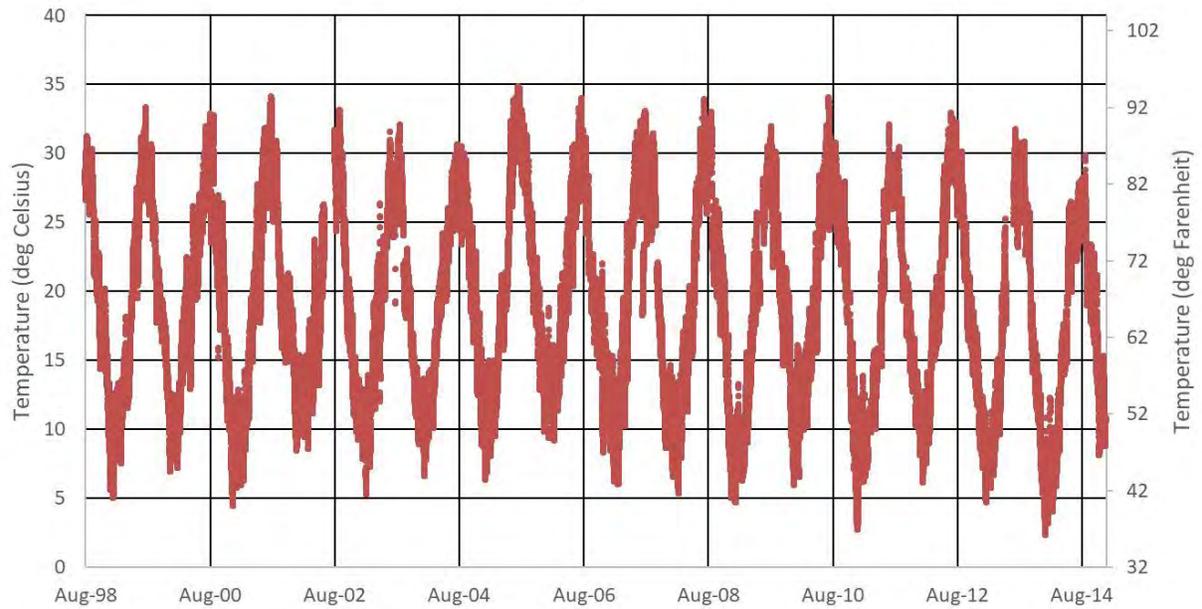
Figure 20 - Canal water temperatures recorded at Lockport Lock from August 1998 through August 2014.

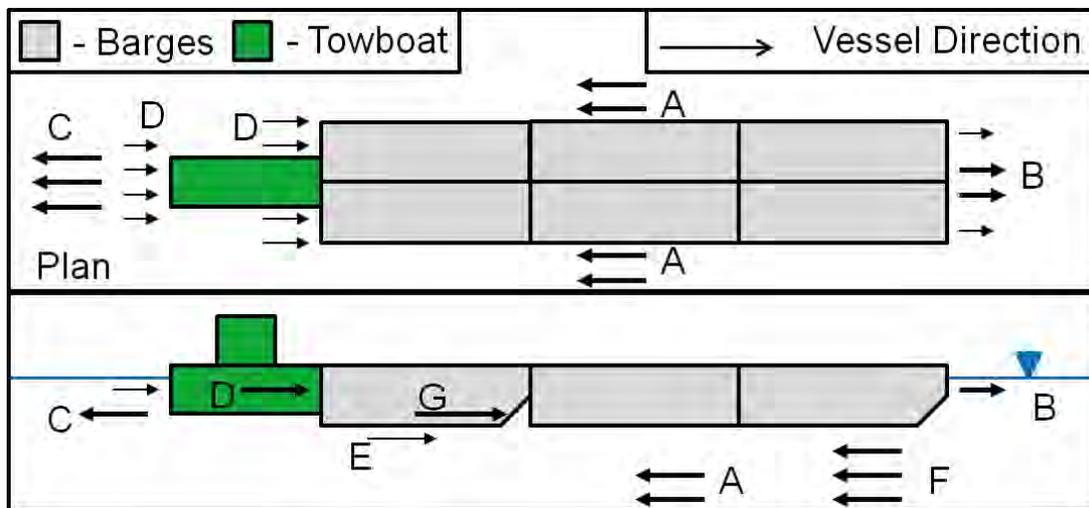
Figure 21– Water motions around tows moving left to right in confined channels. A = return velocity, B = bow wave, C = propeller jet, D = wake flow, E = flow in boundary layer along hull, and G = displacement flow at bow between hull and channel bottom having short duration.

Propeller Jet (C) - The propeller jet generates strong currents and turbulence resulting in a complex flow field behind the tow. At full speed the flow speed exiting the propellers can range up to 30 ft/sec and extend over the depth of the water column. For lower speeds, typical of the CSSC, the propeller jet is much weaker and may not reach the bed. For these lower speeds, near bed velocities under the propeller jet are dominated by the wake flow (D) and are in the same direction as the tow. For all propeller speeds, outside the width of the propeller jet but behind the barges, the wake flow is the dominant mechanism and the current is in the same direction as the tow.

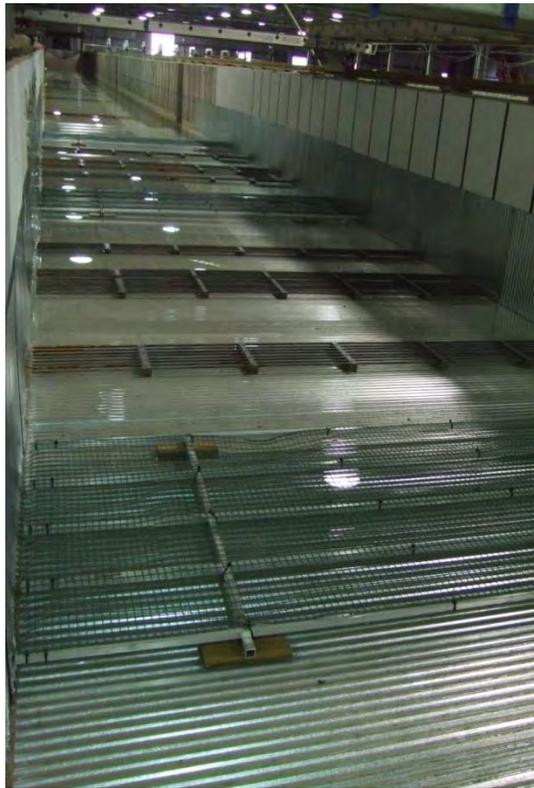
Figure 22– Model of CSSC with Barriers IIA and IIB at ERDC.

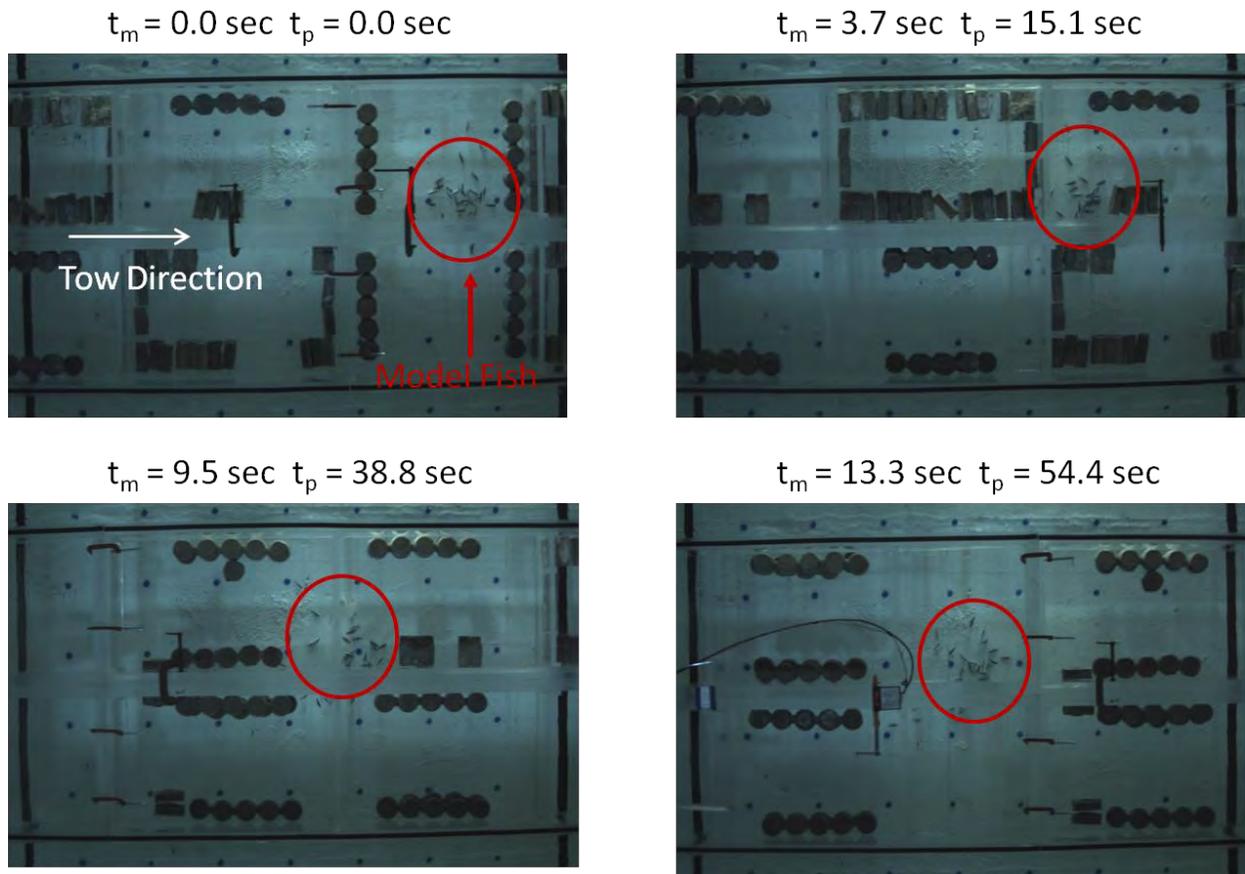
Figure 23– Snapshot showing the transport of model fish in the return current (A) as the barge passes overhead with corresponding model and prototype time.

Figures 23 through 26 demonstrate the model fish transport for the various mechanisms discussed previously. Modes of transport include the return current (A), the barge wake (D), the prop wash (C), the barge/towboat boundary layer (E) and barges and towboat junctions (G). Figure 23 shows four snapshots of model fish moving along the bottom in the boundary layer caused by the return current (A). Above each snapshot the corresponding model time, t_m , and prototype time, t_p , is given. This mechanism moves any fish along the bottom or channel walls in a direction opposite the tow and is important for southbound tows. The vessel is moving left to right in the four snapshots, but the model fish, surrounded by the red circle, are moving in the opposite direction. The model fish move 66.8 ft (prototype) in 54.4 seconds (prototype).

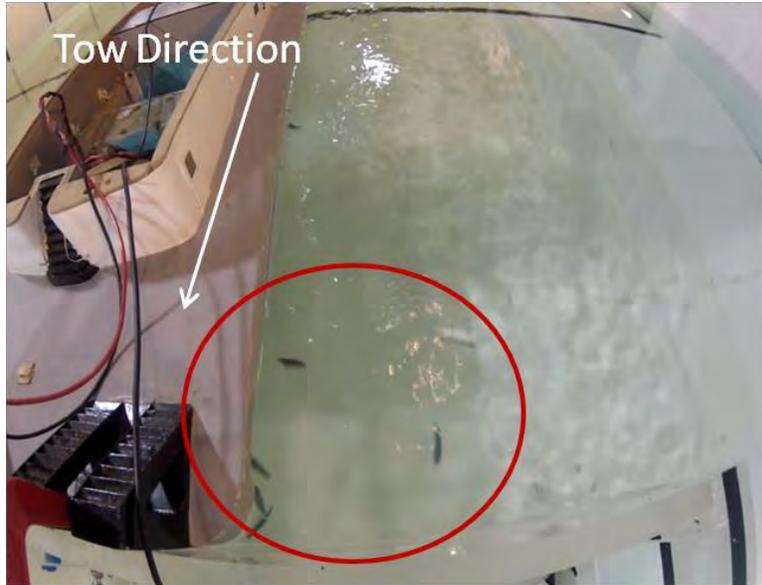
Figure 24– Snapshot showing the transport of model fish in the barge wake (D).

Figure 24 shows model fish, highlighted by the red circle, moving with the tow in the barge wake (D). The tow direction in this picture is towards the bottom left corner. This mode of transport is effective at moving model fish in the same direction as the tow. Figure 25 shows model fish being carried within the barge boundary layer (E). The tow is moving right to left with the fish being pulled along. This mode of transport is not as efficient due to mixing and the intermittency of boundary layer vortex structures that can eject the fish. Another effective mode is the junction between barges as shown in Figure 26. In this series of snapshots the tow moves forward into the page as the model fish are suspended beneath. The black box represents the barge junction (G) region of the tow configuration. As the tow moves over the model fish (red circle) they become entrained in the junction area and are carried in the same direction as the tow. The snapshots show the model fish being transported 100.2 ft (prototype) in 36.8 seconds (prototype). Once the model fish become entrained in the vortex, they tend to remain trapped for long periods of time resulting in efficient transport.

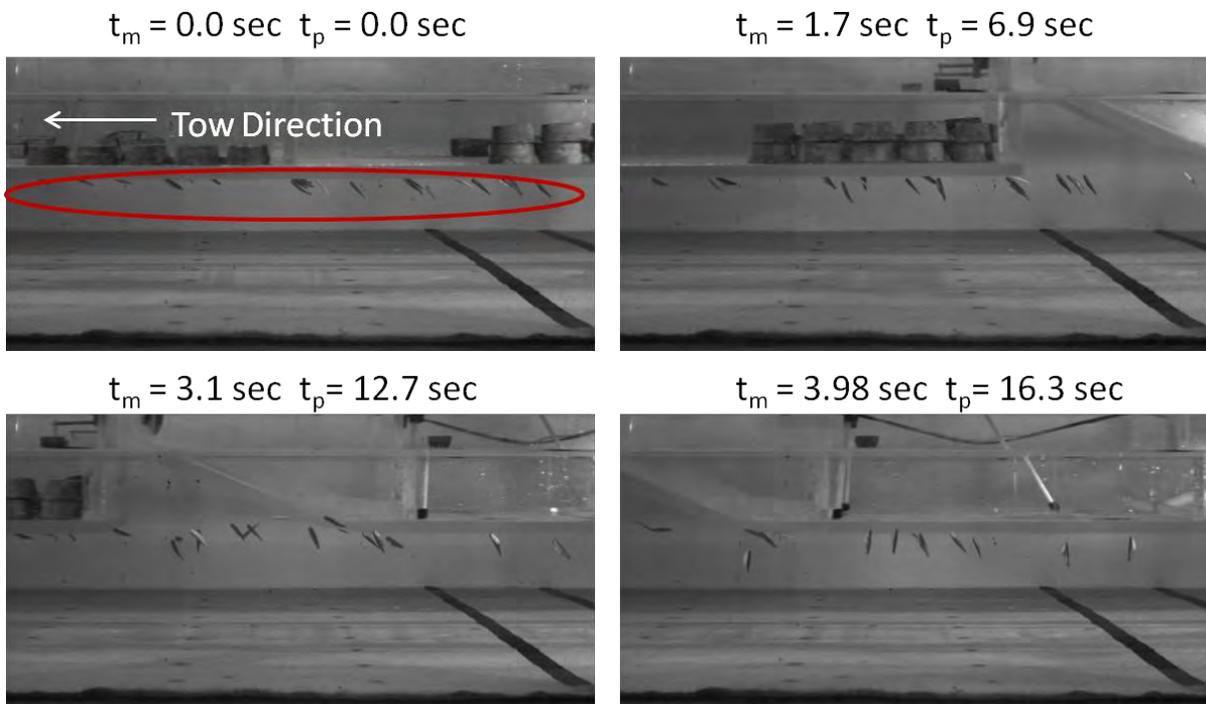
Figure 25– Snapshot showing the transport of model fish in the barge boundary layer (E) and entrainment of some of the model fish between two barges with corresponding model and prototype time.

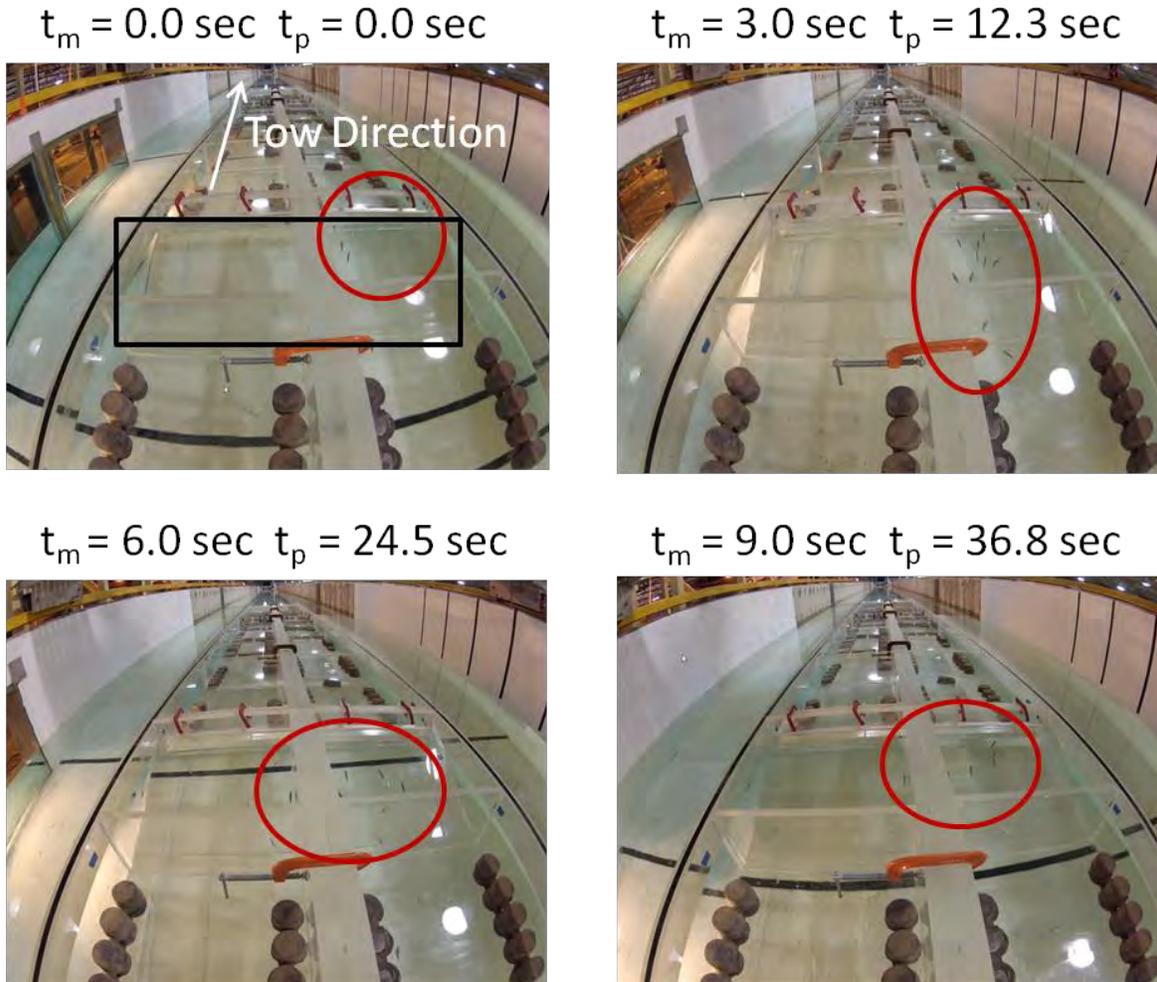
Figure 26– Snapshot showing the transport of model fish in the junction between a raked barge and a square barge (G) with corresponding model and prototype time.

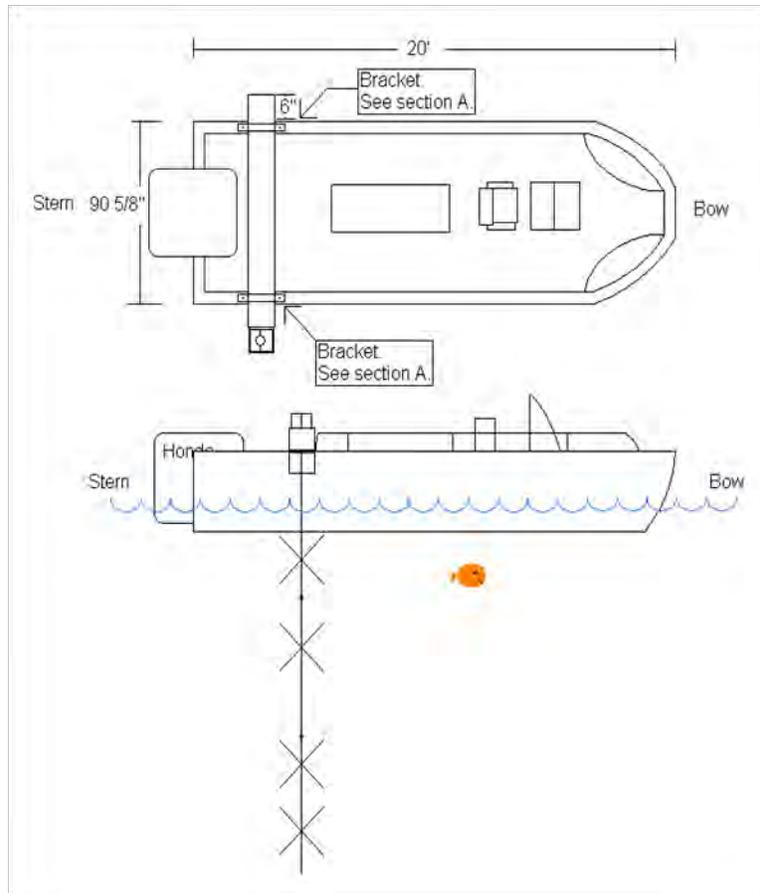
Figure 27 – Schematic of the Boston Whaler and probe array.

Electrical data were continuously collected at a rate of 8000 samples per second as the boat traversed the barriers from the Romeo Road Bridge to the pipeline arch. This extends the data-collection region well beyond the Demonstration Barrier to the north and Barrier IIA to the south. Geo-positional data were taken concurrently with the voltage and current measurements during field mapping to allow them to be geo-referenced. A minimum of ten passes — two passes along five transect paths spread across the canal were taken to allow for data interpolation throughout the barrier zone.

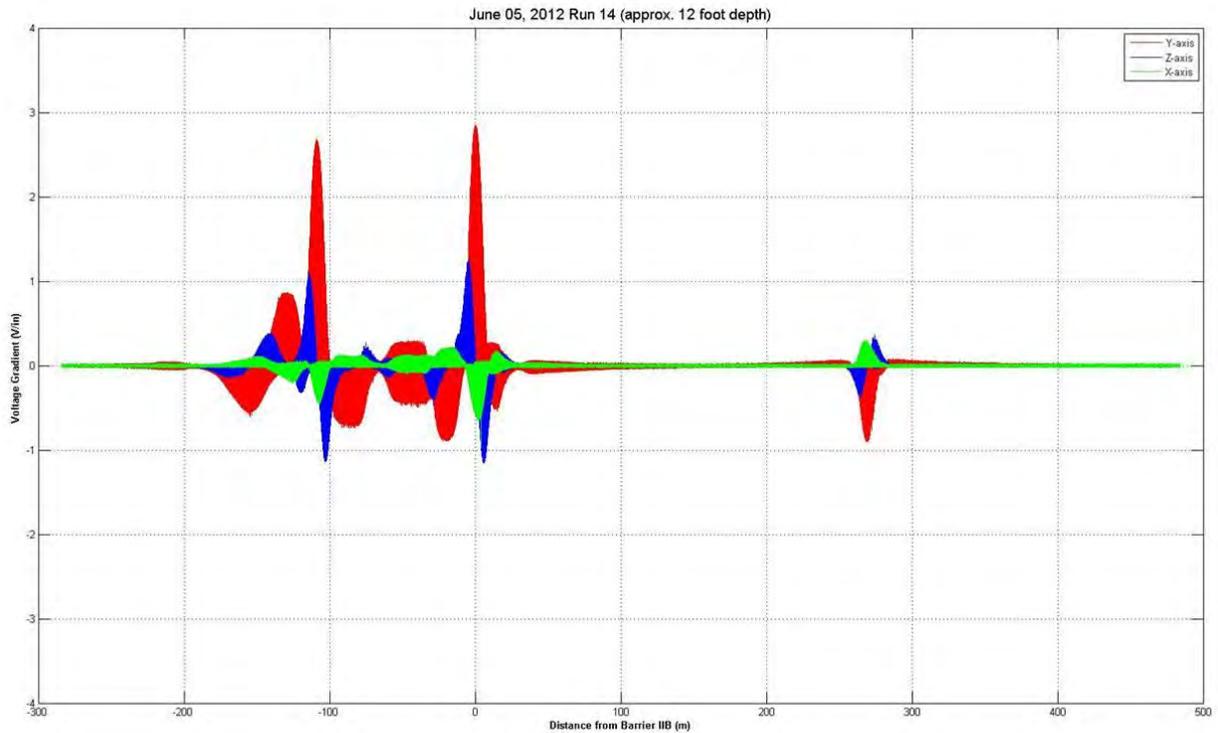
Figure 28 – Typical 3-D electric field mapping plot.

Geo-referenced electrical data collected in this effort was projected into a GIS format to determine the location of field strengths and weaknesses. These maps not only provided the baseline for comparison to later runs but were also used to generate safety zone maps in preparation of Barrier I construction.

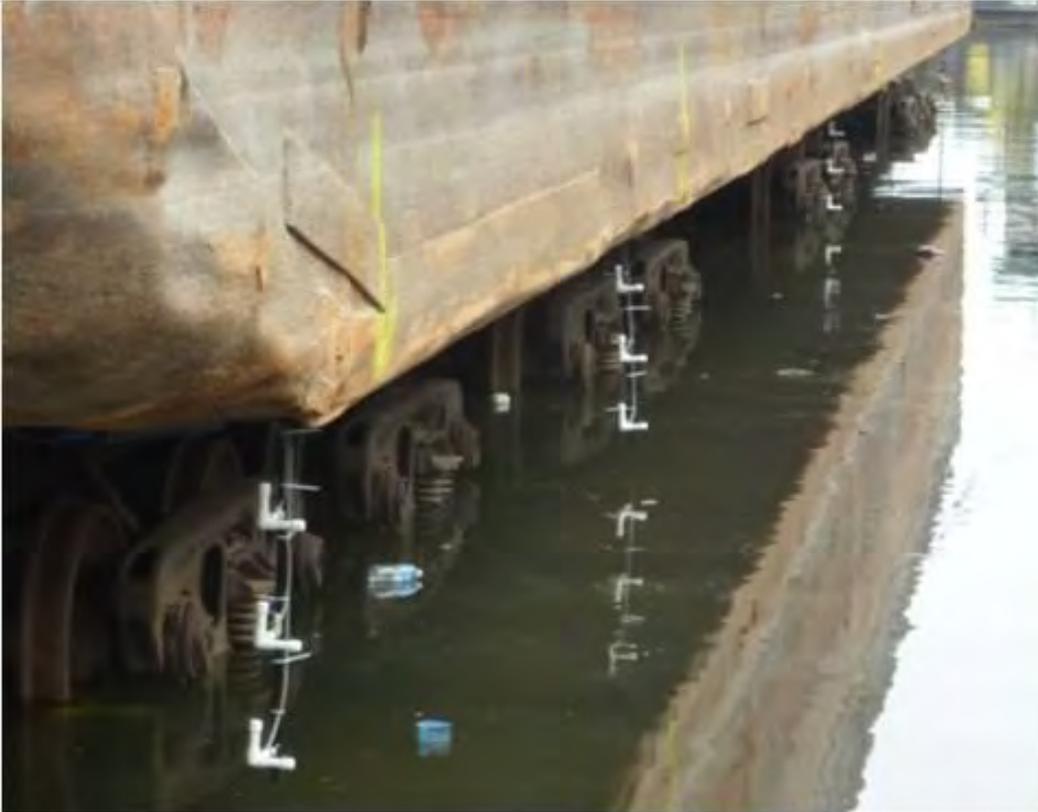
Figure 29 – 3 Dimensional probe arrays along the bottom edge of rake barge in dry dock.

For the July and October testing, a total of forty-six 3-dimensional sensors were designed and fabricated at ERDC-CERL and welded to the barges in dry dock. Each array contained three sensors spaced 1 foot, 2 feet, and 3 feet from the surface of the barges (Figures 29 and 30). A pair of arrays was suspended within the wedge of the rake barge to measure the electric fields within this area (Figure 31). During testing, electrical field data was collected on up to 24 channels at a sampling rate of 8000 samples per second. These readings are geo-referenced using GPS receivers mounted to the forward and aft areas of the instrumented barge. The combined electrical and geo-positional data was used to determine the strength and direction of the electrical field around the barges throughout the barrier zone. Testing occurred with the barges in multiple configurations (Figure 32) to simulate tow configurations regularly utilized by shipping companies.

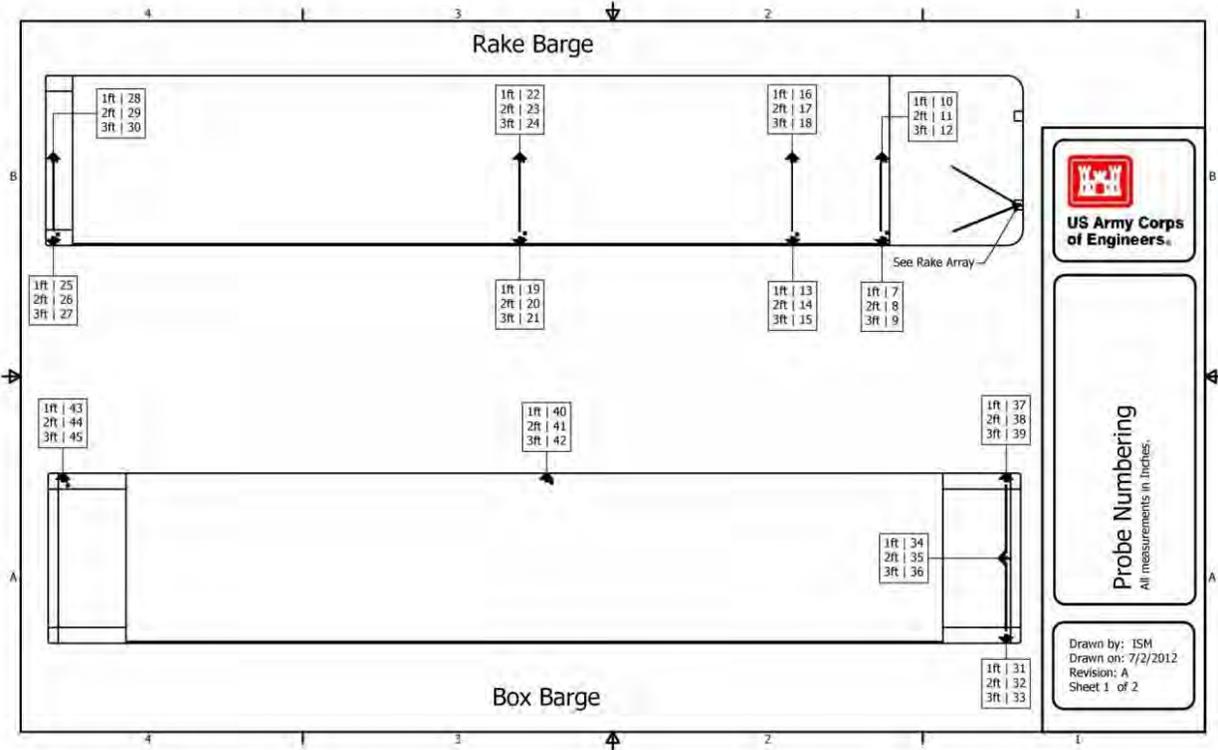
Figure 30 – Sensor array locations and numbering for the rake and box barges.

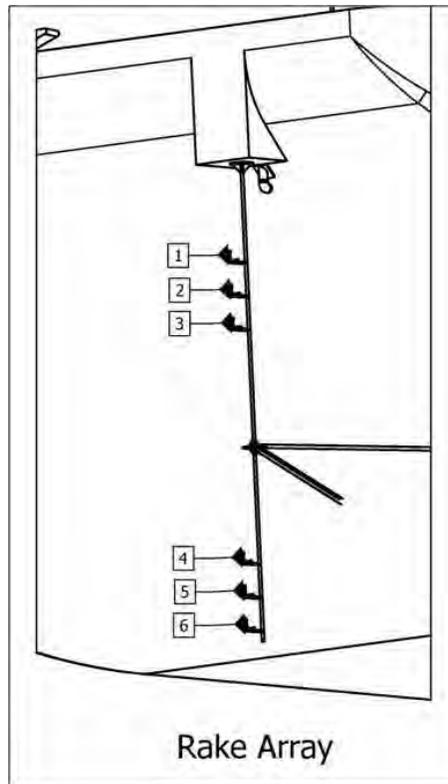
Figure 31 – Rake array locations and numbering.

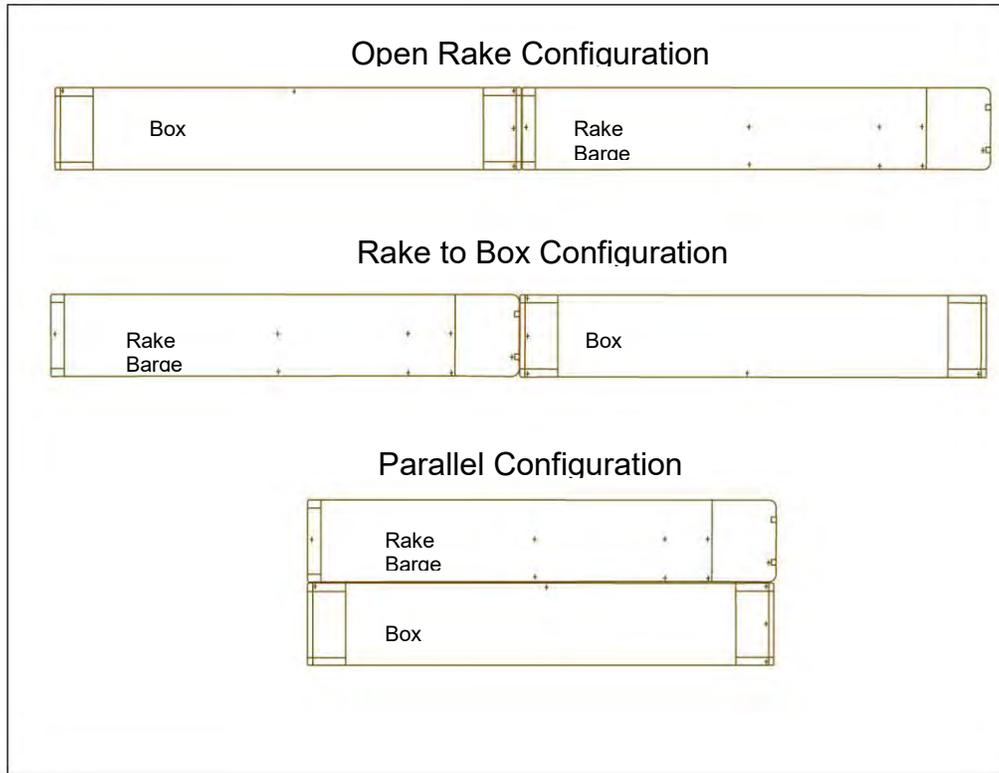
Figure 32 – Barge Testing Configurations

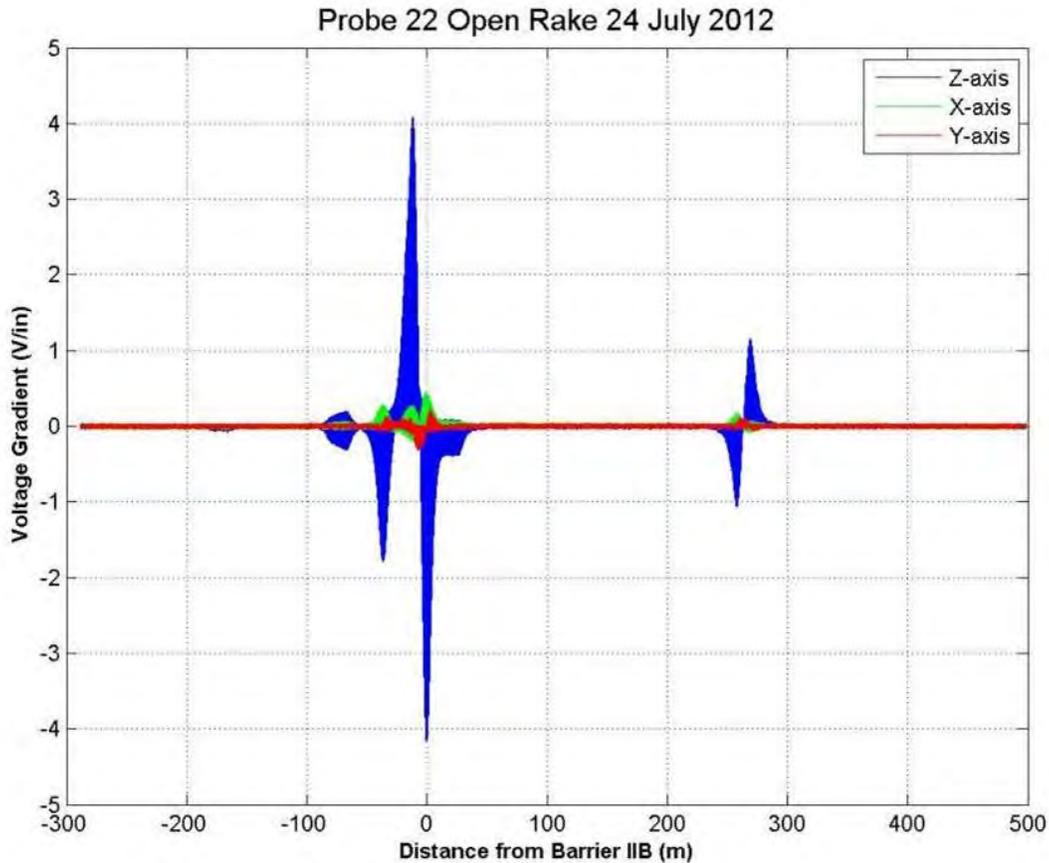
Figure 33 – Typical electric field plot from the bottom of rake barge in the open rake (series) barge configuration.

Several tests were conducted in July using barge configurations where the rake section of one barge was not connected directly to the flat backed box section of another barge (open rake or parallel configurations). A typical voltage gradient plot from open rake barge testing in the series connection is shown in Figure 33. This plot was taken from Probe 22 which was spaced at 1 foot from the bottom of the center of the rake barge. When compared to the field mapping plot from Figure 28, it can be seen that the electric field gradient is significantly distorted due to the presence of the barges. The overall magnitude is much higher, and the dominant electric field component is in the Z direction as opposed to the Y direction, normal to the surface of the barge. (Note: only Barrier IIB was operational during this testing.)

The 3-D voltage gradient at Probe 22 is shown in Figure 36. This can be directly compared to the voltage in the same location with the open rake configuration (Figure 33). The distortions in the electric field gradient at the bottom center of the rake barge are very similar in both configurations. The voltage gradient is increased, and the Z-field (depth) component is dominant. The overall magnitudes are similar between the two.

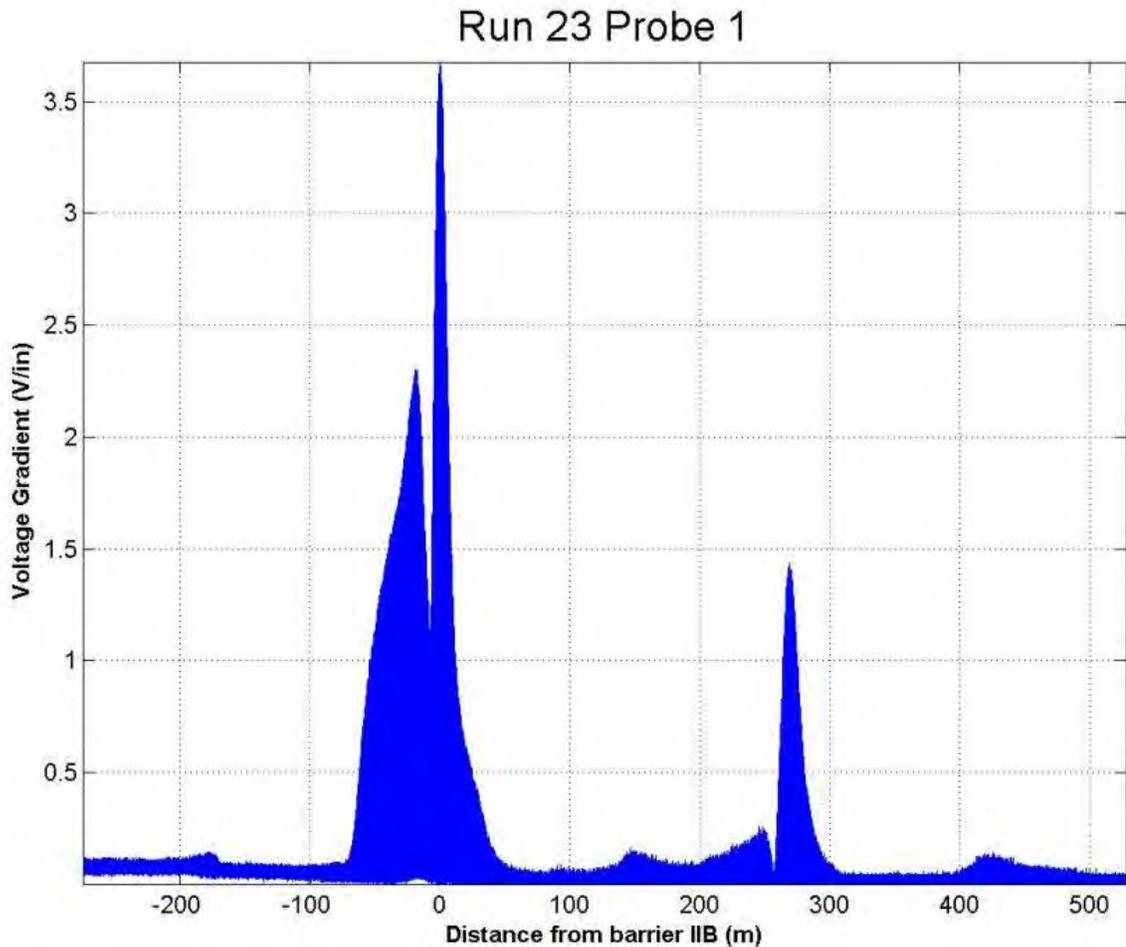
Figure 34 – Vector Magnitude field strength measurements over Barrier IIB and the Demonstration Barrier from the open rake section of an instrumented barge.

The rake array probes provide information on the electric field strength in the water beneath the rake. Figure 34 shows a vector magnitude plot of the electric field at probe 1 near the water surface in the rake as the barges passed over operating Barrier IIB (centered at 0 on the x-axis) and the Demonstration Barrier (centered around approximately 270 m on the x-axis). This shows increased field strength near the surface of the water. With typical peaks of 2.3 Volts/inch and 1 Volts/inch when no barges are passing, the peaks measured from the rake section of a passing barge were 3.7 Volts/inch and 1.4 V/inch.

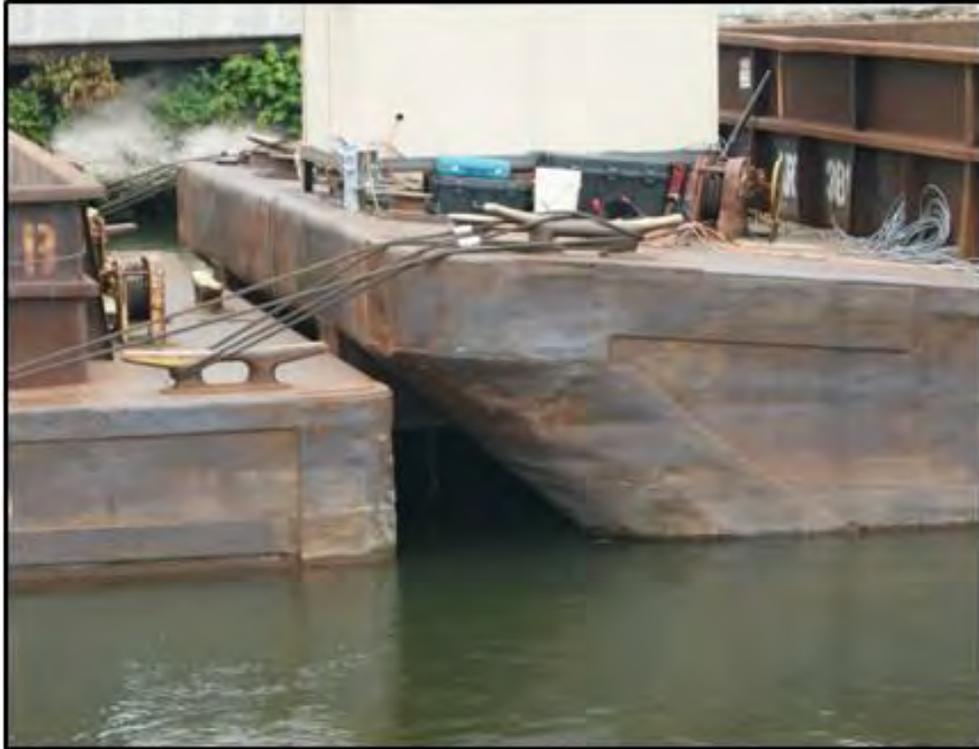
Figure 35 – Instrumented barges in the Rake to Box configuration during testing.

Other testing in July included the barge configuration where the rake section on an instrumented barge is connected to the box section of another barge as depicted in Figure 35. As seen in the figure, the rake and box barges are connected together using steel cables allowing a good electrical connection between them. In this case, the water beneath the rake is partially enclosed by the bow rake.

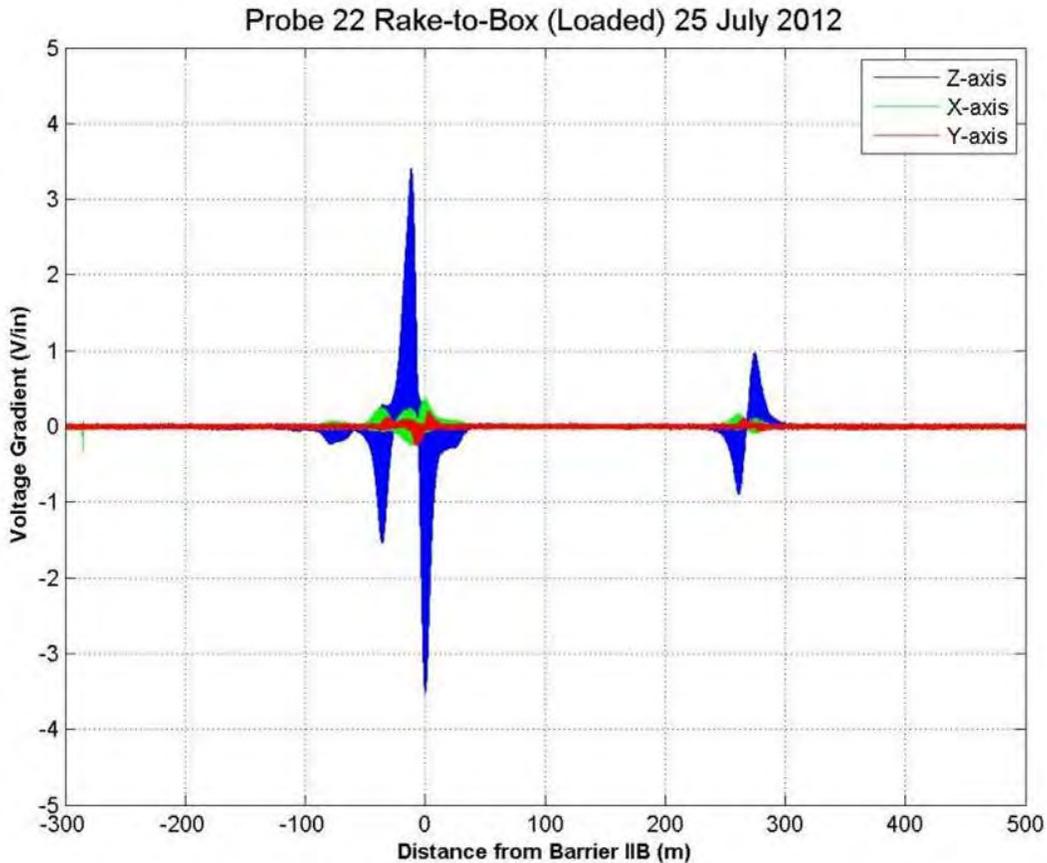
Figure 36 – Typical electric field plot from the bottom of rake barge in the rake-to-box barge configuration.

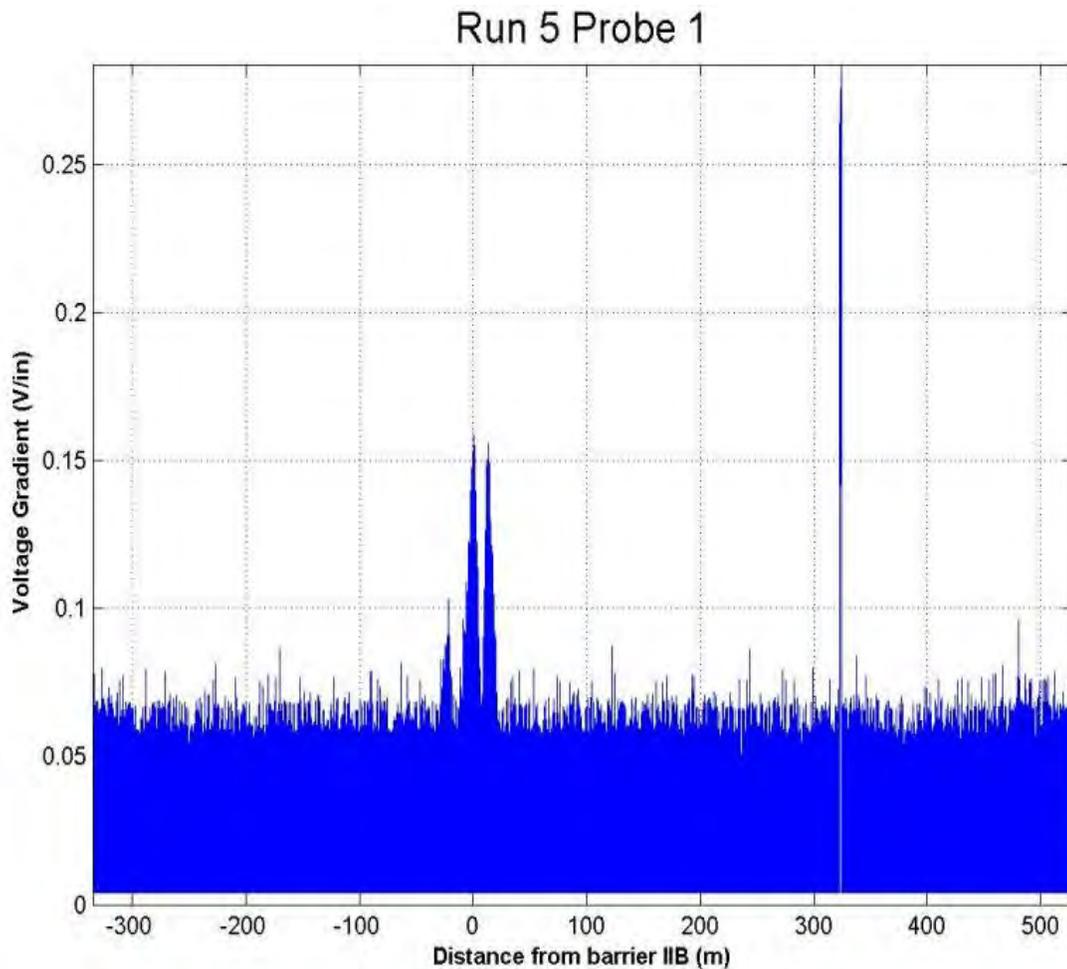
Figure 37 – Field strength measurements over Barrier IIB and the Demonstration Barrier from beneath the rake section of an instrumented barge connected to the box section of another barge. (Note: The line at approximately 320 m is due to radio interference during testing.)

Figure 37 is a plot of the voltage gradient vector magnitude in the water under the rake (Probe 1) in the rake-to-box configuration. Two peaks are visible at the Barrier IIB high field. The field strength measured while passing over the high field of Barrier IIB (0 on the x-axis) is 0.15 Volts/inch rather than the typical peak of 2.3 Volts/inch when no barges are present. This represents a very significant reduction in the electric field strength within the water beneath the rake for this barge configuration. The Demonstration Barrier electric field is not discernible within the noise of the measurement.

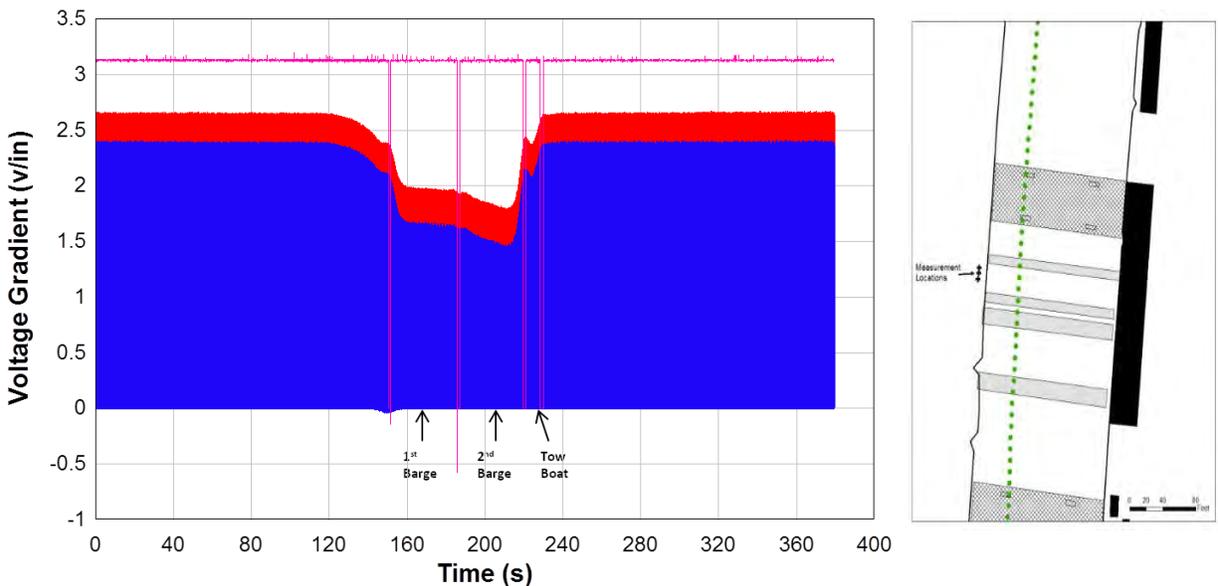
Figure 38 – Far Field Distortion Testing, 20 June 2013 Series Configuration West Wall. Plot shows the envelope of the peaks of the individual pulses at the probe depth of 2' (blue) and 7' (red).
