Dispersal Barrier Efficacy Study

Efficacy Study Interim IV, Chicago Sanitary and Ship Canal Dispersal Barriers Risk Reduction Study

June 2019

US Army Corps
of Engineers
Chicago District

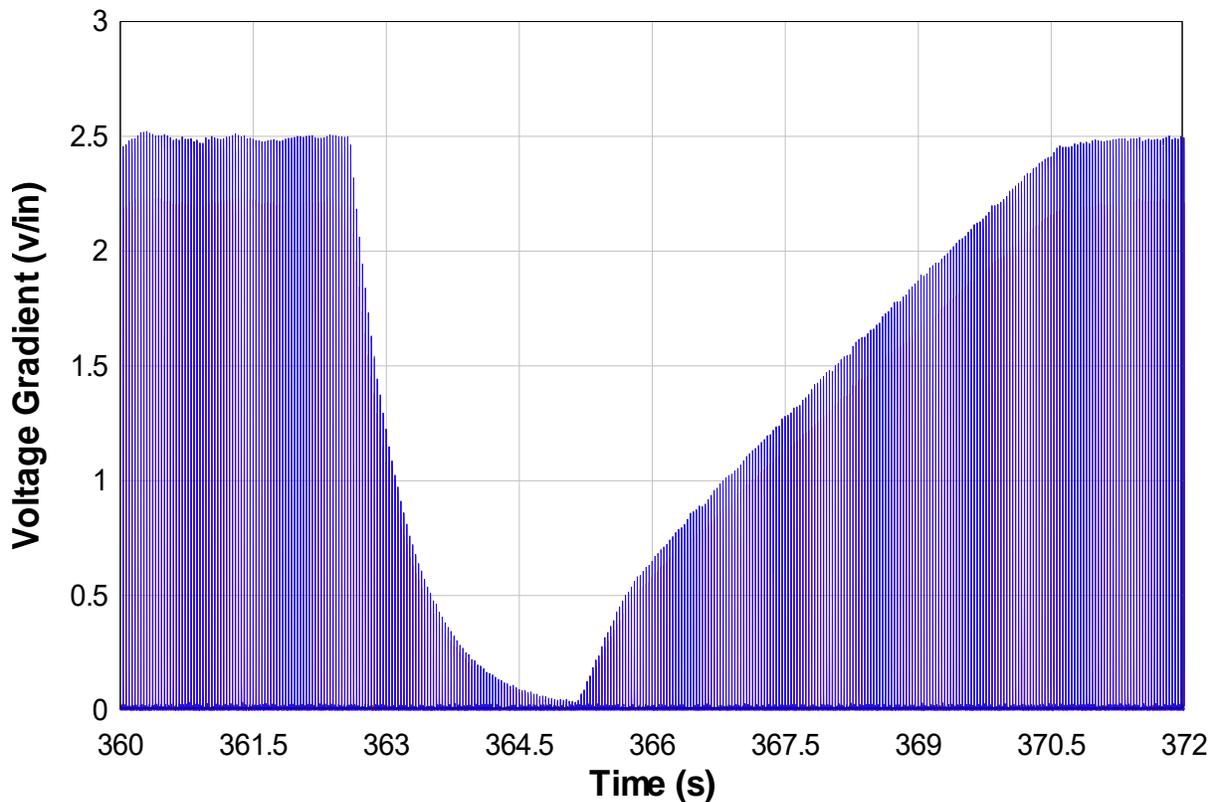
Figure 39 – Barrier IIA Power Transfer Testing plot of voltage gradient vs time at the west bank, 7' below the surface of the water.

On 17 June 2013, the CERL team performed additional electric field measurements in order to quantify the time of loss of field strength in the water during a transfer of power from utility to generator emergency power. The same instrumentation used for the far field distortion testing described above was utilized for these measurements. Probes were submerged at depths of 2 feet and 7 feet below the surface of the water and measured the electric field strength in the y-axis direction parallel to the canal wall. Results indicated that the field strength in the water dropped off steeply upon discharge of the initial power source regardless if that was utility to generator or generator to utility. Upon initialization of the secondary power source, field strength in the water was reconstituted almost immediately but at reduced voltage gradients that were more gradually ramped back up to the specified target levels (Figure 39). Power transfers between generator and utility power caused a drop in field strength in the water for a period of between 10 and 20 seconds regardless of the direction of power transfer (utility to generator or generator to utility).

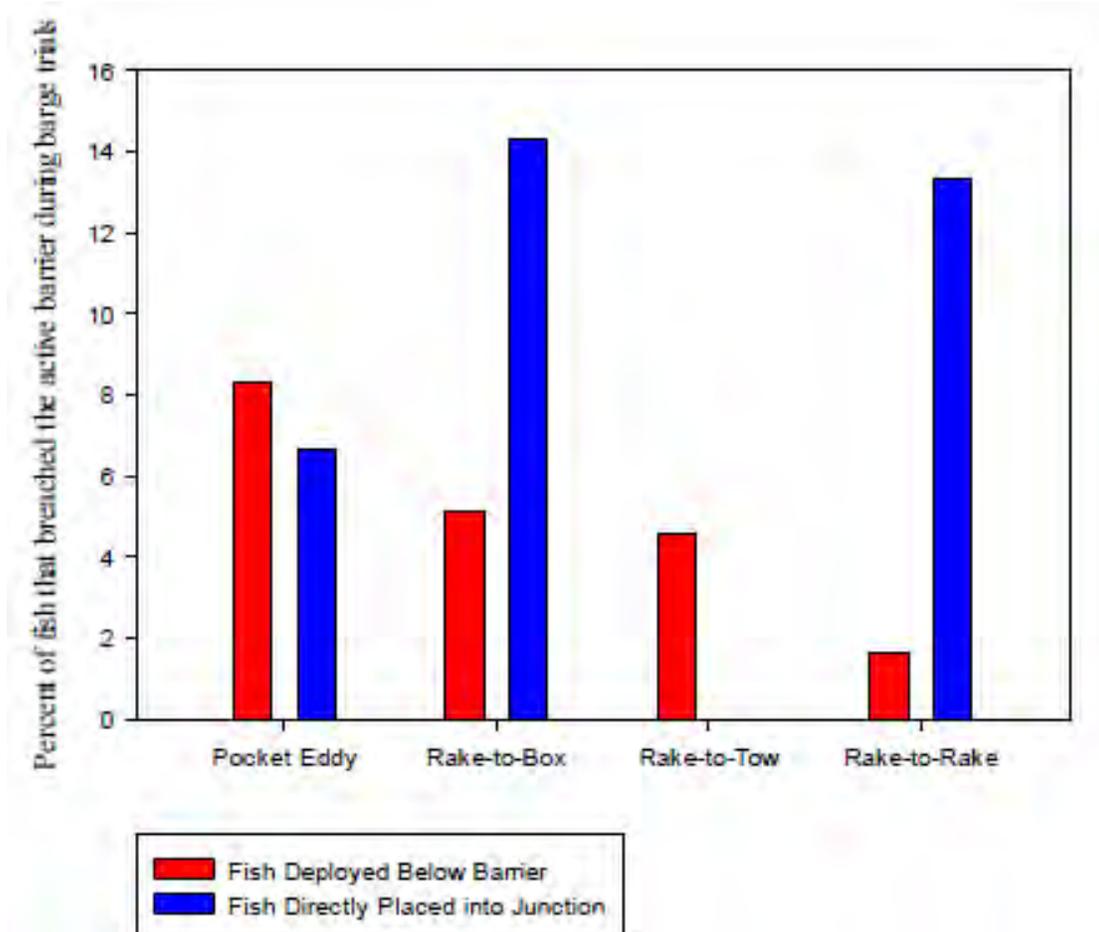
Figure 40 – Percentages of live tethered fish that breached the electric barriers via different barge junction configurations and fish deployment methodologies (MRWG, 2014).

In November 2013, tethered fish were released within barge junction wedges below the barriers under three different modes of unconventional navigation techniques to investigate methods of reducing fish entrainment. These methods included having the tow vessel pull rather than push, pushing but stopping below the barriers for 2 minutes before continuing and finally approaching the barriers with a 'zig-zag' pattern to increase flow within junctions. Twenty tethered Gizzard Shad were released upstream of a tow pulling barges at the barrier over three trials which resulted in no entrainment past the barriers. This method was deemed ineffective however for navigation purposes as feasibility for tow captains to use this method in moderate to high flow events is severely degraded and one trial had to be completely aborted for this reason. For the three trials investigating an extended pause below the barriers for 2 minutes, thirty fish were deployed and three were entrained beyond the barriers. The final mitigation technique of approaching the barriers in a 'zig-zag' fashion completed four trials with forty fish. Six of those fish remained within the rake-to-box junction and were entrained beyond the barriers. Of the nine fish entrained beyond the barriers during unconventional navigation, sizes ranged from 21-26.5 cm in total length (MRWG, 2014; Parker et al, 2015).

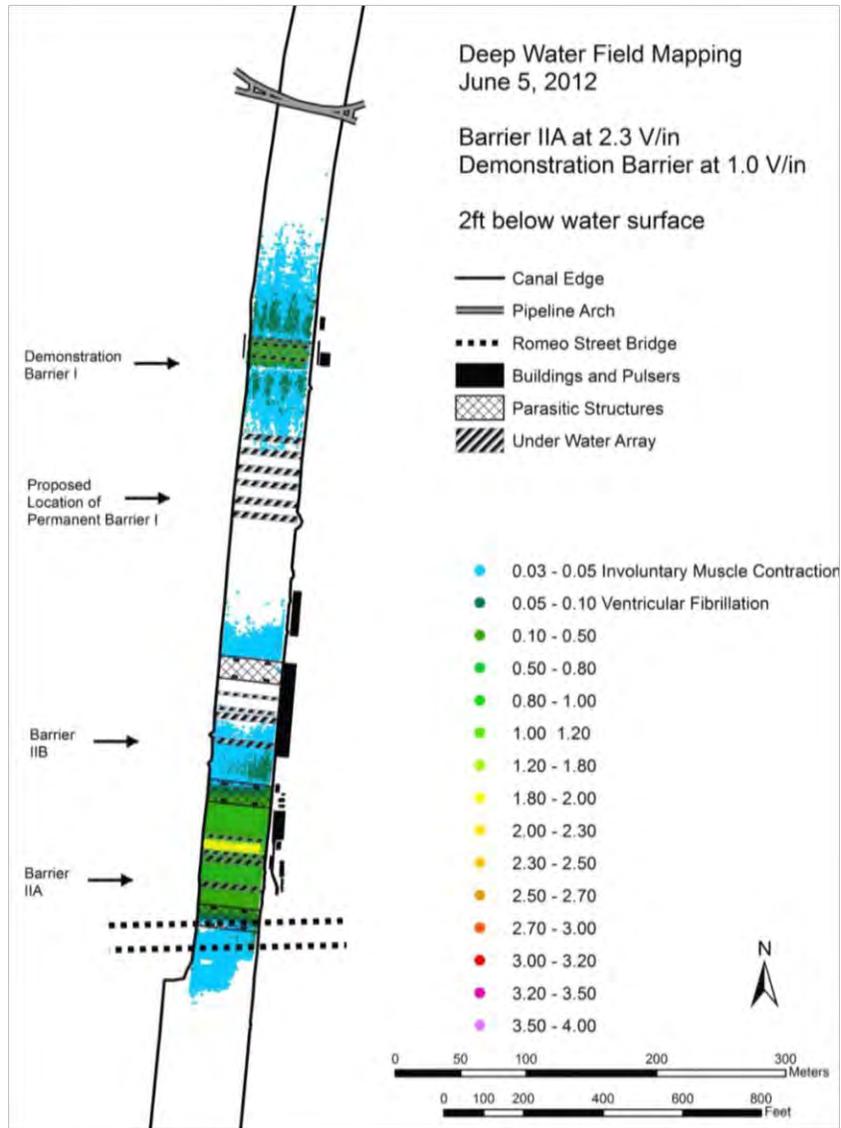
Figure 41 – Electrical field mapping by ERDC-CERL of the Dispersal Barriers indicating an increased electrical field beginning at the parasitic 1 array.

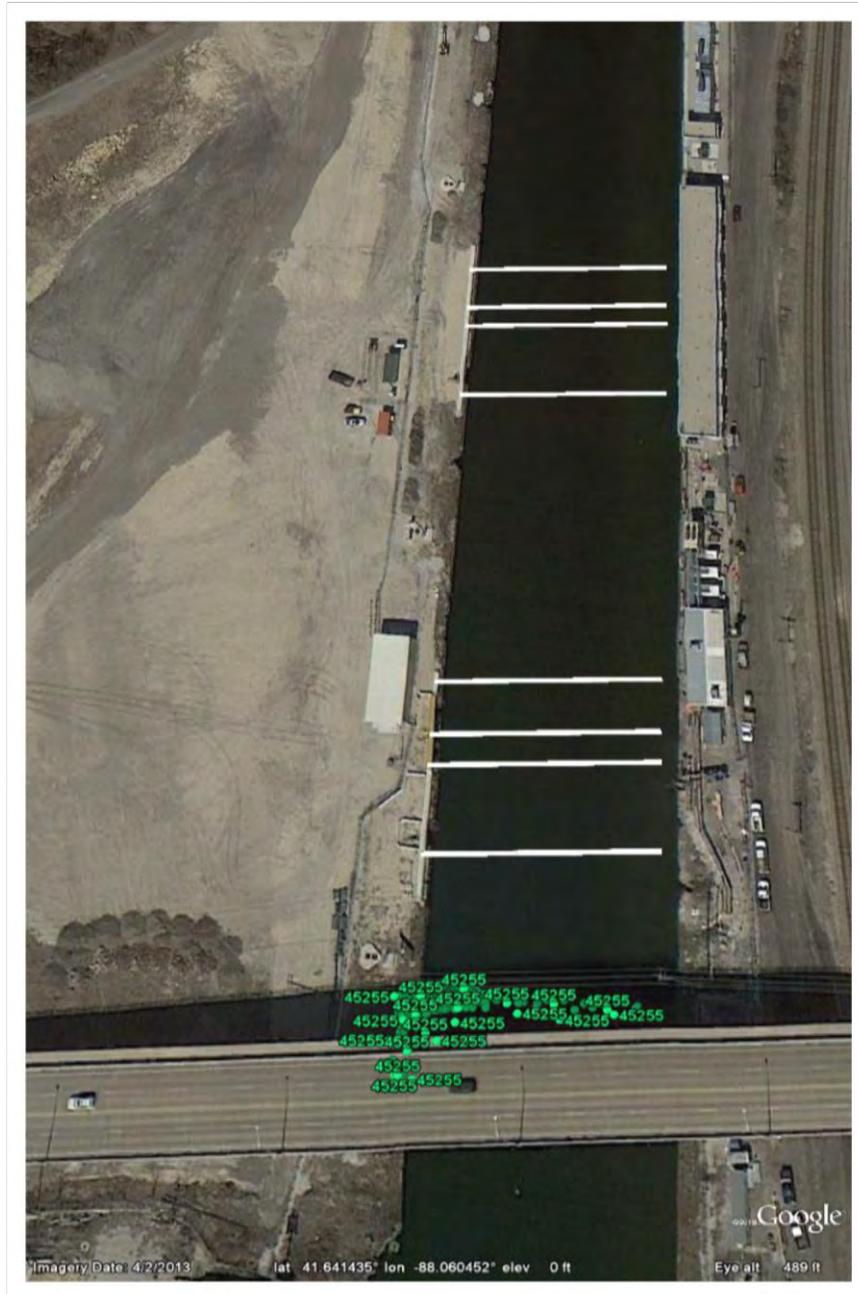
Figure 42 – Typical fish approach displayed as positional data points just downstream of Barrier IIA and indicating that tagged fish are reacting to elevated field strengths over the parasitic array.

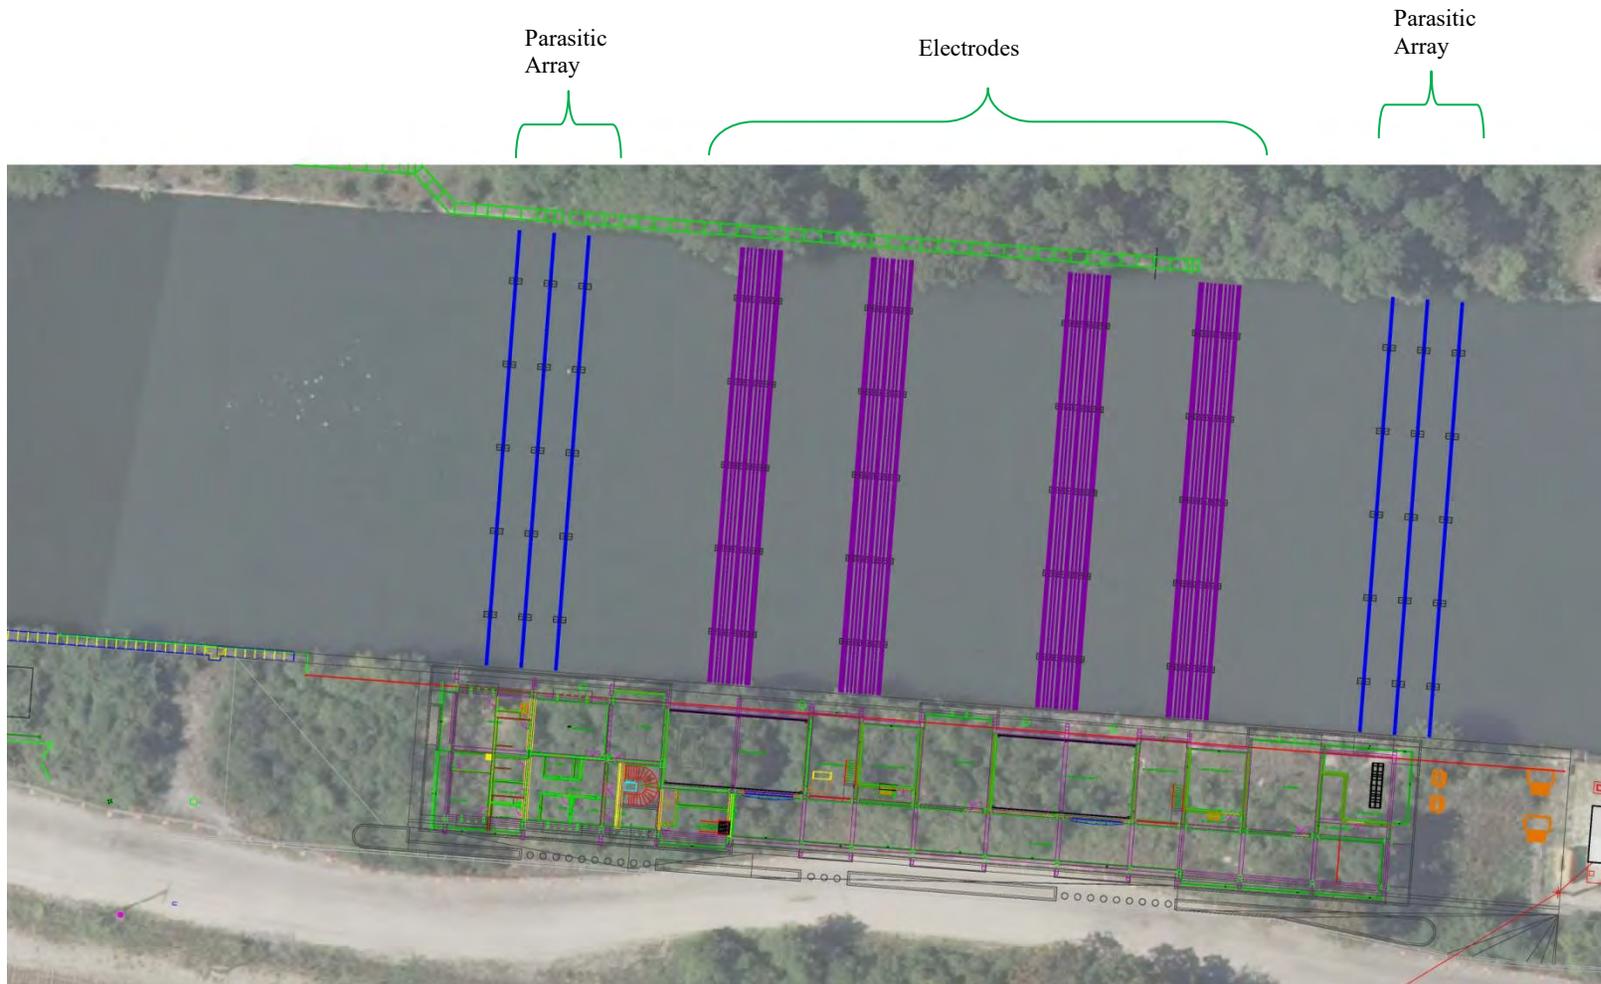
Figure 45 – Plan View of the Permanent Barrier I Design Layout in the Chicago Sanitary & Ship Canal.

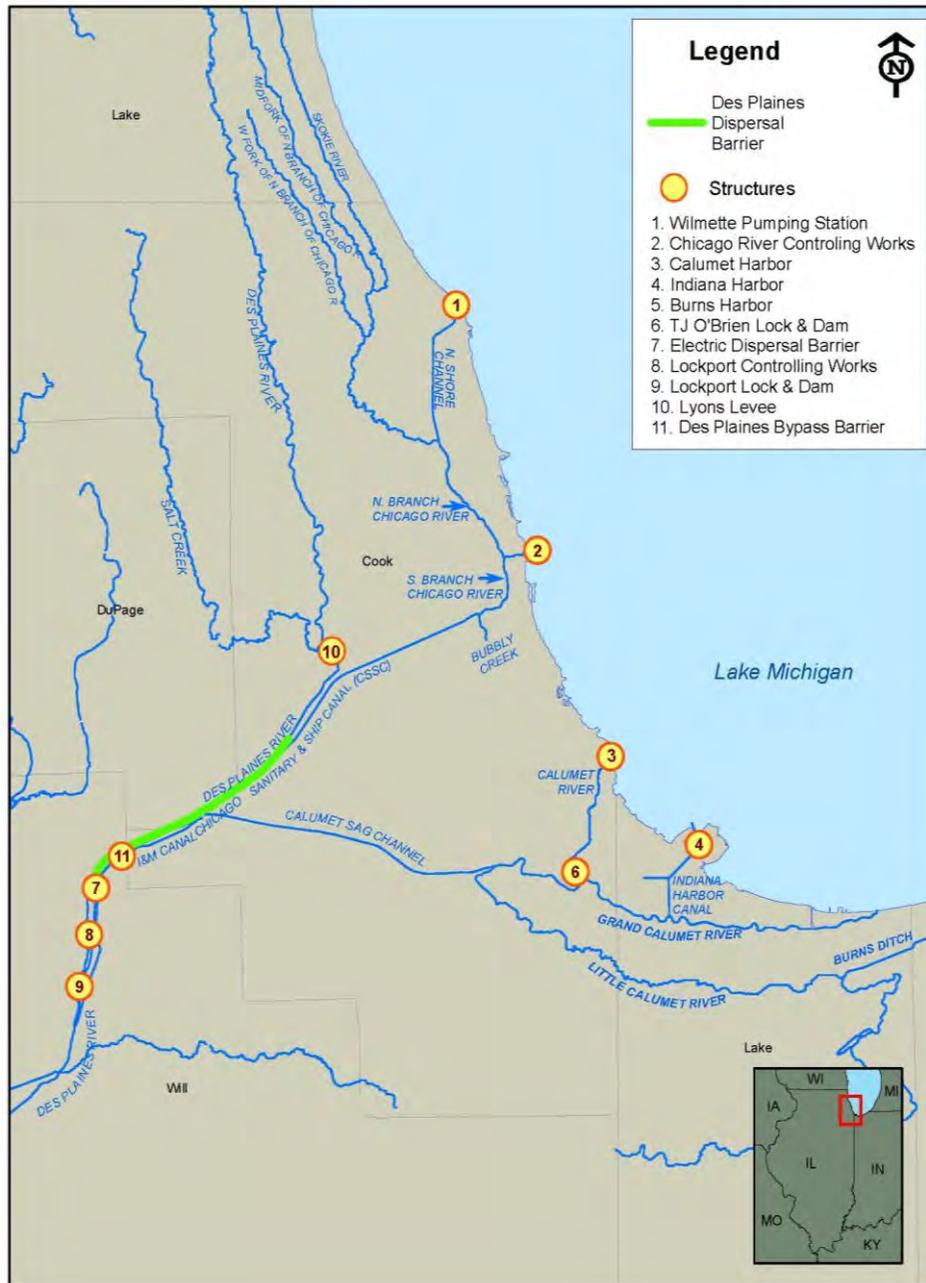
Figure 49 – Interbasin Connections and Existing Control Structures within the CAWS.

Three possible interbasin connections that could allow bypass of the barriers were identified by the PDT. These connections are illustrated on Figure 49. The connections include the Des Plaines River (IB-1), the I&M Canal (IB-2), and the Lyons Levee (IB-3).

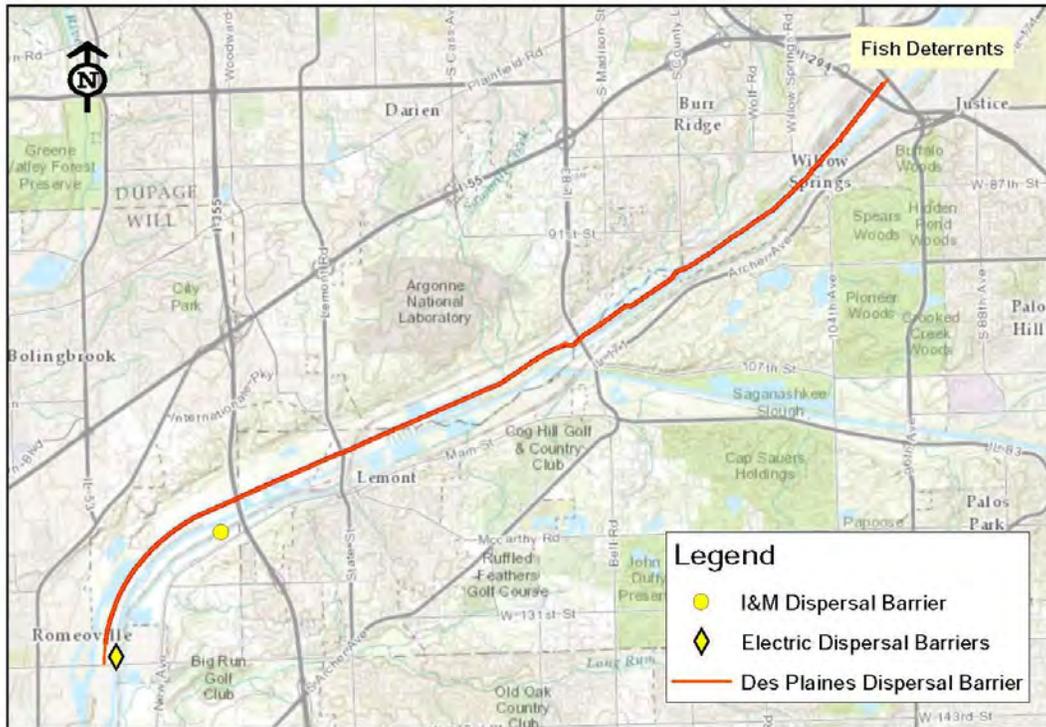
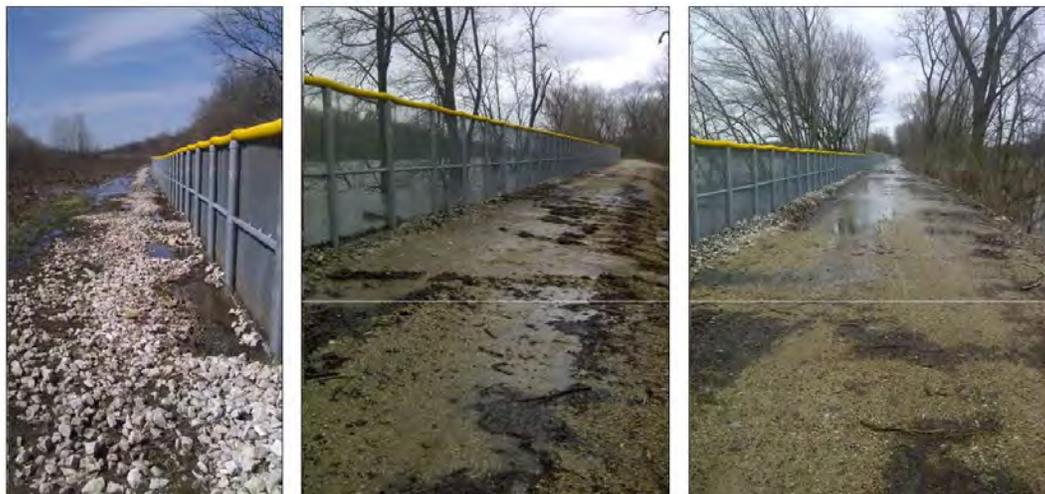
Figure 50 – Des Plaines River Bypass Barrier.

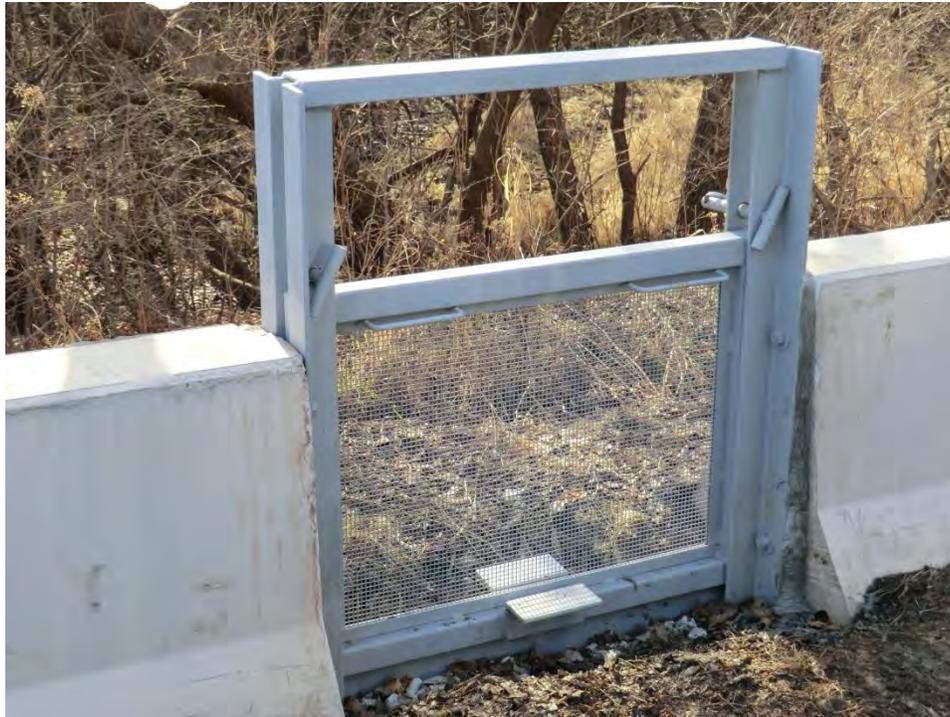
Figure 51 – Turtle Gate in the Des Plaines Bypass Barrier.

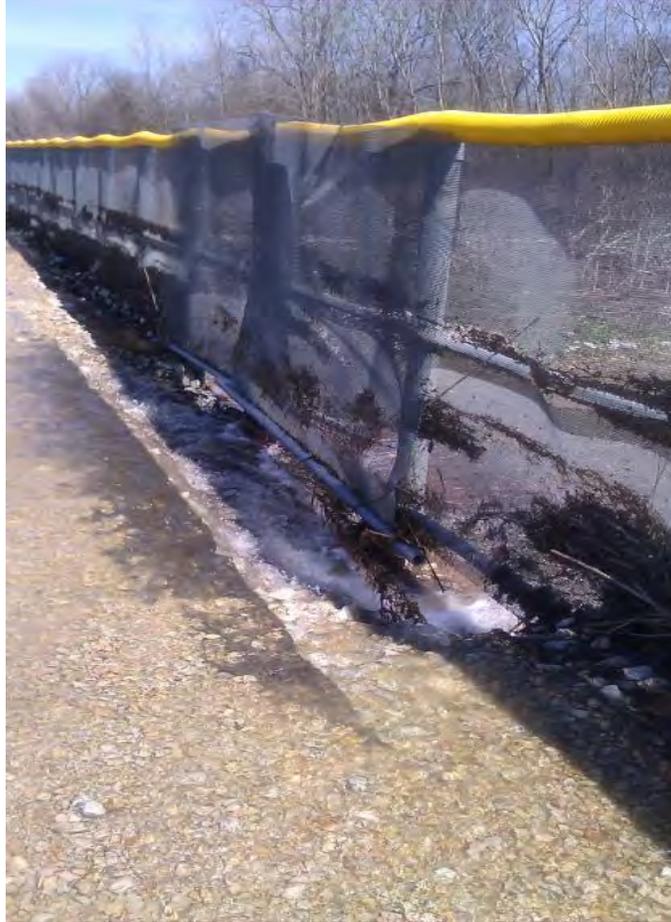
Figure 52 – Flow under the Des Plaines River Bypass Barrier, April 22, 2013.

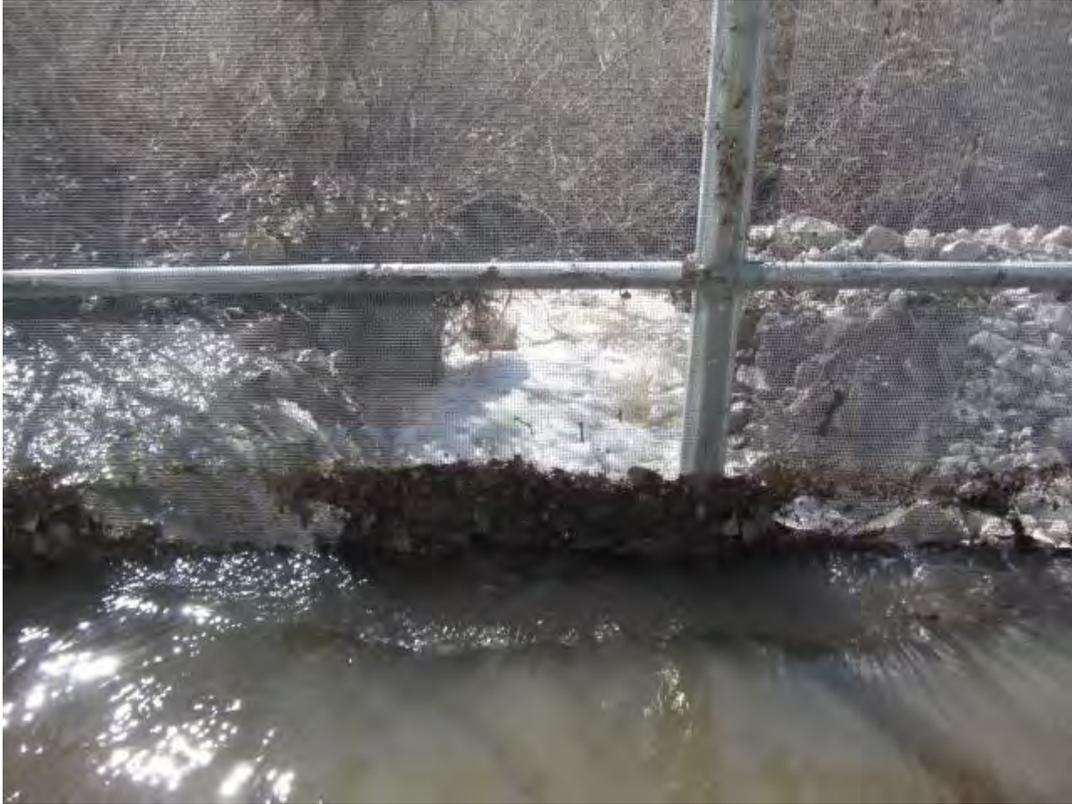
Figure 53 – Scour at the Des Plaines River Bypass Barrier near Willow Springs Road, April 20, 2013.

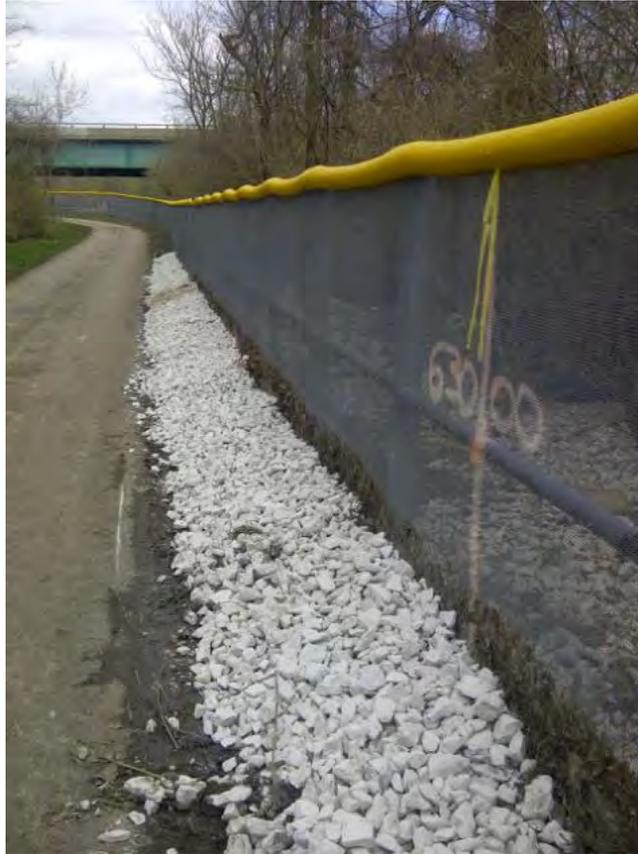
Figure 54 – Placement of stone fill in areas of scour and undermining of the Des Plaines River Bypass Barrier near Willow Springs Road, April 25, 2013.

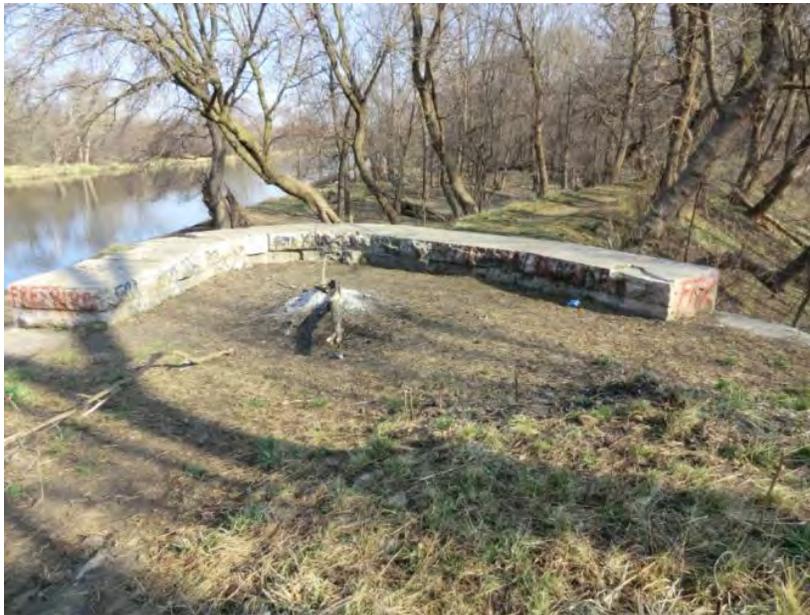
Figure 57 – Concrete structure in Lyons Levee.

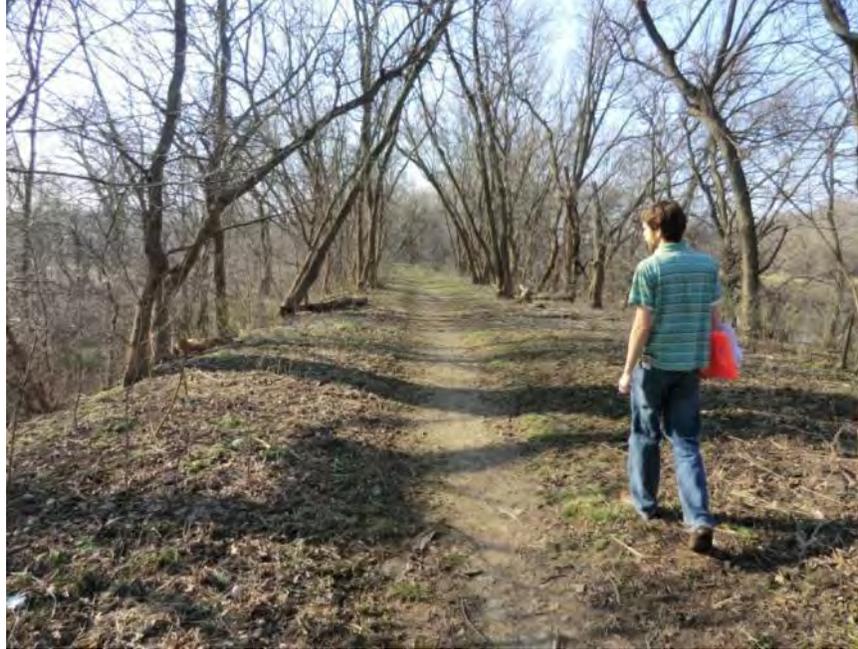
Figure 58 – Lyons Levee with trees along crest and slope.

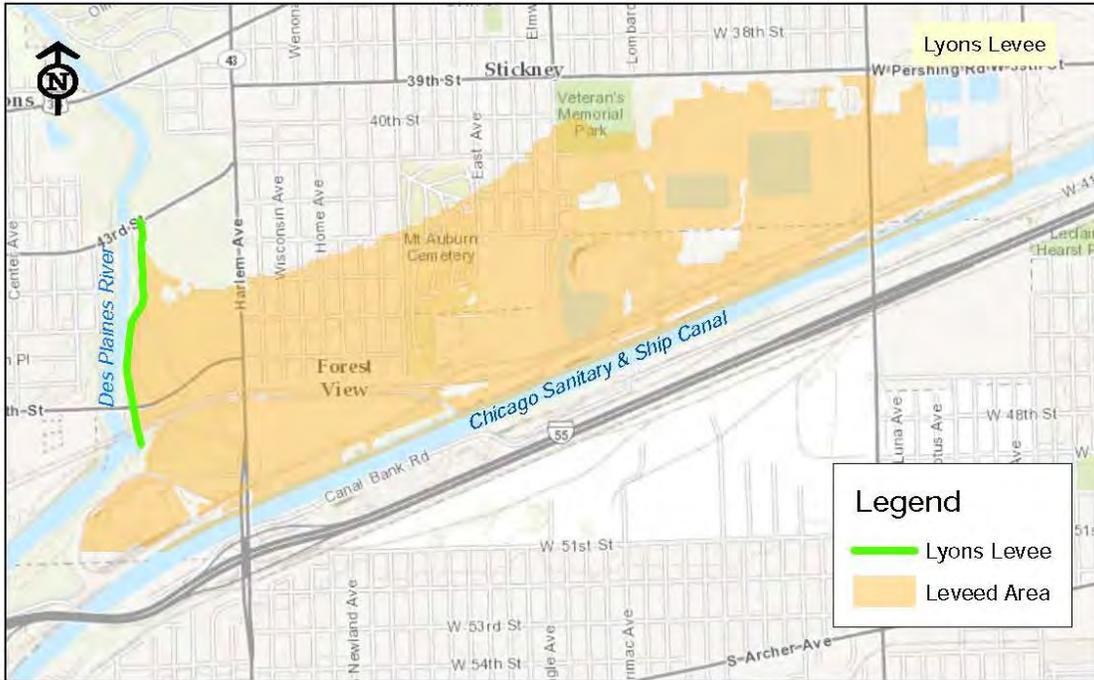
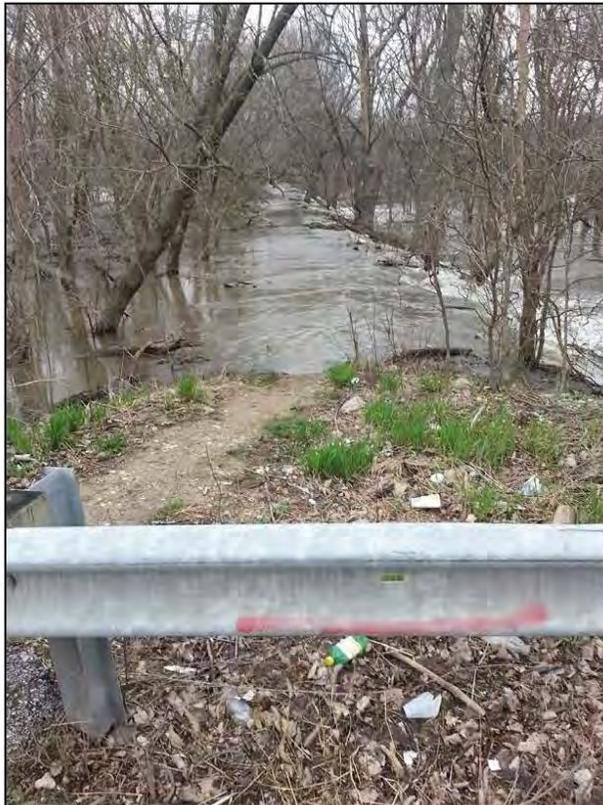
Figure 59 – Lyons Levee Vicinity; Levee Overtopping—April 2013.

Overtopping of Lyons Levee - April 2013 Flood

On April 18-19, 2013 there was a significant rainfall event in northeastern Illinois resulting in high water levels and flooding throughout area waterways, including the Des Plaines River. There are two USGS gages measuring river stage on the Des Plaines near the areas of bypass concern. The gage in Riverside, IL is located approximately 1.5 miles north of the Lyons Levee. It peaked on April 18 at a record stage, approximately 0.5 feet higher than the previous record. The event at the Riverside gage was estimated to be a 500-year flood. USACE personnel inspected the area around the Lyons Levee on the morning of April 19. Water from the Des Plaines was overtopping the levee and was at least 1-foot higher than the levee crest. There was extensive flooding and damage in residential and commercial areas east of the levee. Water from flooded areas north of the CSSC was observed flowing over the canal wall and into the CSSC approximately 500 feet east of Harlem Avenue within the Village of Forest View (Figures 59-60). In addition, a culvert approximately 2,300 feet east of Harlem Avenue was observed discharging a significant amount of flow into the CSSC from the north.

When USACE personnel visited the area again on the morning of April 20, no overland flow into the CSSC was occurring. The culvert noted the day before was continuing to discharge a significant flow into the CSSC and a second culvert several hundred feet east of the first was also noted to be discharging a significant flow into the CSSC. The source of the water flowing **out of the culverts couldn't be readily identified.**

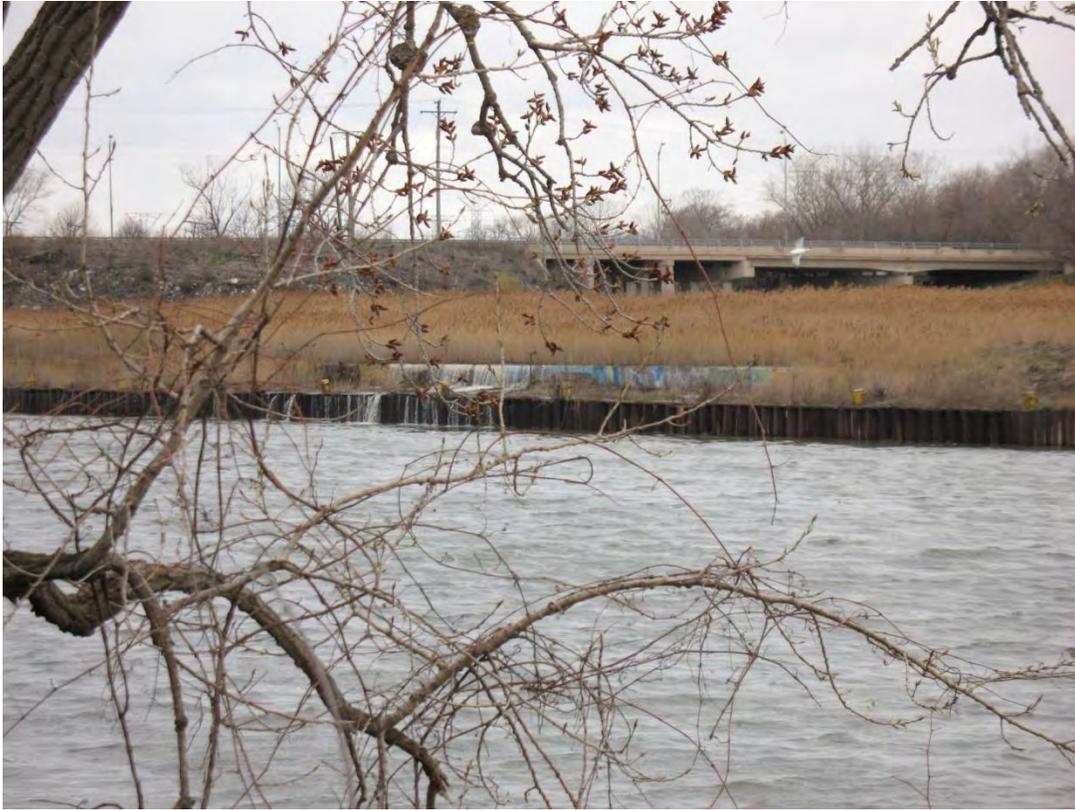
Figure 60 – Overland flow into the CSSC from the direction of Lyons Levee overtopping.
