**UPPER DES PLAINES RIVER AND TRIBUTARIES,  
ILLINOIS AND WISCONSIN INTERGRATED  
FEASIBILITY REPORT AND ENVIRONMENTAL  
ASSESSMENT**

**GEOTECHNICAL DESIGN - APPENDIX G**

U.S. Army Corps of Engineers, Chicago District  
Geotechnical & Survey Section

August 2013

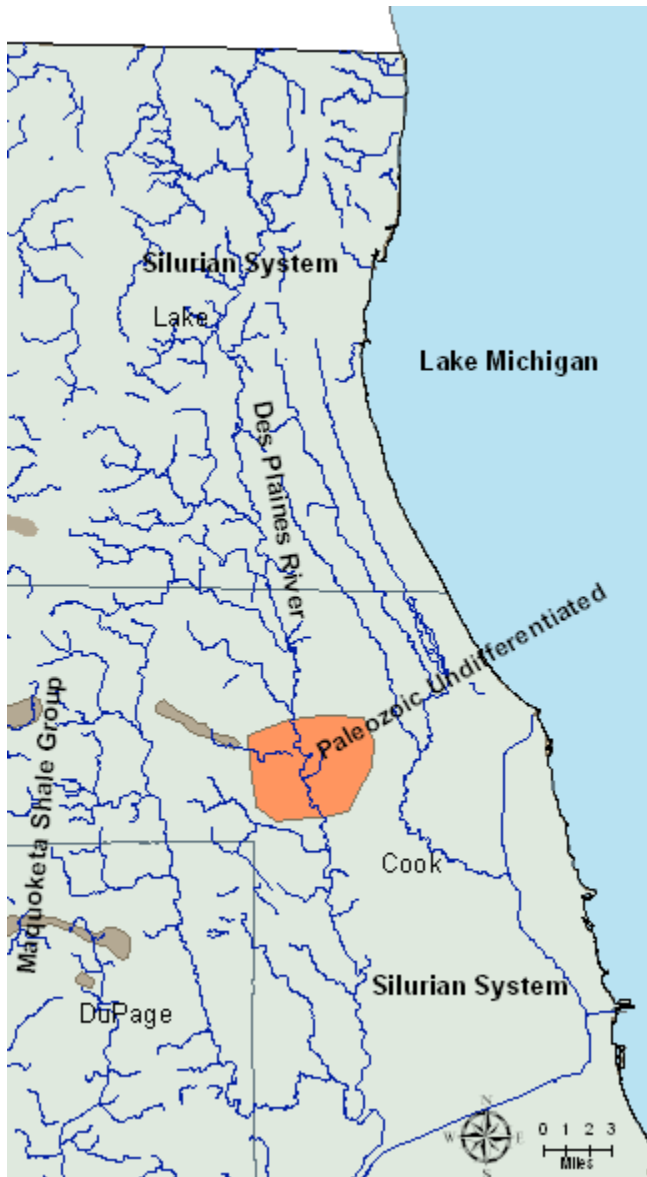
**Figure 2. General Bedrock Geology of Project Area**

9. The surface bedrock of the region consists predominantly of rock of the Silurian System (Figure 2). There is a geologic contact between the Silurian, Ordovician, and Pennsylvanian Systems at the headwaters of the Illinois River. The Upper Des Plaines River is located within a region where the seismic probability is minor. The closest geologic structure to the project area is the Des Plaines Disturbance faults located near the boundary of the northeast corner of DuPage and Cook Counties. This disturbance encircles the Paleozoic Undifferentiated area shown on Figure 2. The Sandwich fault is several miles southwest of the project area. Bedrock in the region is principally dolomite of the Niagran and Alexandrian Series since the Silurian System includes the Niagran Series underlain by the Alexandrian Series.
