**APPENDIX G - GEOTECHNICAL
FOR
WESTMINSTER, EAST GARDEN GROVE
FLOOD RISK MANAGEMENT STUDY**

APRIL 2020

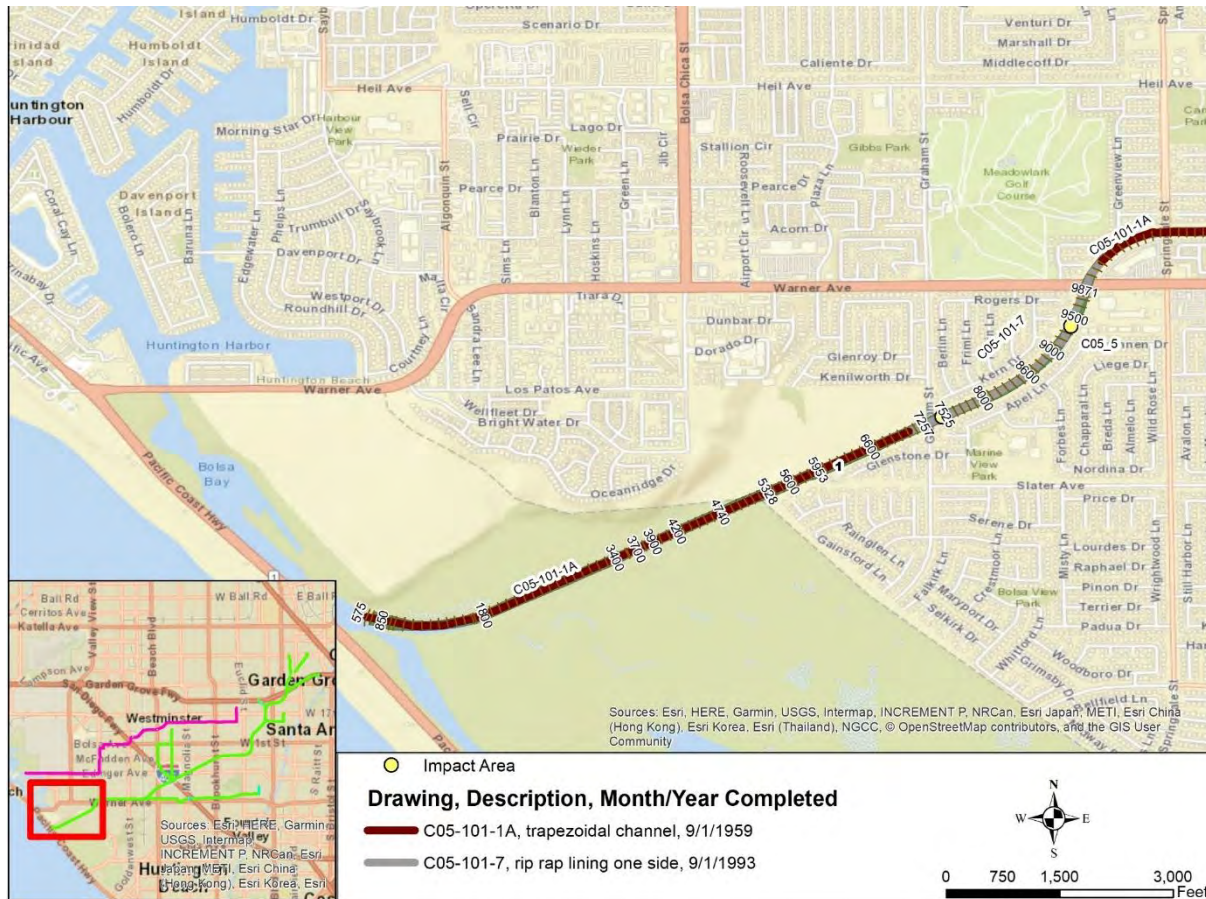
Figure 2. Pre-project impact area locations, reach 1

As shown in Figure 2, Channel 05 was initially completed in September of 1959 and consisted mainly of earth trapezoidal channels lined with rip rap. In Sep 1993 a portion of reach 1 rip rap was repaired.

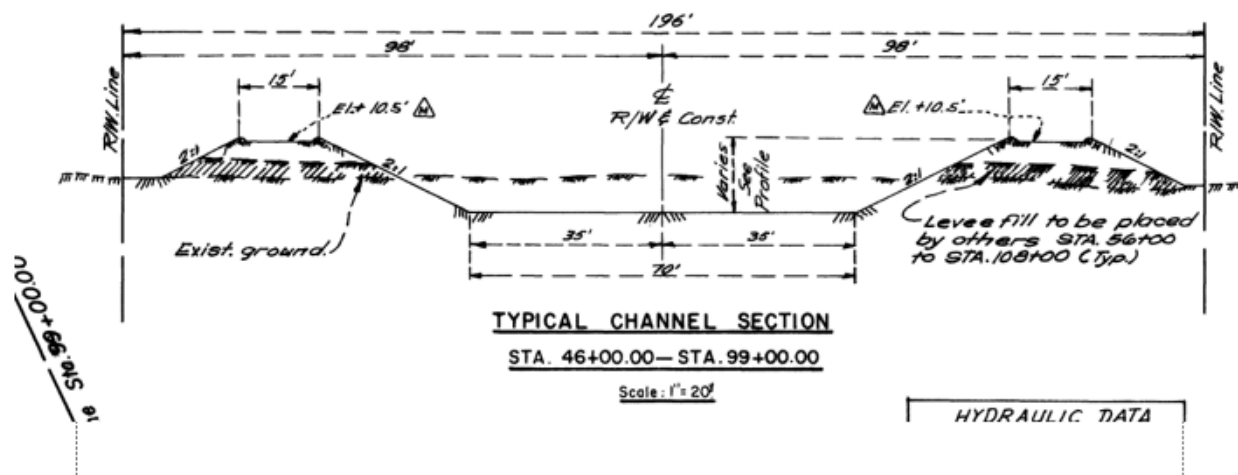
Figure 3. Typical section, Channel 05, Reach 1, without project

Figure 3 shows a typical section of channel C05, reach 1. Because the channels are sunk into the ground, the effective height of the levee is reduced. The section shown is a typical section, which is reflective of the sections analyzed for impact areas C05_6 (Sta 75+93) and C05_5 (Sta 95+00).

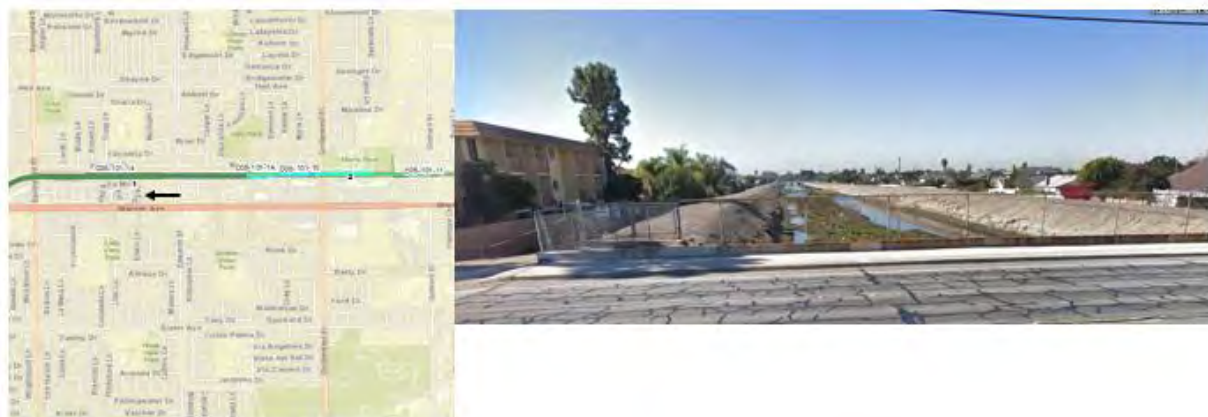
Figure 6. C05, Reach 1, Edwards looking west, example without project.

Though the levee is now with project south and west of Warner Avenue, an example of the levees for Channel 05, which would be how the levees south and west of Warner would have looked prior to project, are shown in Figure 6.

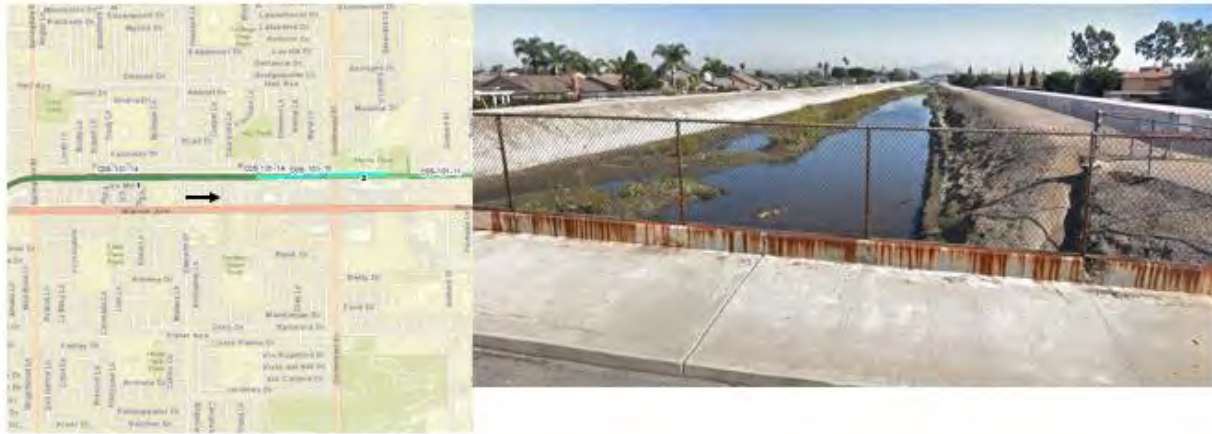
Figure 7. C05, Reach 1, Edwards looking east, example without project.

Figure 7 shows another view of the levees without project. In this case there is considerable erosion of the levee. Though analyses in this report will show that the gradients are low, there were no inspection reports available as part of this study. This adds to the uncertainty regarding the resilience of the levee system. There is, however, a history of repairs to the levees due to sloughing that coincides with flooding events.

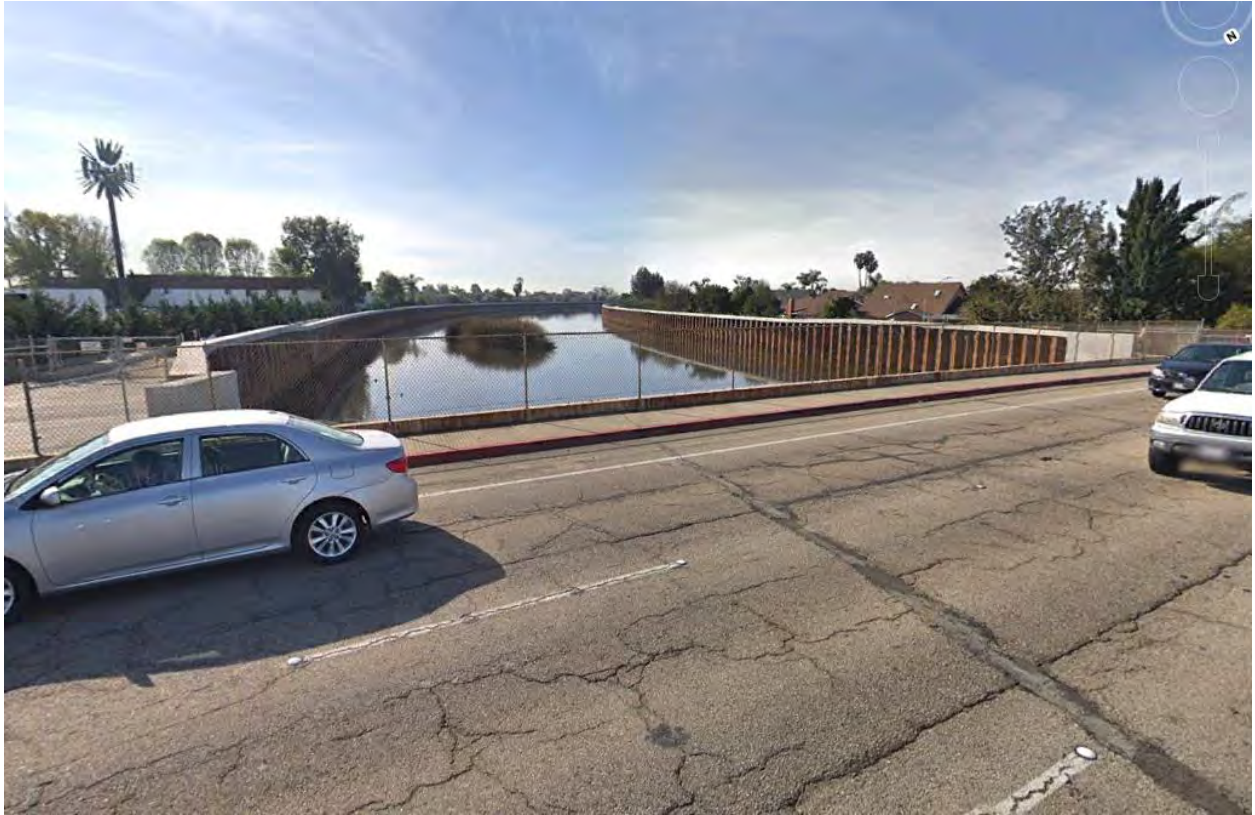
Figure 11. Warner looking southwest, example with project

Figure 11 shows the project condition. From Warner Avenue and the C05 Channel (Reach 1), there is adequate protection against breach because of the double sheetpile walls on both sides of the channel. However, this is a portion of the channel system that is with project.

As shown in Figure 10, sheetpile was added to reach 1 south and west of Warner Avenue in 2008 (drawing C05-101-13R) and double sheetpile was added in this area in 2012 (Drawing C05-101-12). A review of Google Earth imagery shows that the C05-101-12 project drawings were implemented. However, because this work occurred after 2000, it is analyzed as “with project.”

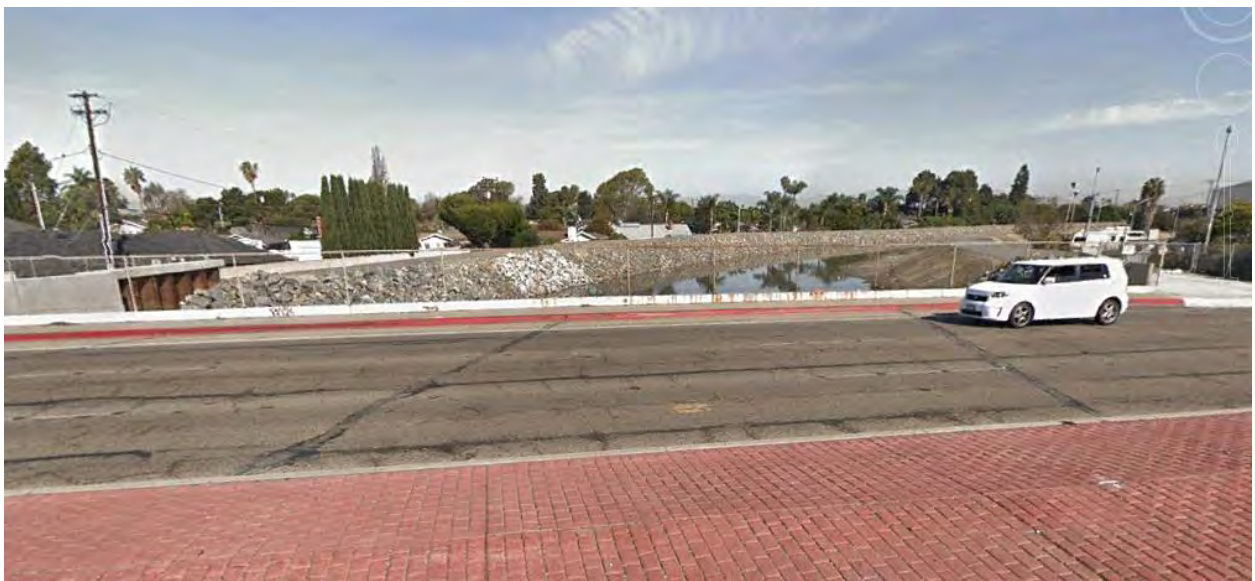
Figure 12. Warner looking northeast, example without project.

Figure 12 shows upstream of Warner on the C05 channel there are stone lined trapezoidal channels, which represents the case without project. Plans to improve this channel are located in drawing C05-101-14, which are dated Apr 2010. However these plans have yet to be implemented.

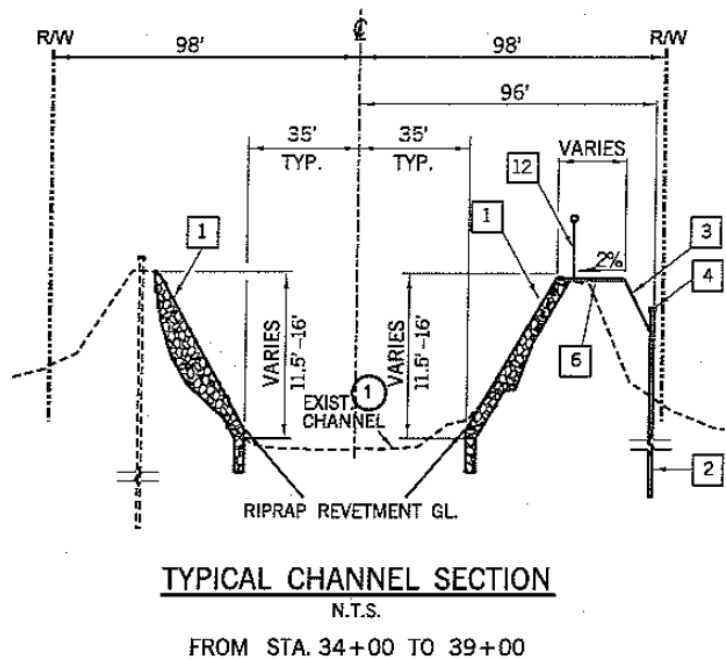
Figure 15. The south side has sheetpile installed that would reduce the likelihood of failure. This is with project
