Contract Report 2013-01

Continued Operation of a 25-Raingage Network for Collection, Reduction, and Analysis of Precipitation Data for Lake Michigan Diversion Accounting: Water Year 2012

Nancy E. Westcott

January 2013

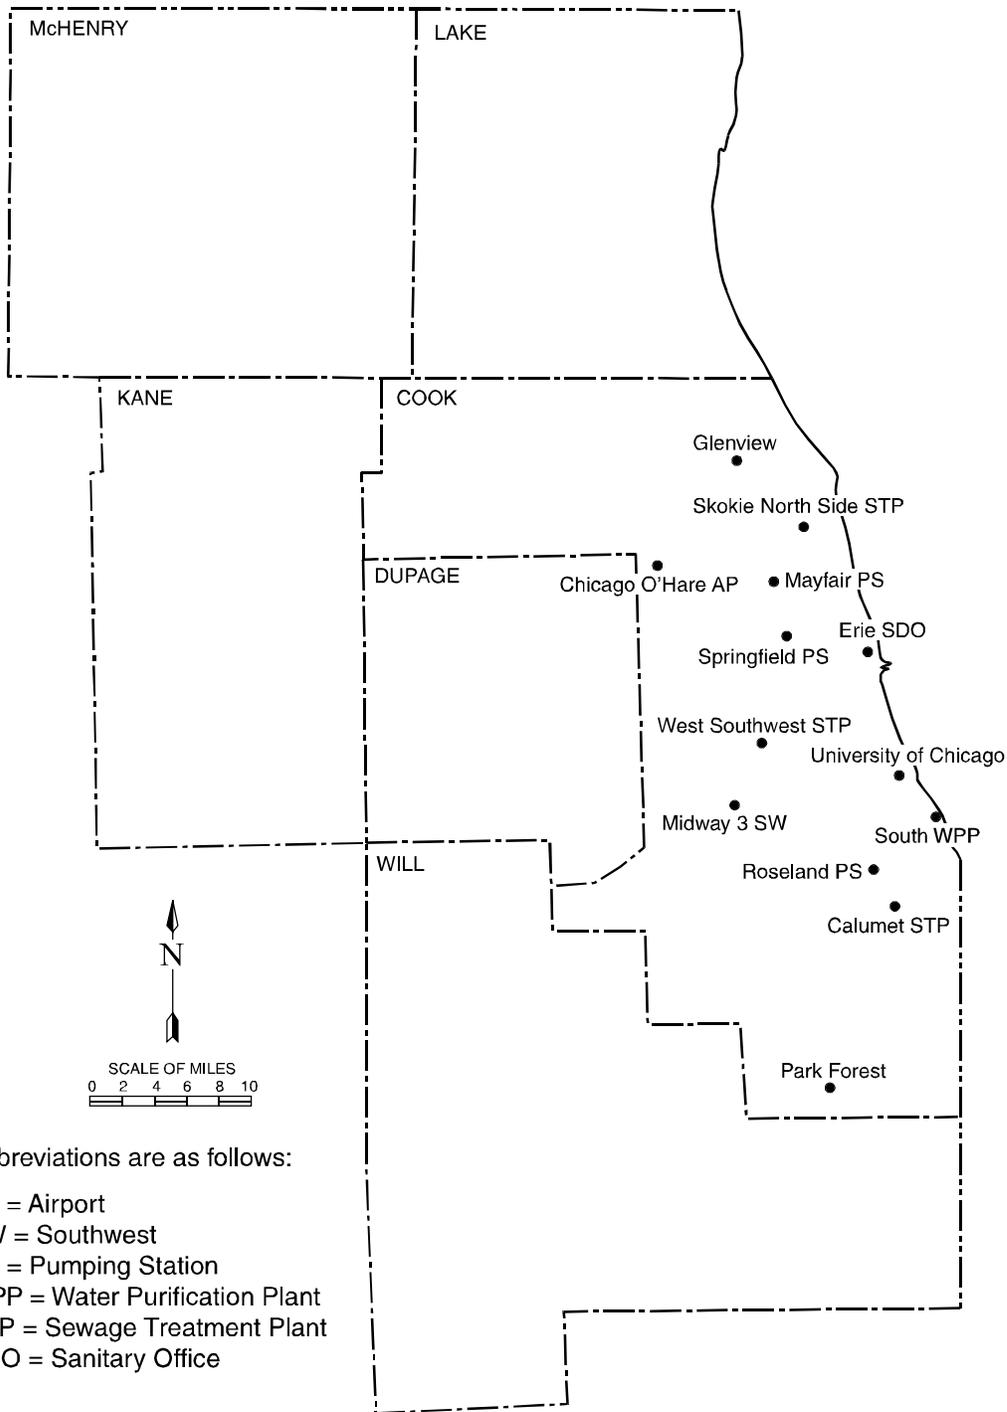
Figure 1. Raingage locations used for diversion accounting purposes prior to Water Year 1990. These include National Weather Service gages located at Chicago O’Hare AP, Midway 3 SW, University of Chicago, and Park Forest; City of Chicago gages located at Mayfair PS, Springfield PS, South WPP, and Roseland PS; and Metropolitan Water Reclamation District of Greater Chicago gages located at Glenview, Skokie North Side STP, Erie SDO, West Southwest STP, and Calumet STP.

The unusual patterns were caused by abnormally low precipitation totals at a select number of the 13 sites used by the accounting procedure (Figure 1). Inspection of these sites (Vogel, 1988), which are irregularly distributed over the region, revealed that low precipitation totals were caused by 1) inadequate raingage exposure (e.g., gages situated on rooftops or too near natural or artificial air flow-restricting

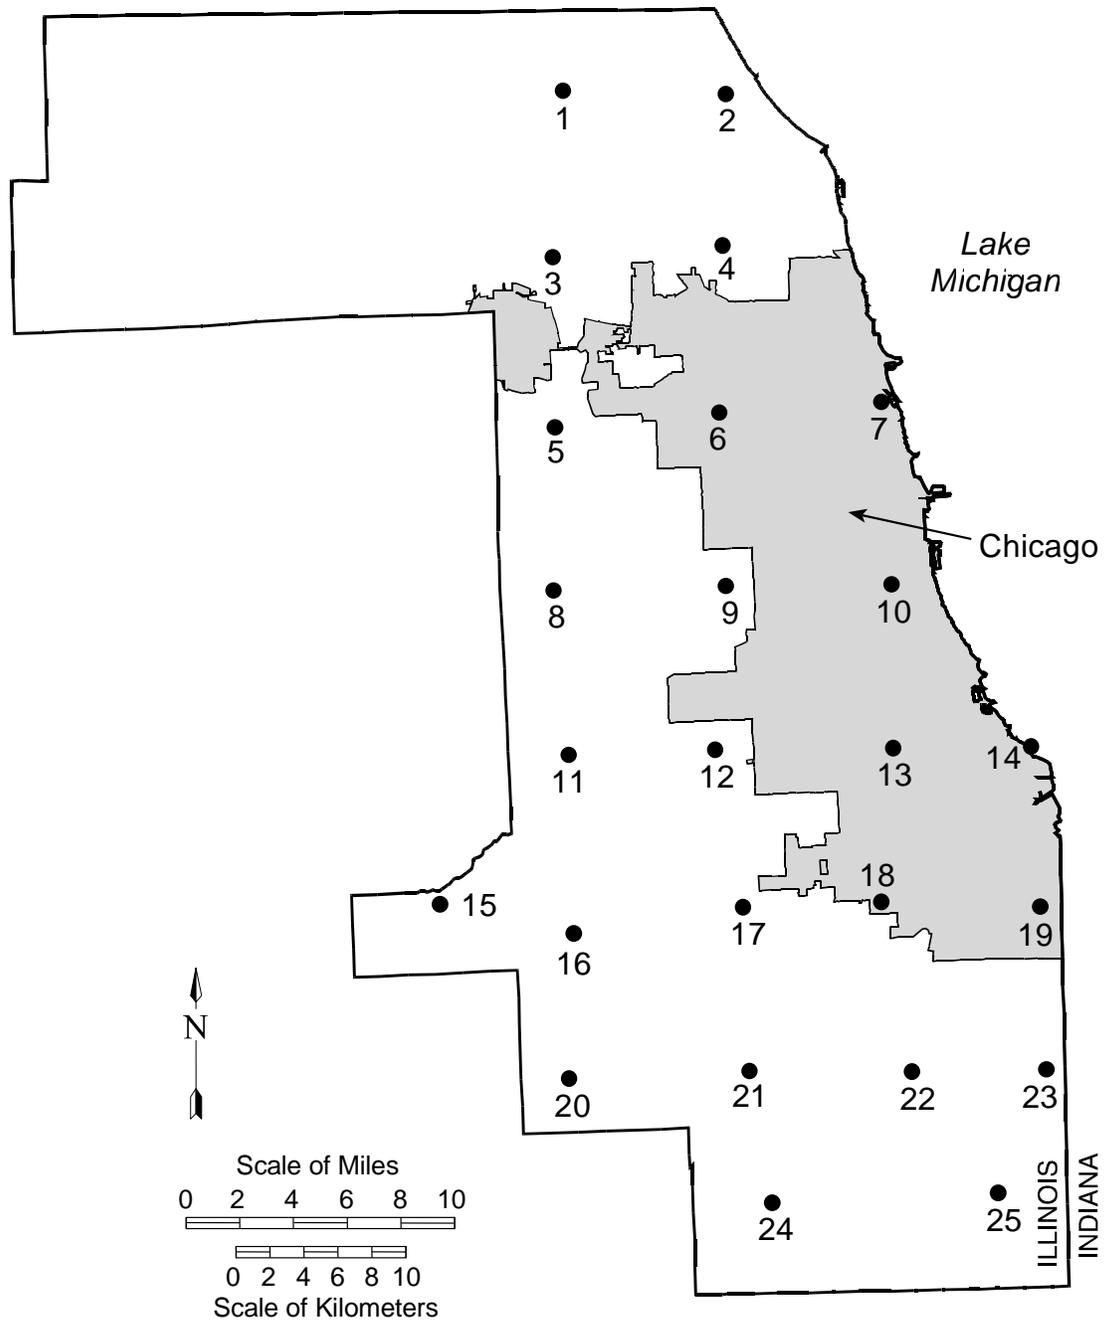
Figure 2. The Cook County 25-site rain gage network for Water Years 1990–2012. City of Chicago indicated by shading.

The largest precipitation amounts during Water Year 2012 occurred in the central portion of the network (sites #9, #10, #11, #12, #16, #18, and #21, Figure 3). See Figure 2 and Appendix I for site information. The lightest amounts occurred in the eastern and southern portions of the network (sites #3, #5, #14, #23, and #24). The heaviest precipitation in the network during Water Year 2012 fell at site #10 (33.96 inches), while the lightest fell at site #14 (22.99 inches).

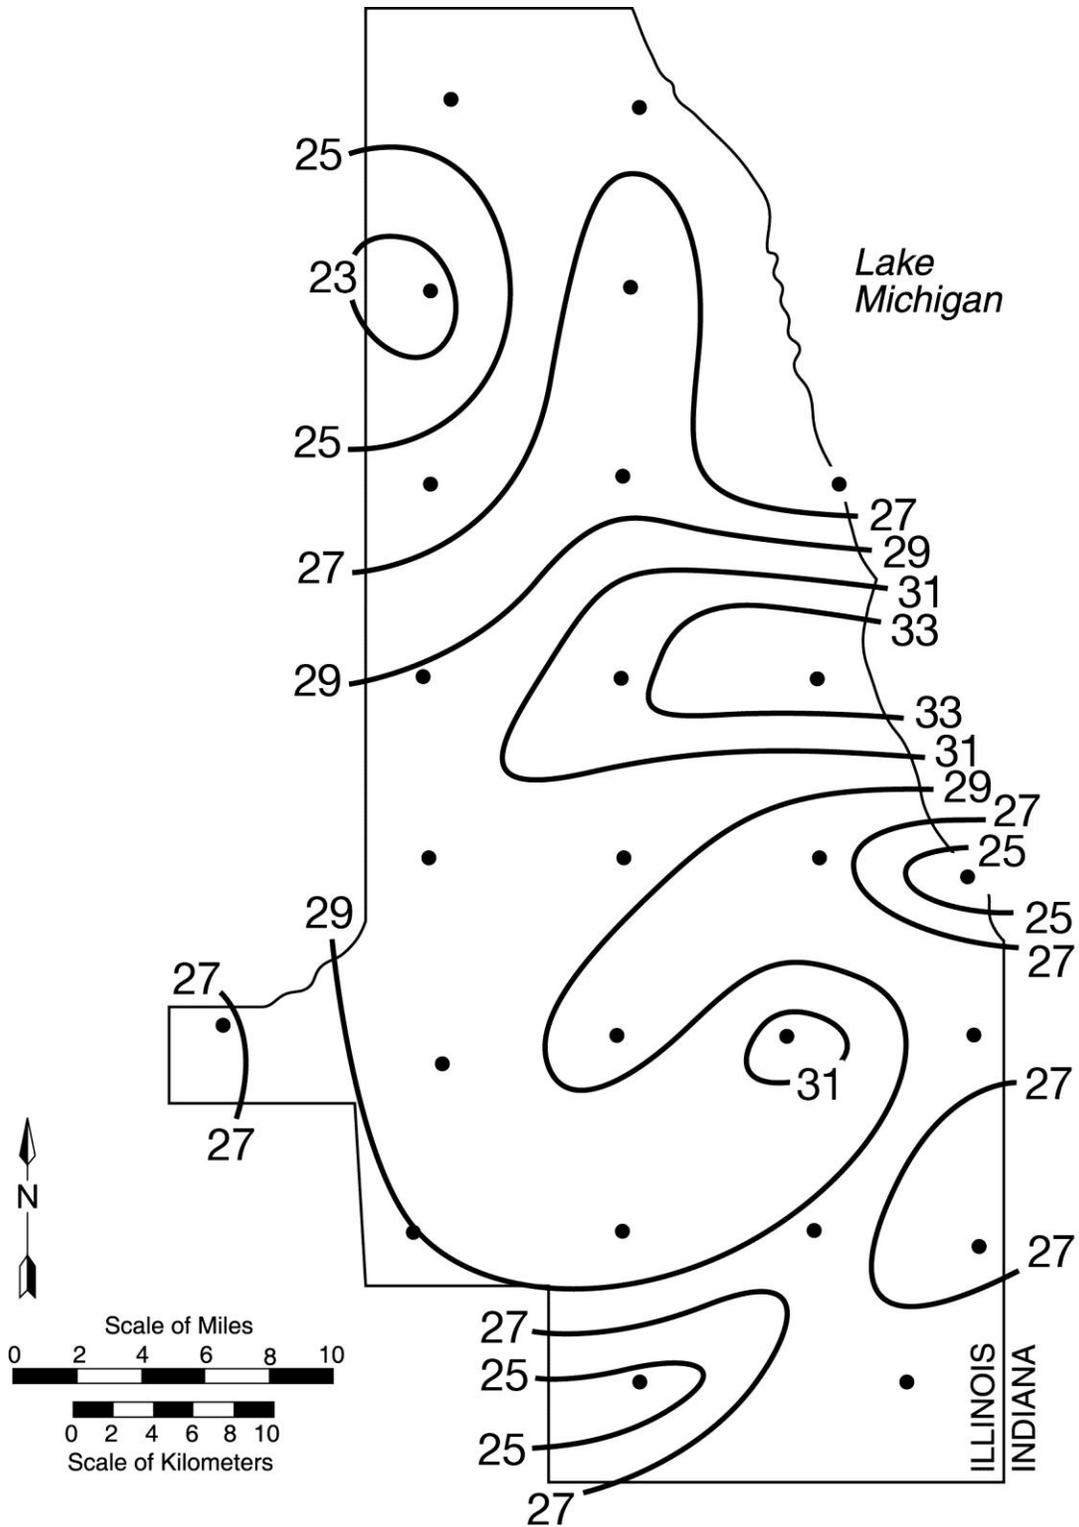
Figure 3. Precipitation pattern (inches) for Water Year 2012

As in the case of the other network water year patterns, the spatial pattern for Water Year 2012 (Figure 3) does not contain the anomalies found in an analysis using sites operated by the MWRDGC, the NWS, and Cook County for Water Years 1984–1989 (Vogel, 1988; Pepler, 1993b). Gradients of 15 to 20 inches were common in those analyses. Precipitation data from those sites were the input for diversion accounting before construction of the present network (Pepler, 1993b). For Water Year 2012, there was an 11-inch gradient between Sites #10 and #14. Siting issues may be responsible for this difference. Site #10 is a well-protected location. Possible changes to Site #10 are under consideration. The location of Site #14 is open near Lake Michigan. The gage at Site #14 is shielded, which should help reduce any wind-driven precipitation losses. These siting differences may accentuate actual precipitation gradients suggested by nearby gages.

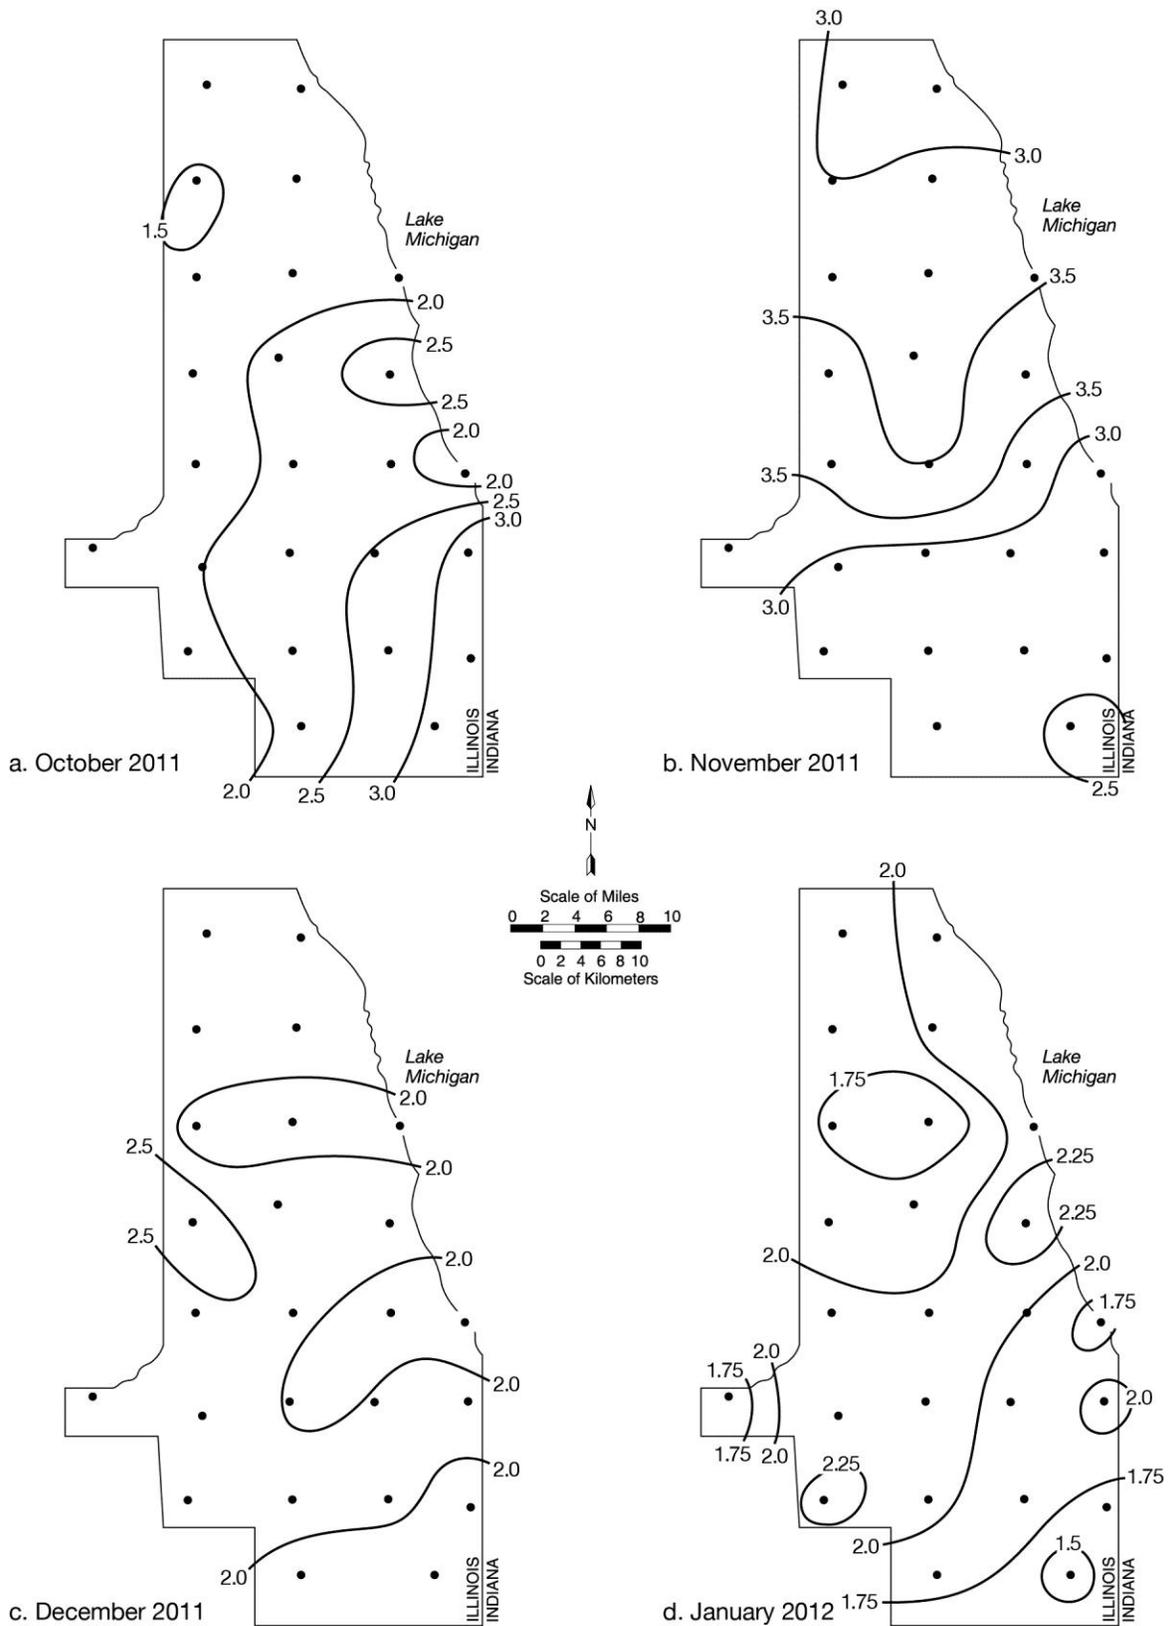
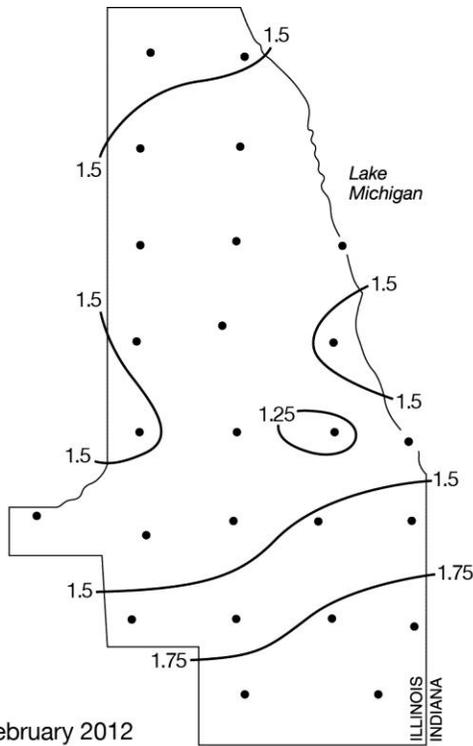
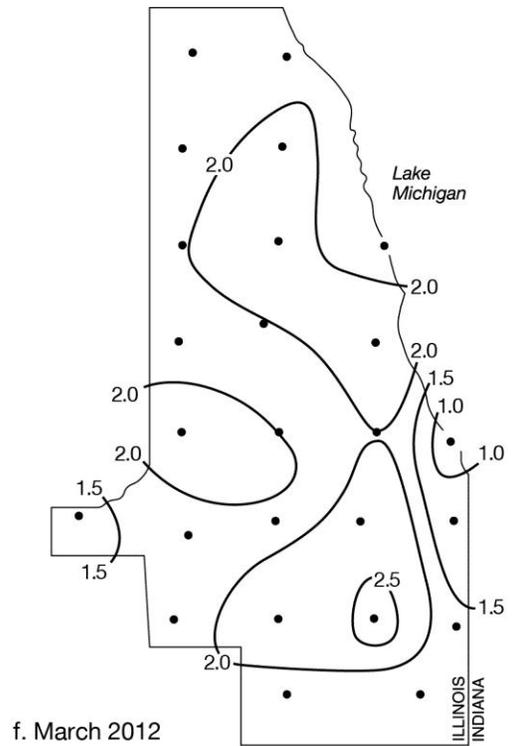
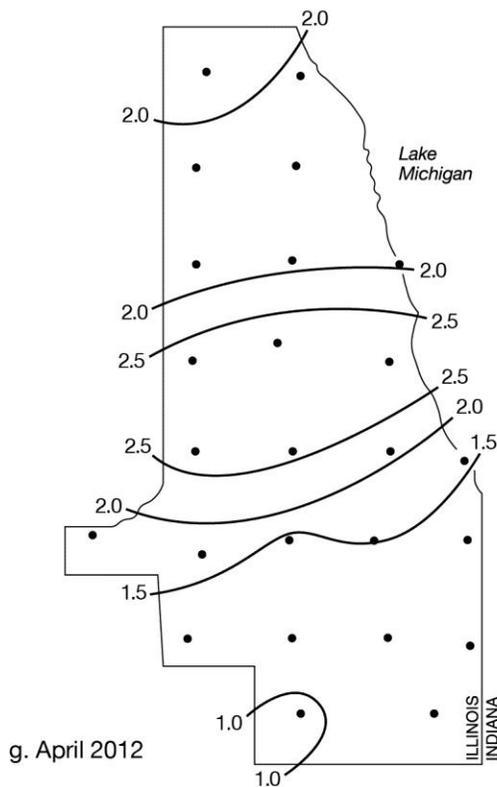
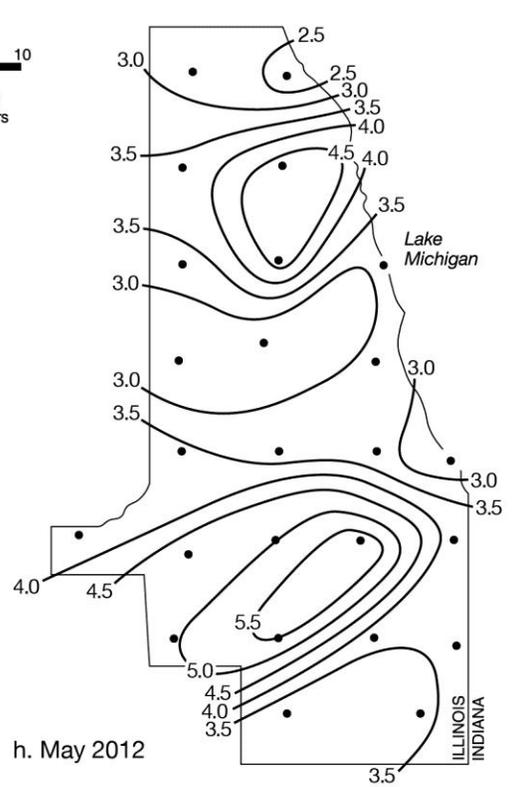
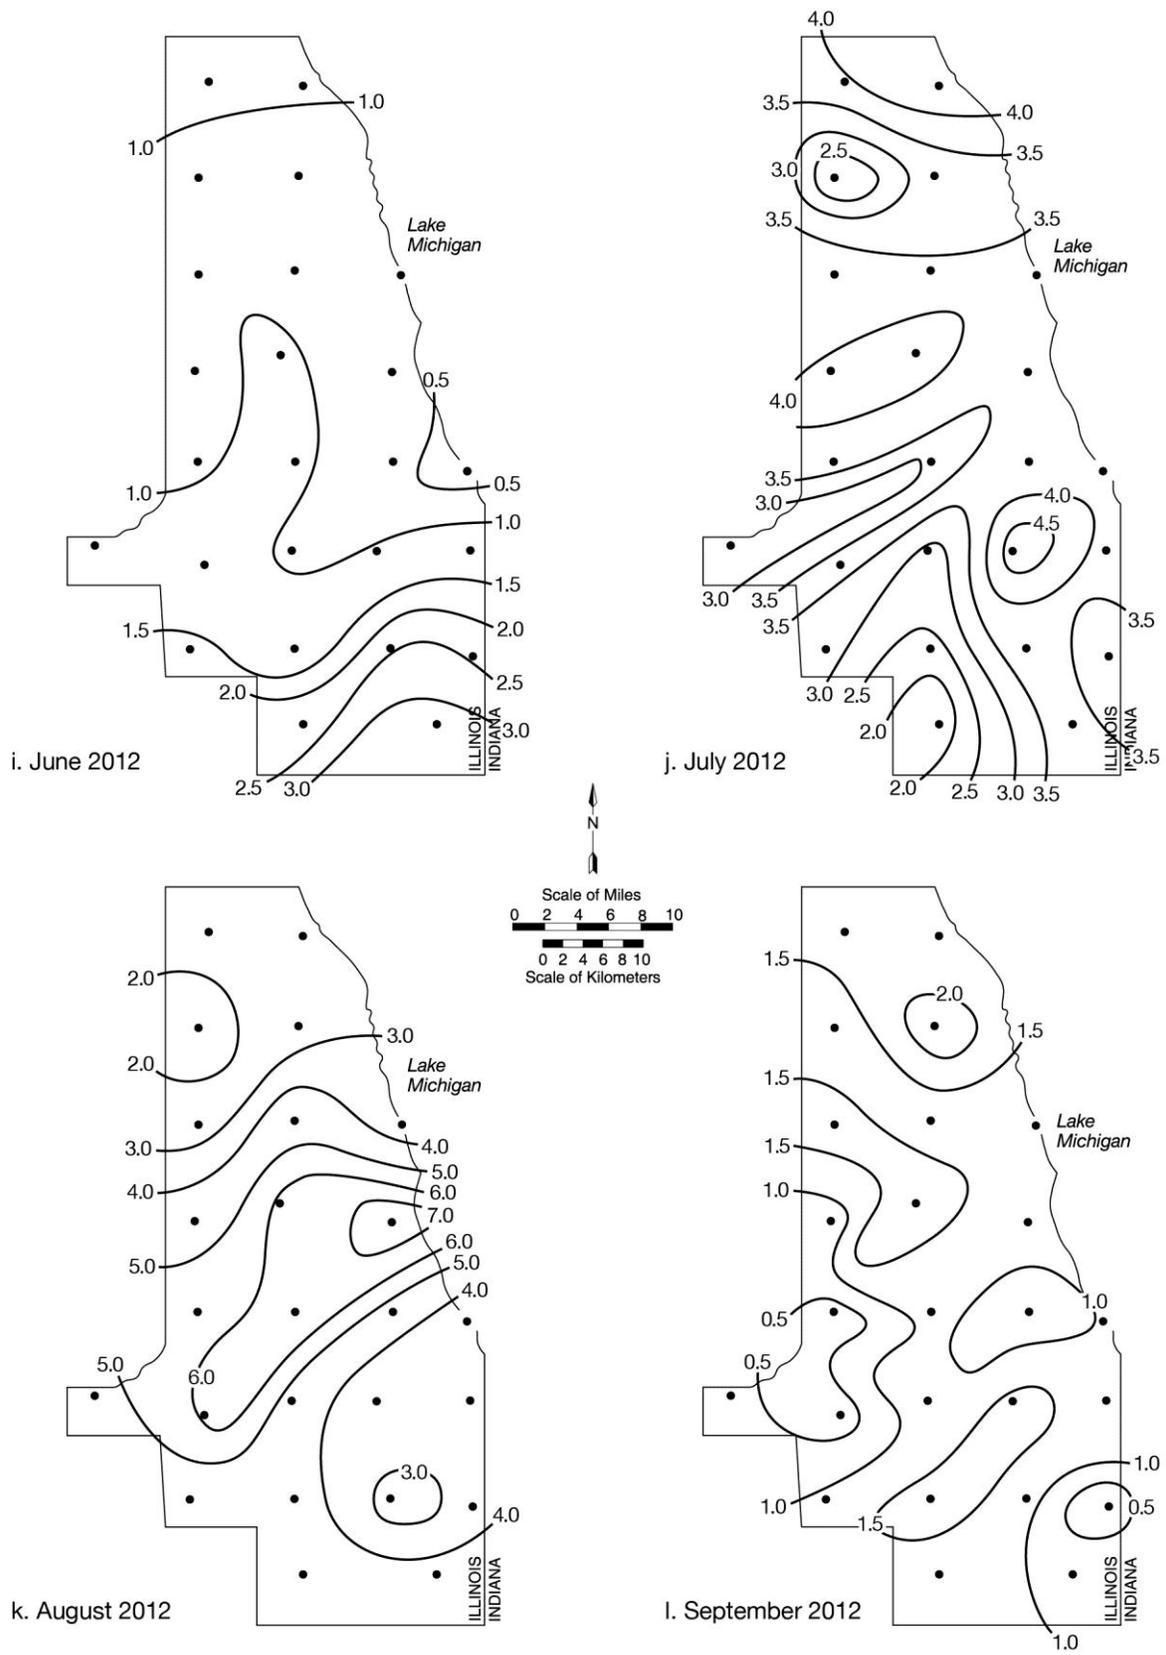
Figure 5. Precipitation pattern (inches) for October 2011–September 2012

Figure 5 presents monthly precipitation patterns for Water Year 2012. Monthly network precipitation amounts were 51 percent or less of the 22-year average in April, June, and September 2012. During the other months, network amounts ranged from 68 to 112 percent of normal. Less than 2.0 inches of precipitation fell in January, February, March, April, June, and September 2012. More than four inches of precipitation fell in August 2012.

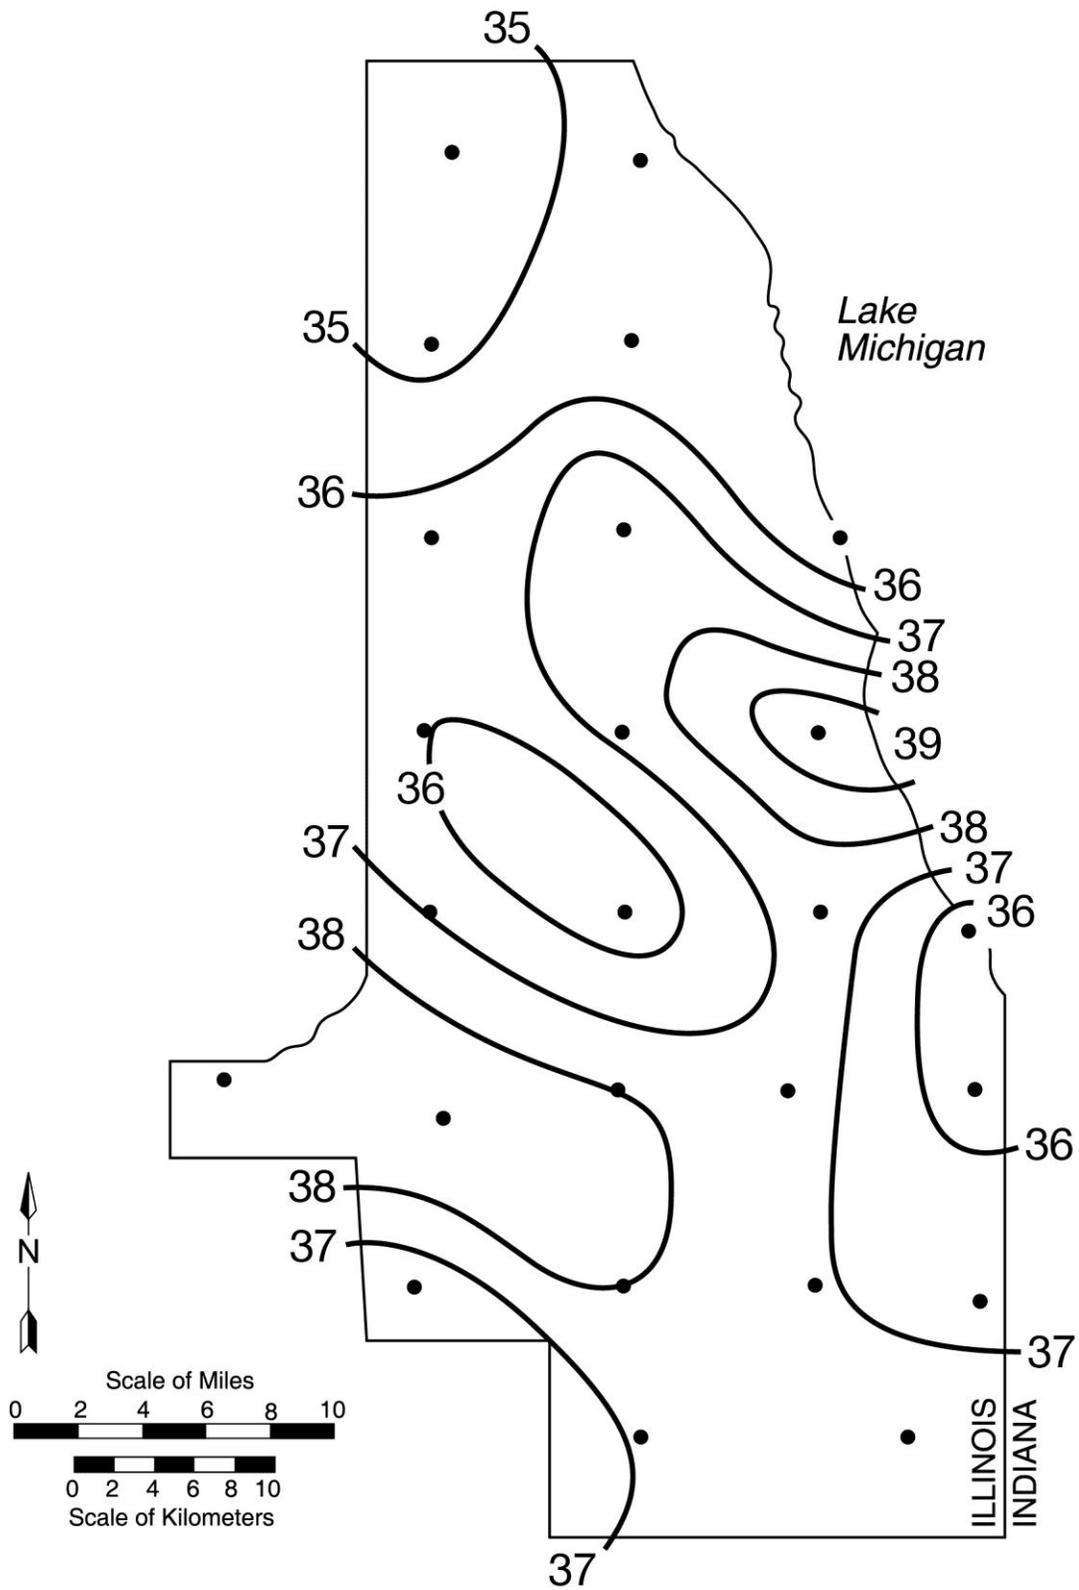
Figure 6. The 23-year average precipitation pattern (inches), Water Years 1990–2012

The 23-year (1990–2012) average precipitation pattern (Figure 6) shows, as in previous years, an area of higher values across southwestern Cook County (sites #15, #16, #17, and #21) and northward to Chicago site #10. Lower values are found at northern sites #1, #2, #3, #4, #5, and #7, and at southern sites #12, #14, and #19. The 23-year network-wide average is 36.77 inches.
